Ministry of Works
and Development
ALEXANDRA RESIDENCY

CENTRAL OTAGO IRRIGATION SCHEMES

FLOOD DAMAGE REPORT

9-11 MARCH 1987

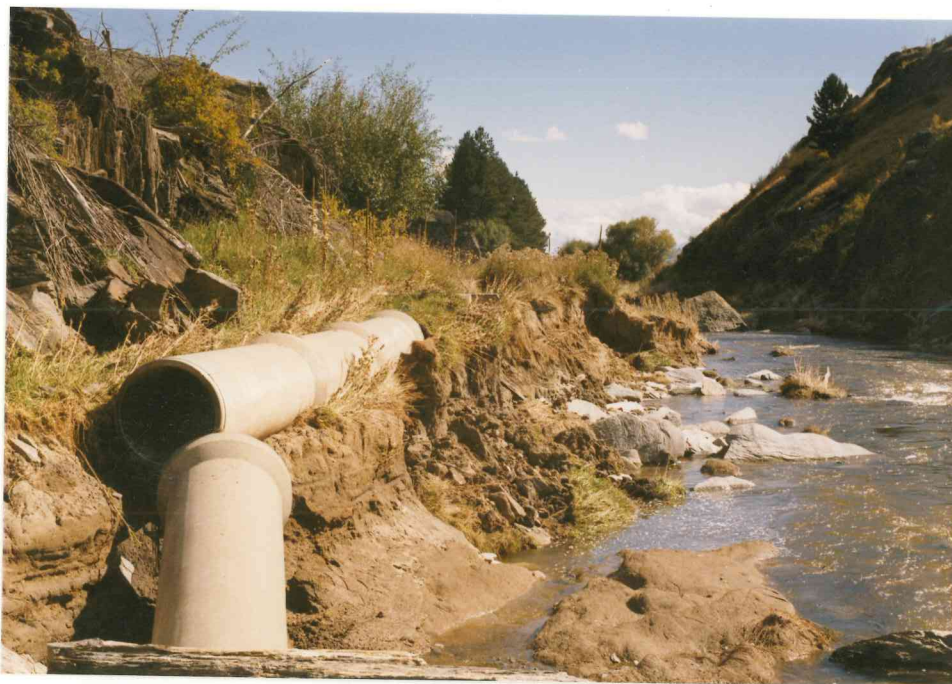
The existing intake structure over a distance of some 150 metres was washed away and a new pipeline structure is now required. The assessed very rough order costs to repair the intake has been estimated at \$11,000. However it is clear further engineering input is necessary in an effort to ensure the necessary remedial works for the Idaburn Intake are the most cost effective. The major component in any remedial proposal is the pipe conveying system.

The above photograph highlights the extent of damage to the Idaburn Intake

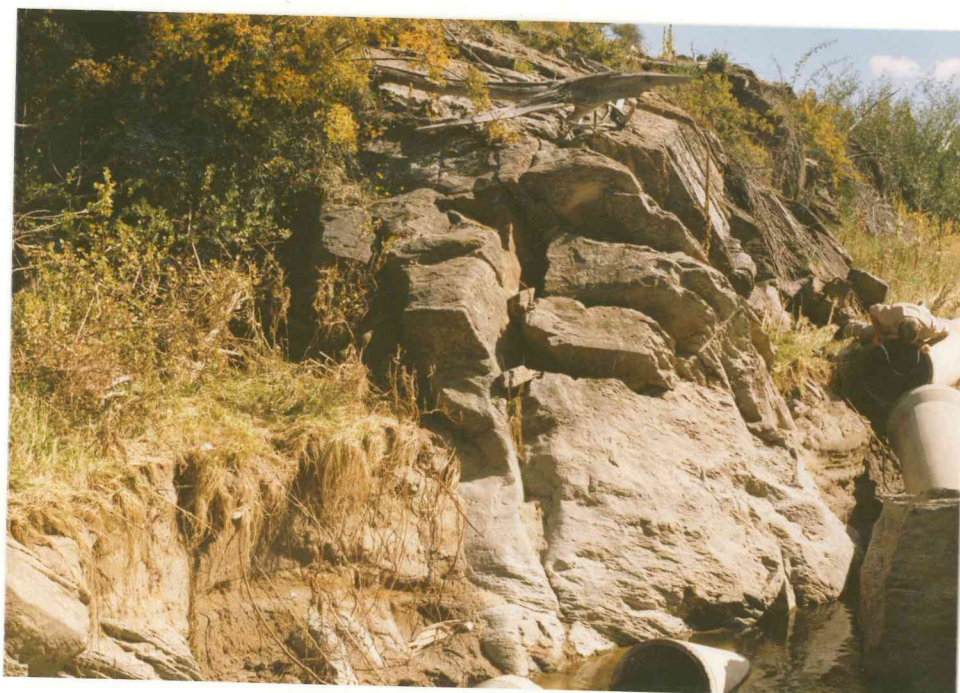
87088/E

The river has in many places eroded the bench, on which the pipeline was previously located, back to natural bedrock. Repairs will necessitate either the construction of a bench with adequate rock protection (Rip Rap) to ensure against future erosion, or some other proposal to convey the water around such areas.

Further Engineering input is required to arrive at the most cost effective proposal to convey water around the rock bluff

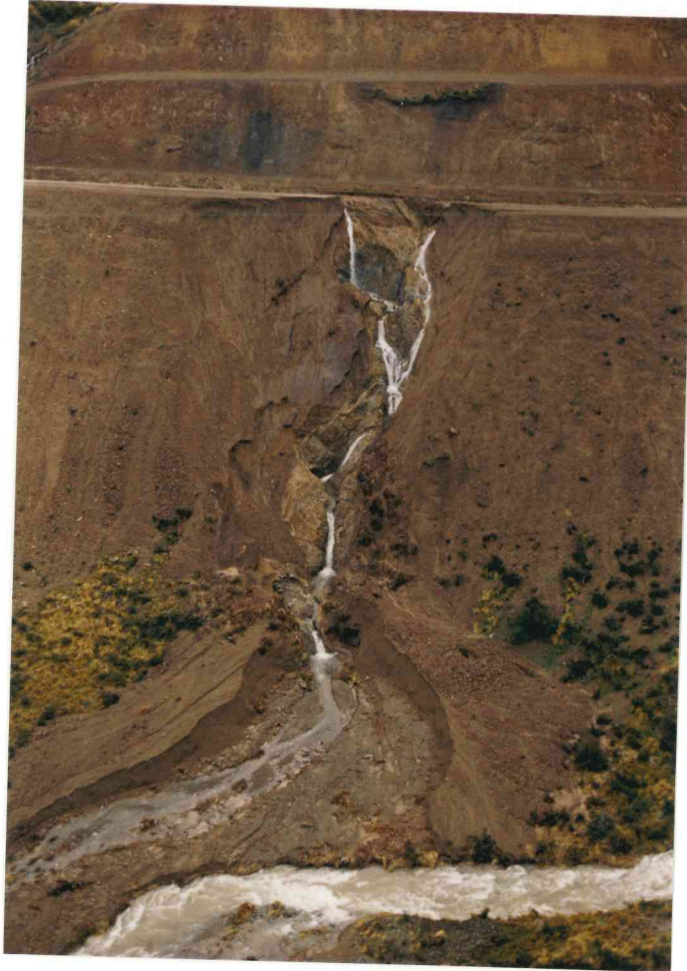
87060/8

A major race failure has occurred in the main race at Pierces Gorge which will involve significant remedial earthworks. The estimated cost of repairs is estimated at \$14,000.

Photograph highlighting the extent of the
Pierces Gorge Race failure

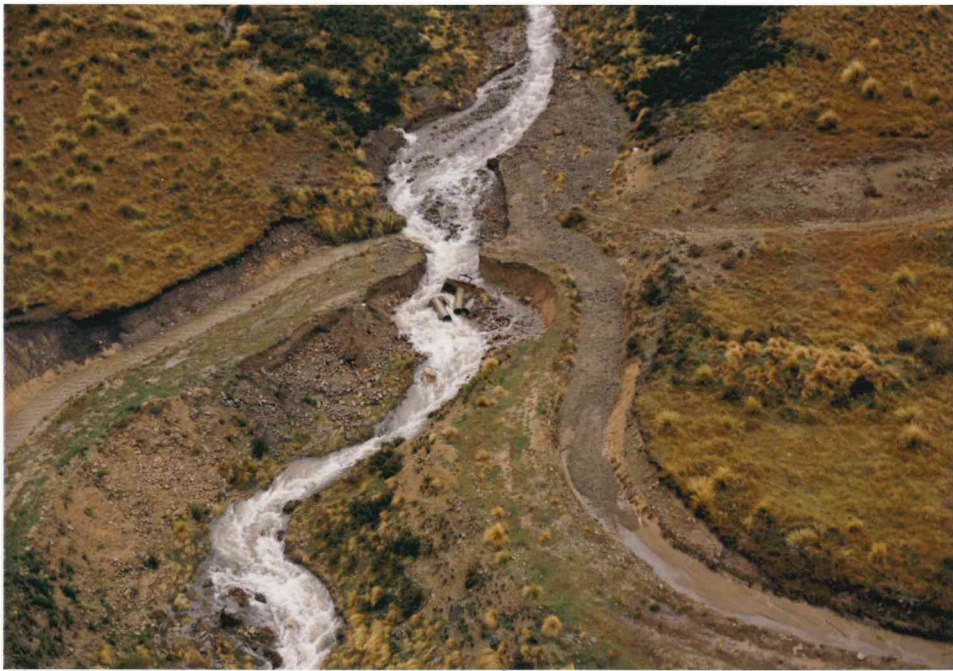
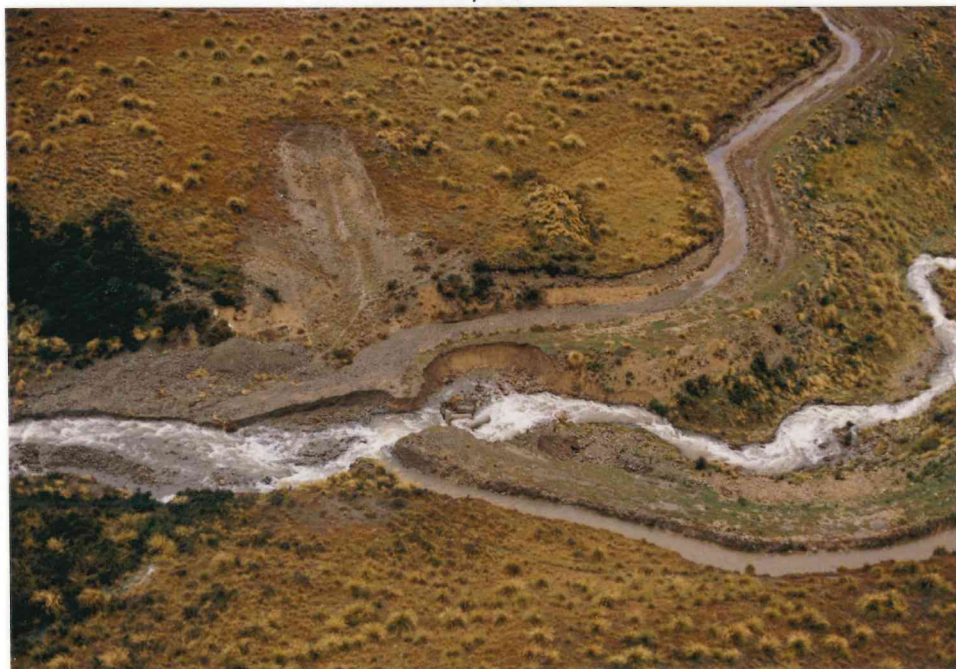
The existing bywash structure has been completely destroyed and the estimated cost to repair the structure to the previous standards is estimated at \$13,000. However in view of the high estimated repair cost, a revised approach to the method and location of bywash structures may have to be considered.

Photograph highlights the damage suffered to the Gate Creek

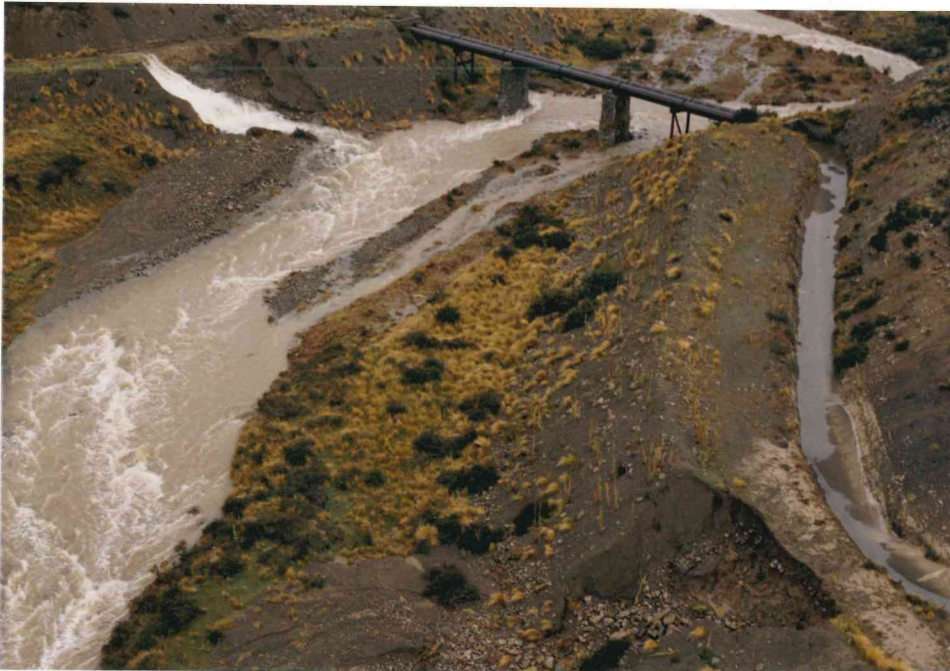
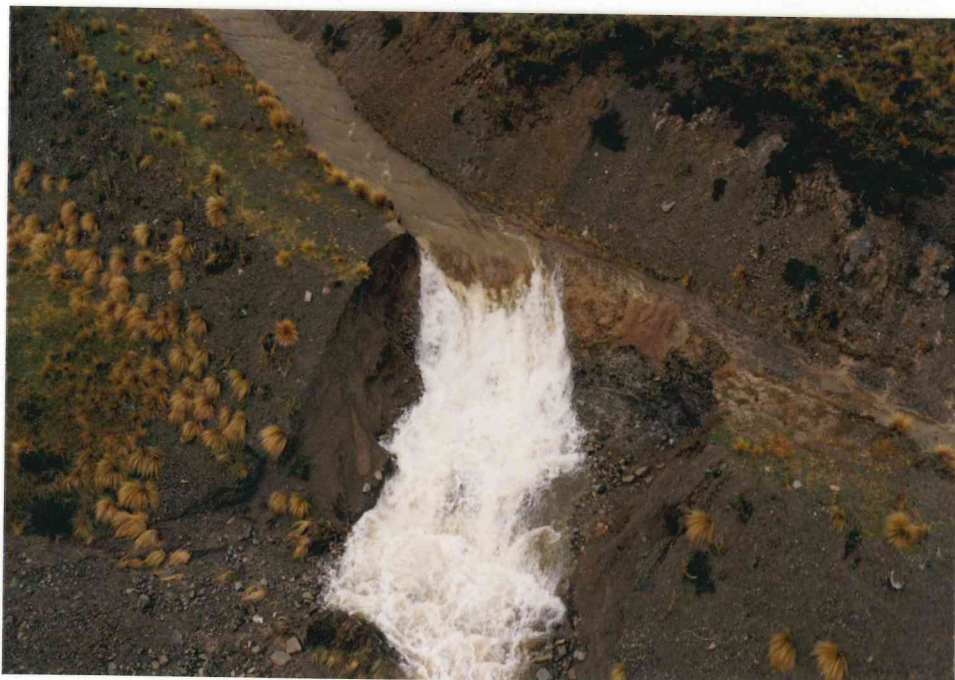
A major race failure has occurred immediately upstream of the Johnstone Creek Syphon. Remedial earthworks to repair the race bank and access track has been estimated at \$6,500.

Johnstone Creek Race Failure

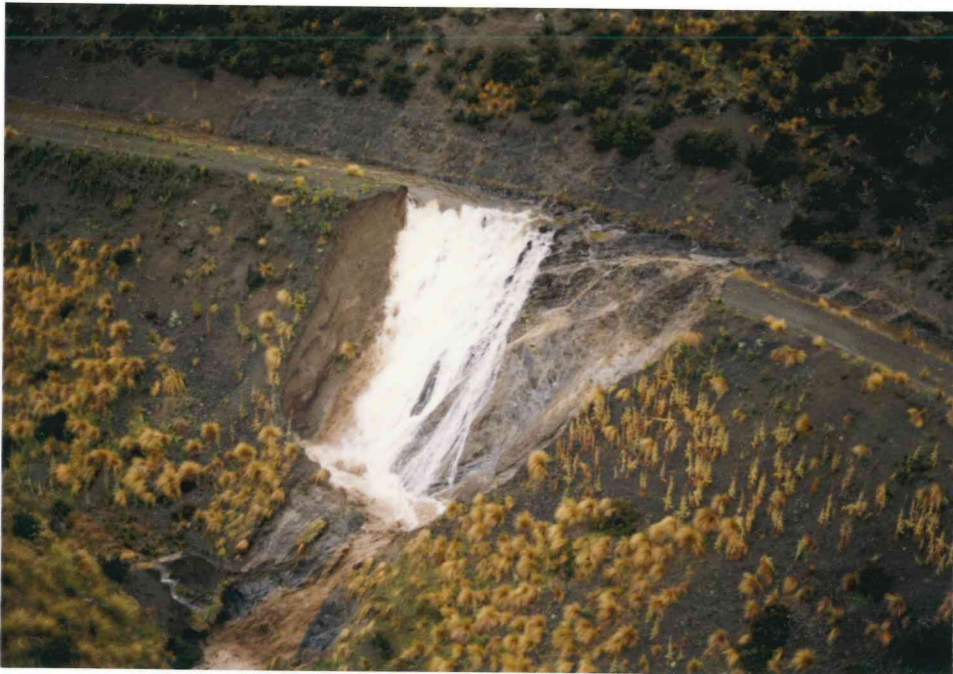
87060/25

A race failure has occurred at Dillons Gorge which will involve significant remedial earthworks. Earthwork costs have been estimated at \$6,500.

Dillons Gorge Race failure

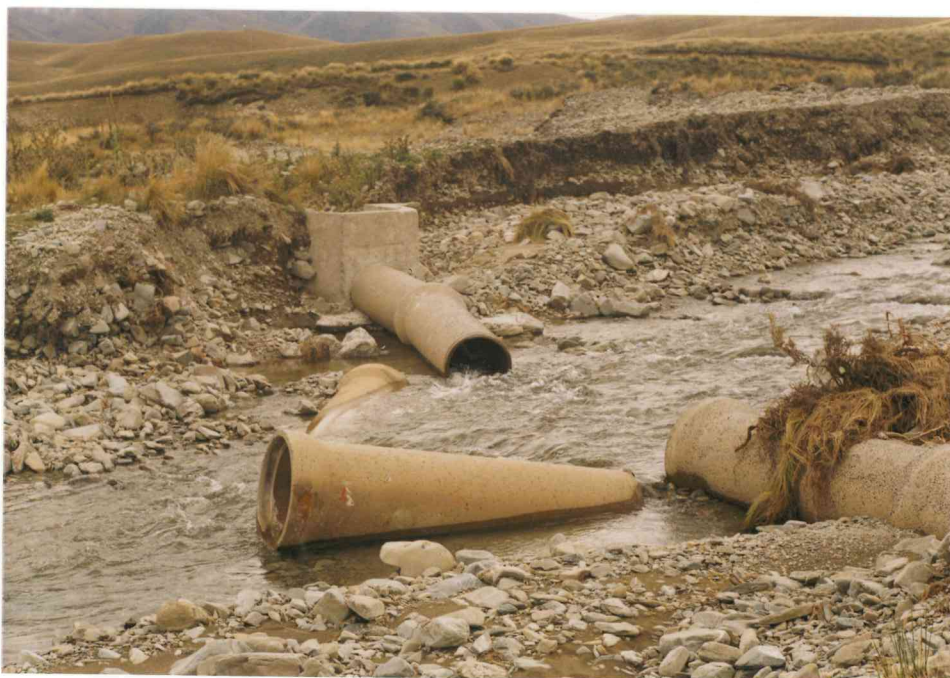
87082/9

The Boundary Creek Syphon has been severely damaged with at least three or four pipes being washed out. One could suggest that many of the syphons are rapidly turning into aqueducts. Costs to repair the syphon has been estimated at \$3,500.

Boundary Creek Syphon failure

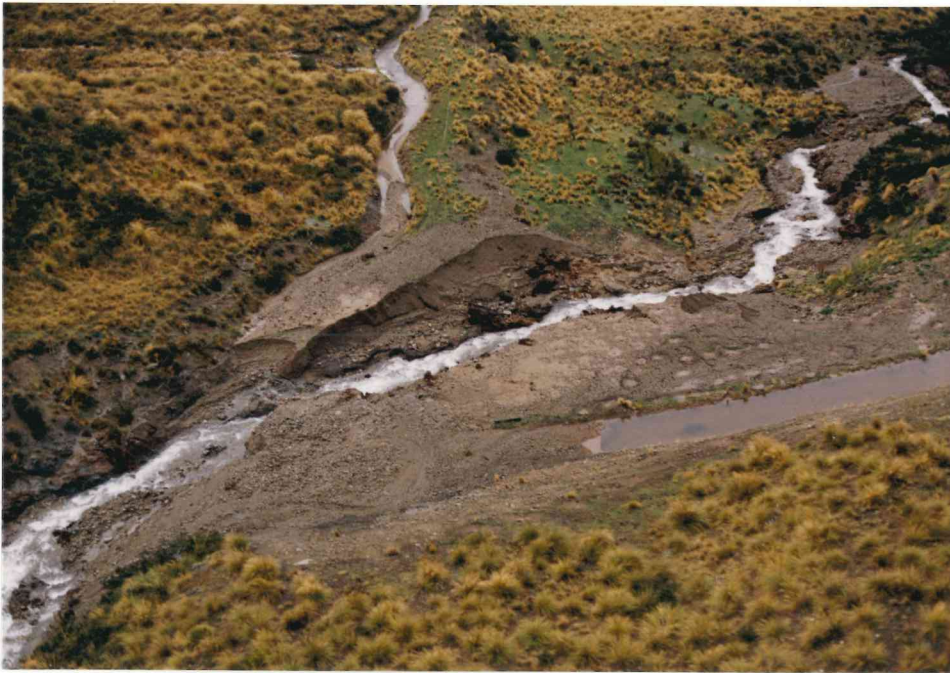
87060/16

Photograph highlighting damage to the
Mount Ida race at Little Ten Chain Creek

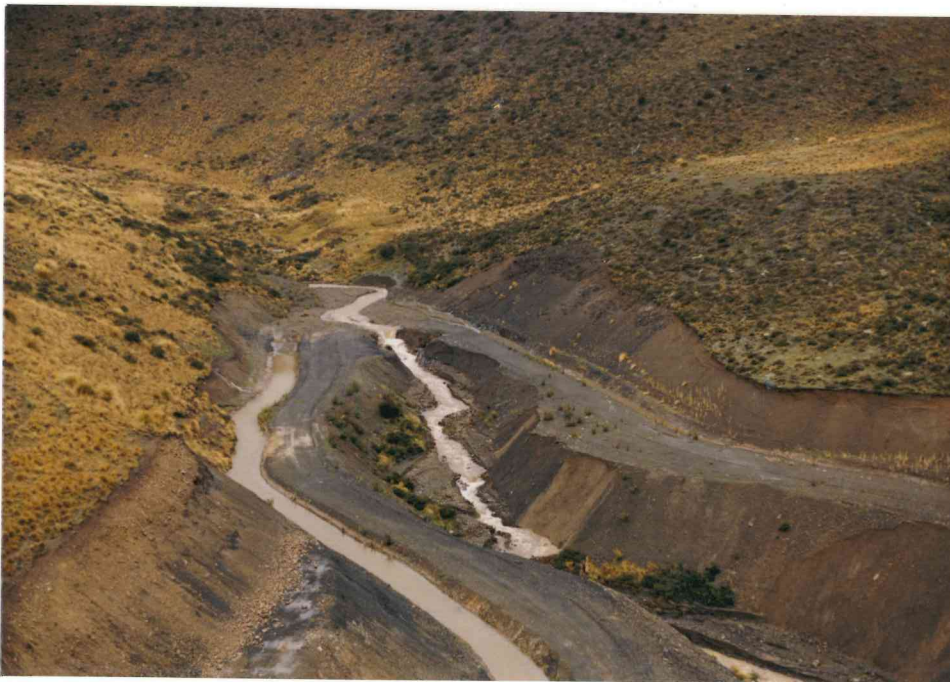
87060/2

Photograph highlighting damage to the
Ida race at Peepoes Creek

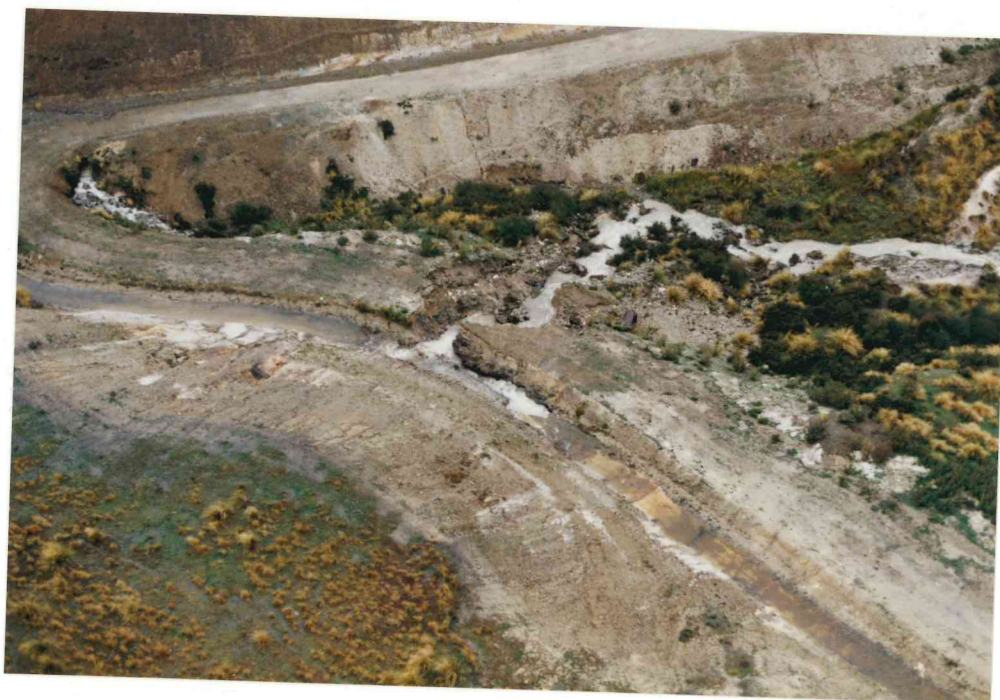
87060/11

Photograph highlighting race failure at
Coal Gully

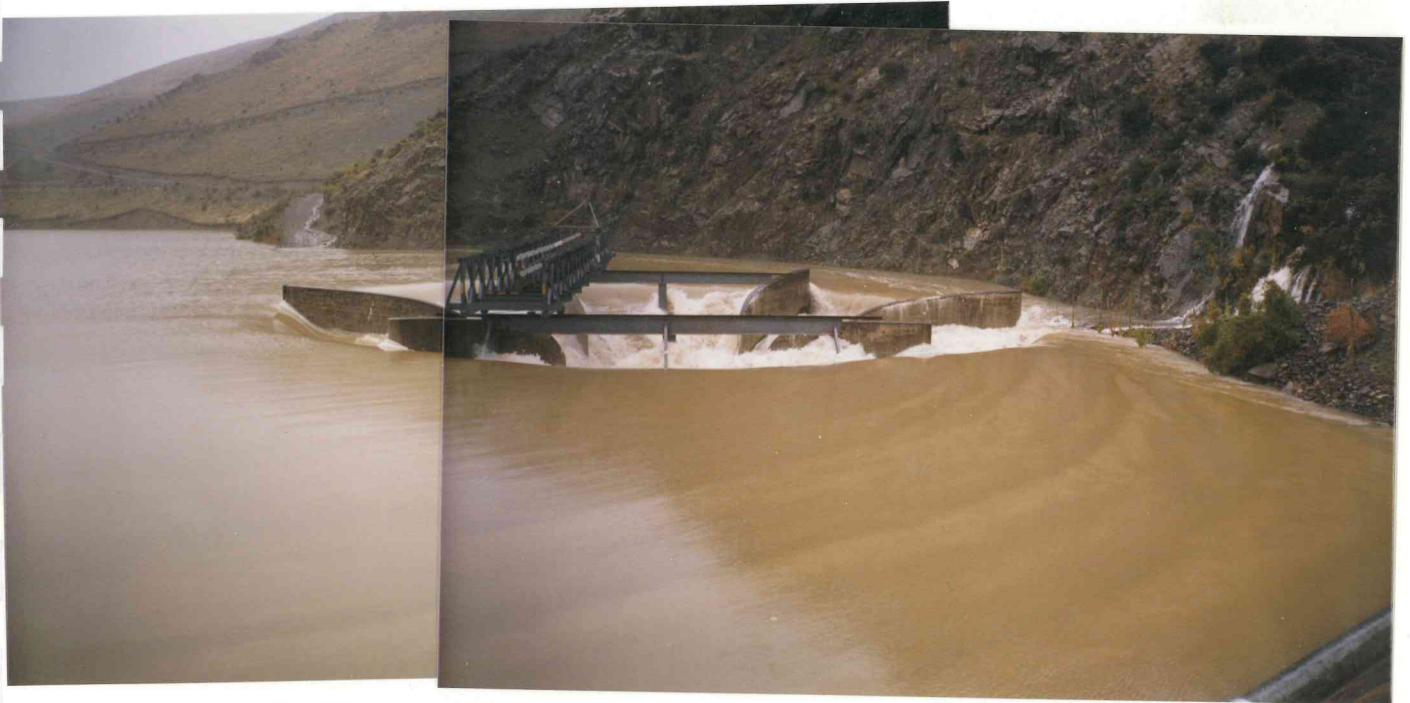
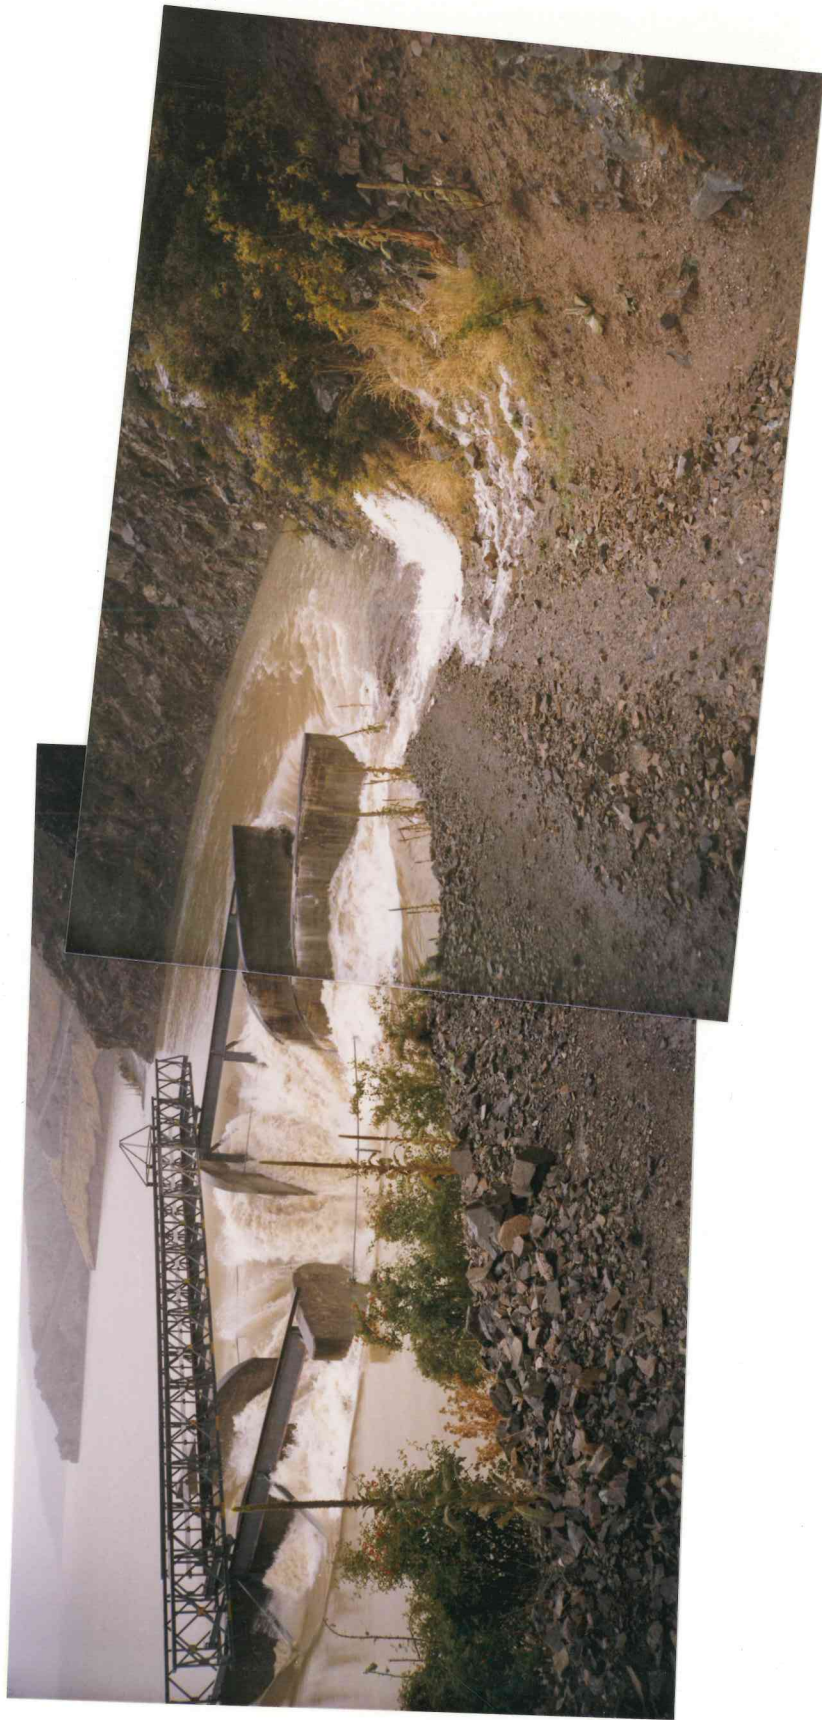
A further point of concern is the access track which is used for launching boats etc. it is clear the construction of the ramp inhibits discharge especially during flood conditions.

Photographs highlighting the close proximity of
the boat launching ramp to the spillway

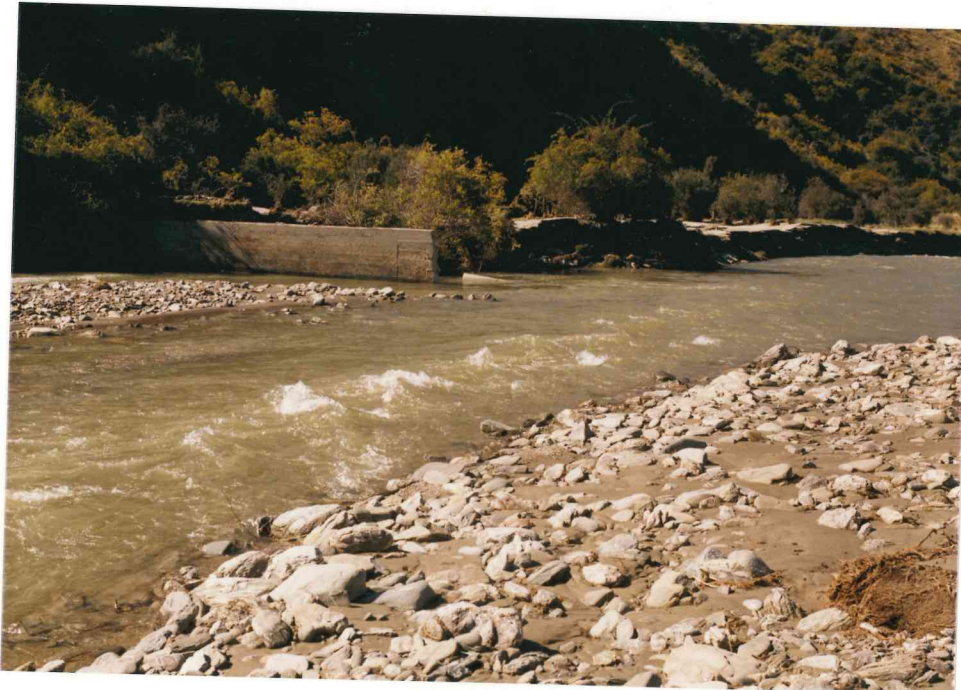
87079/16

The existing intake structure has been substantially damaged with a section of the structure being destroyed completely. Estimated cost of repairs has been assessed at \$5,500.

Photograph highlighting the section of
Intake which was completely destroyed

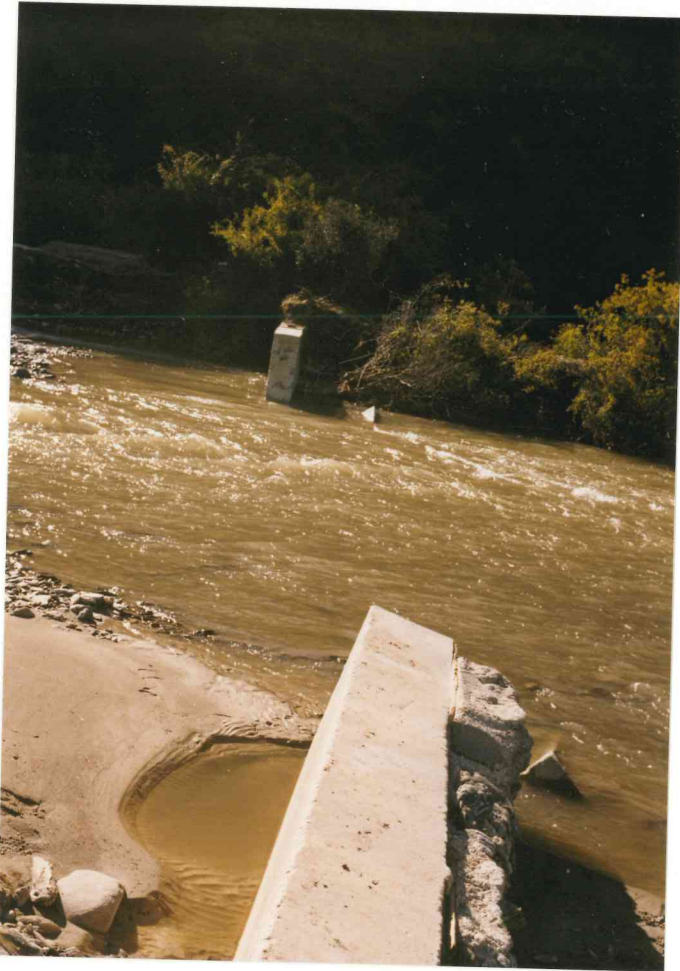
87079/19

Photograph highlighting the movement off line of the right hand abutment and the section which was completely destroyed

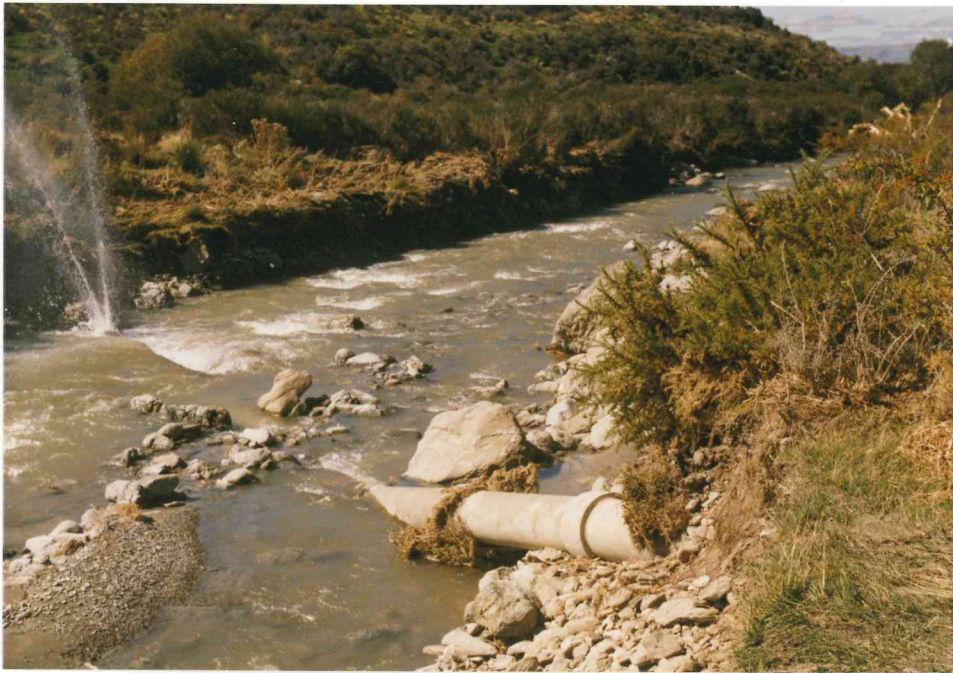
87086/13A

The above syphons have been exposed in the river bed and as a consequence, suffered minor structural damage. Remedial repairs involving patching and rock protection has been estimated at \$3,500.

Photograph showing damage to the Matakanui 'A' syphon which traverse under Thomson Creek

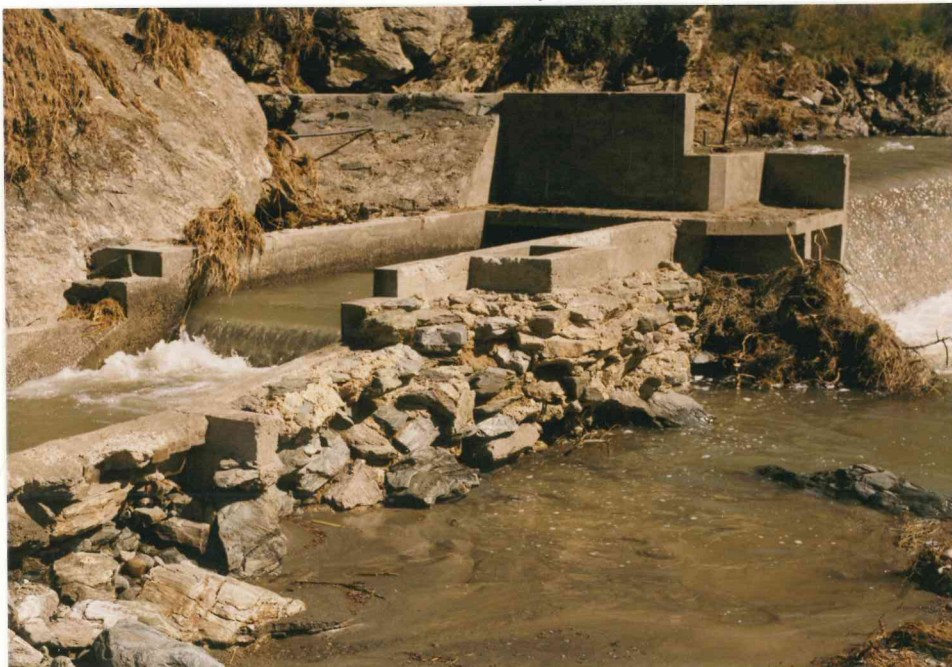
87086/17A

Repairs to the above intake involving mechanical plant and materials has been estimated at \$1,700.

Matakanui Main Intake

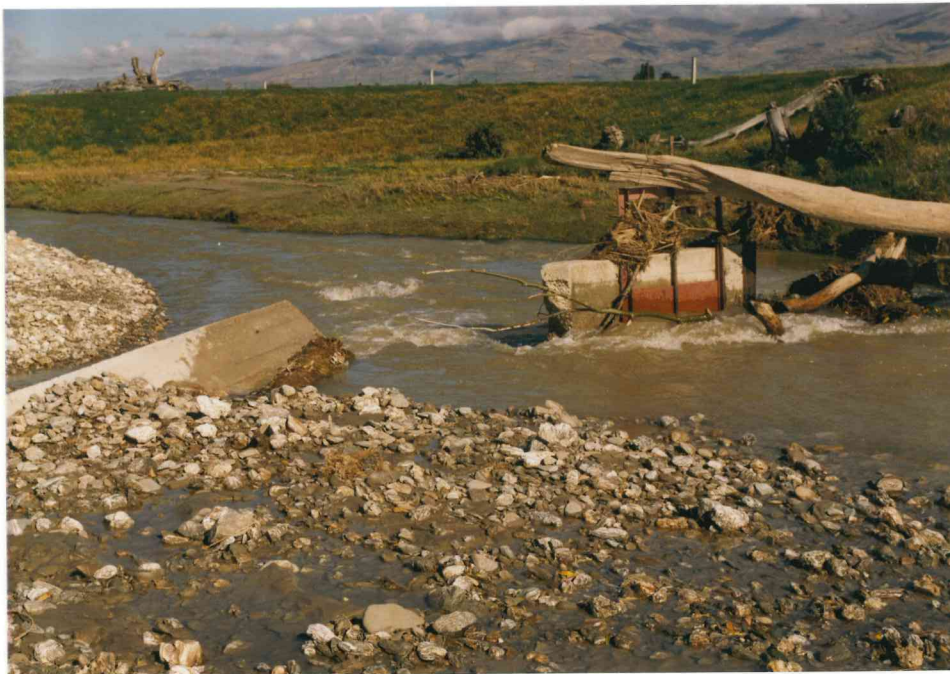
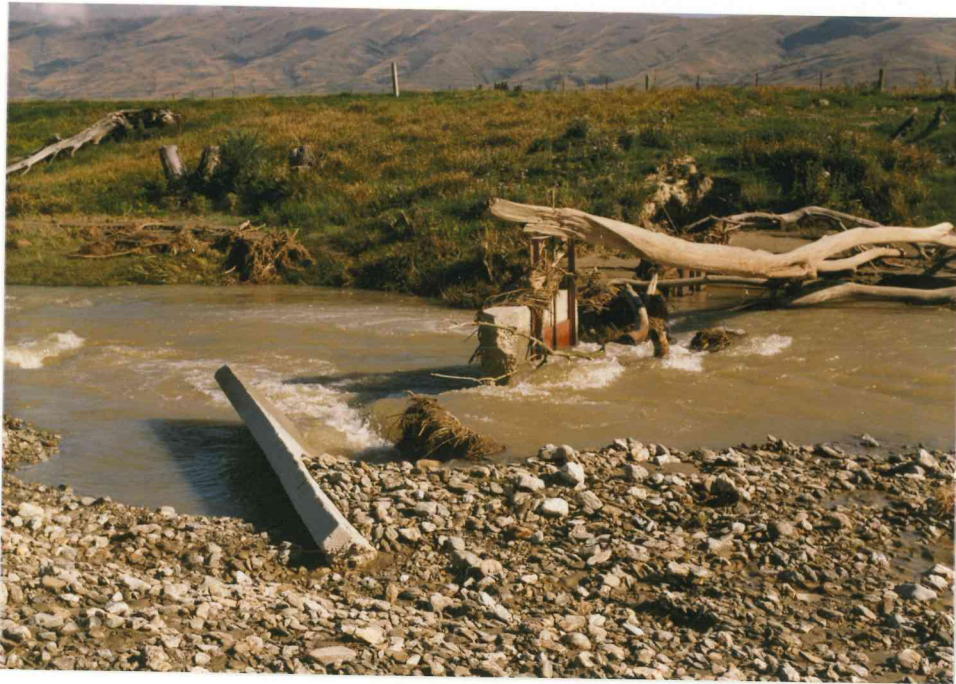
The above intake has suffered major damage and repairs involving mechanical plant, the purchase of ten 600 mm diameter (RCRRJ) pipes and miscellaneous material has been estimated at \$6,500.

Photographs highlighting damage
to the Clear Water Intake

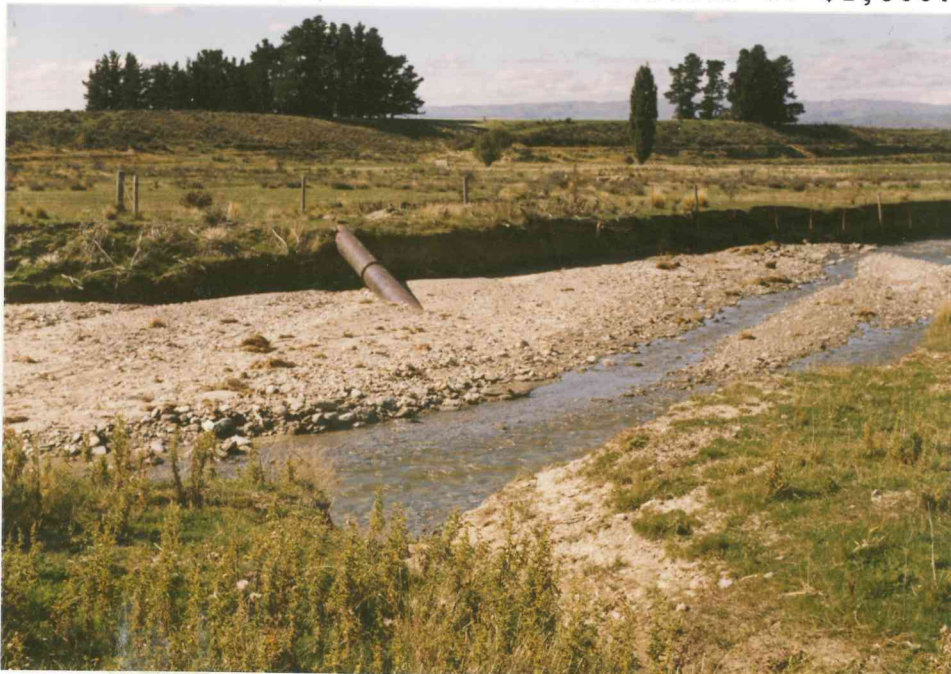
87086/7A

Repairs involving mechanical plant and the purchase of six second hand steel pipes has been estimated at \$2,500.

County Pipeline under Devonshire Creek

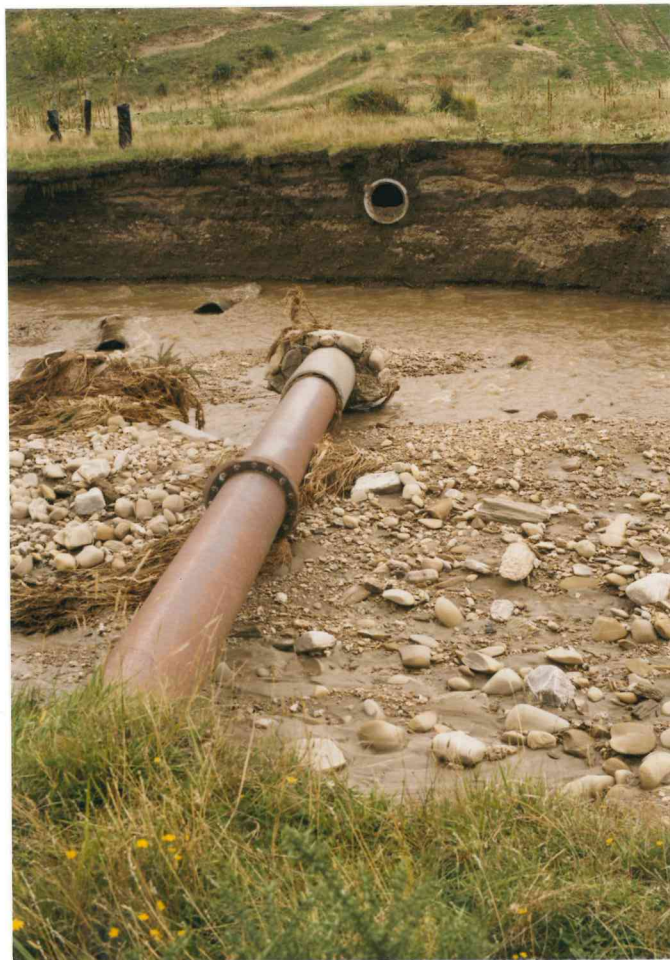
87084/09

The Waikerikeri Syphon has once again been washed out and is in reality, rapidly turning into an aqueduct. Temporary repairs have already commenced and (ROC) costs to carry out temporary repairs to the above syphon is estimated at \$3,700.

Waikerikeri Syphon

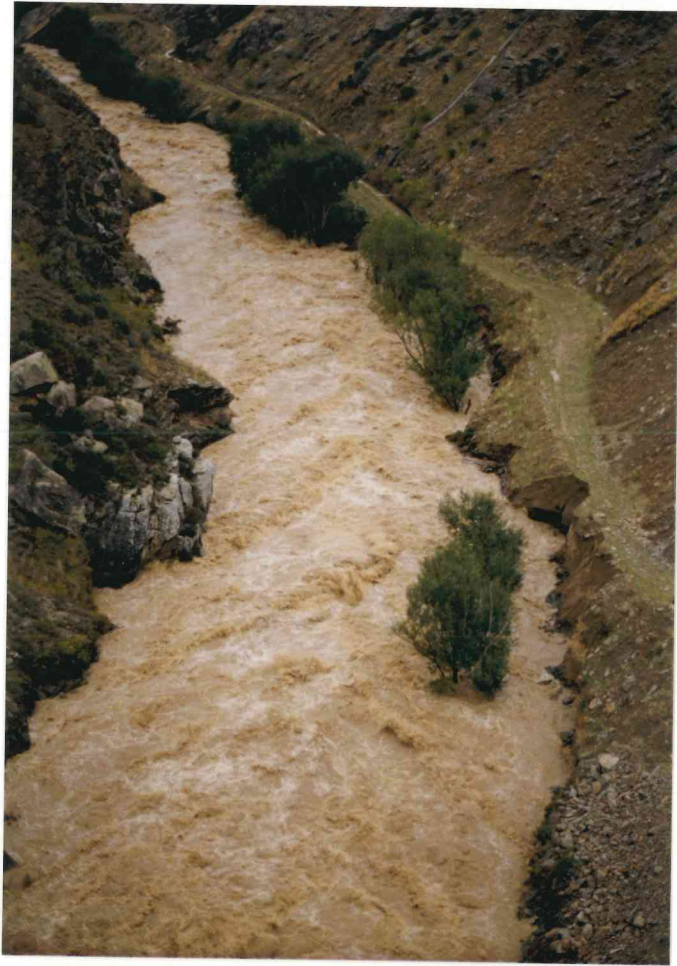
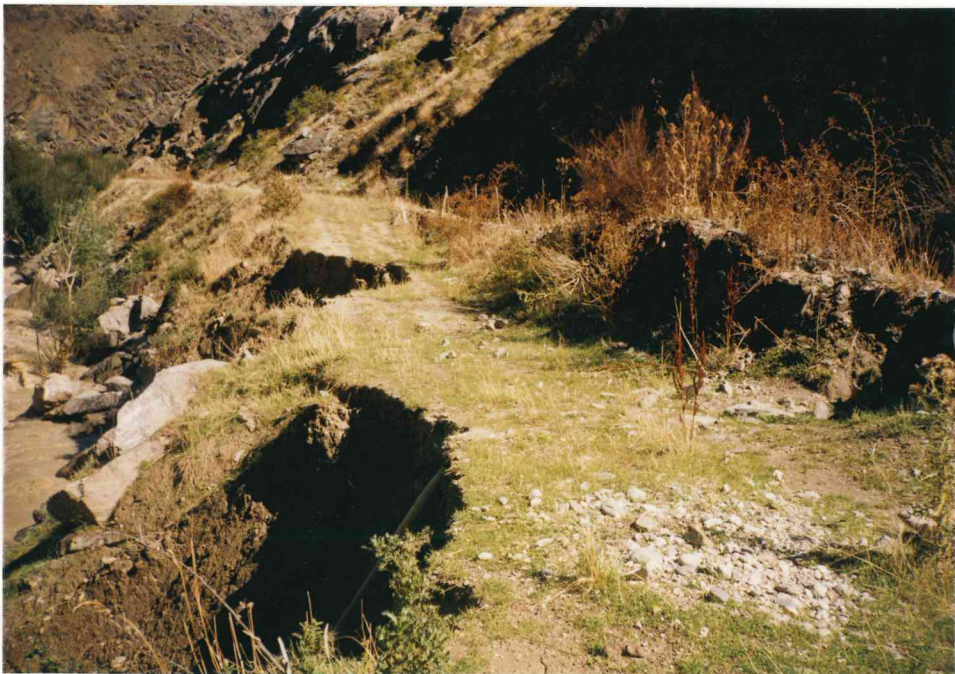
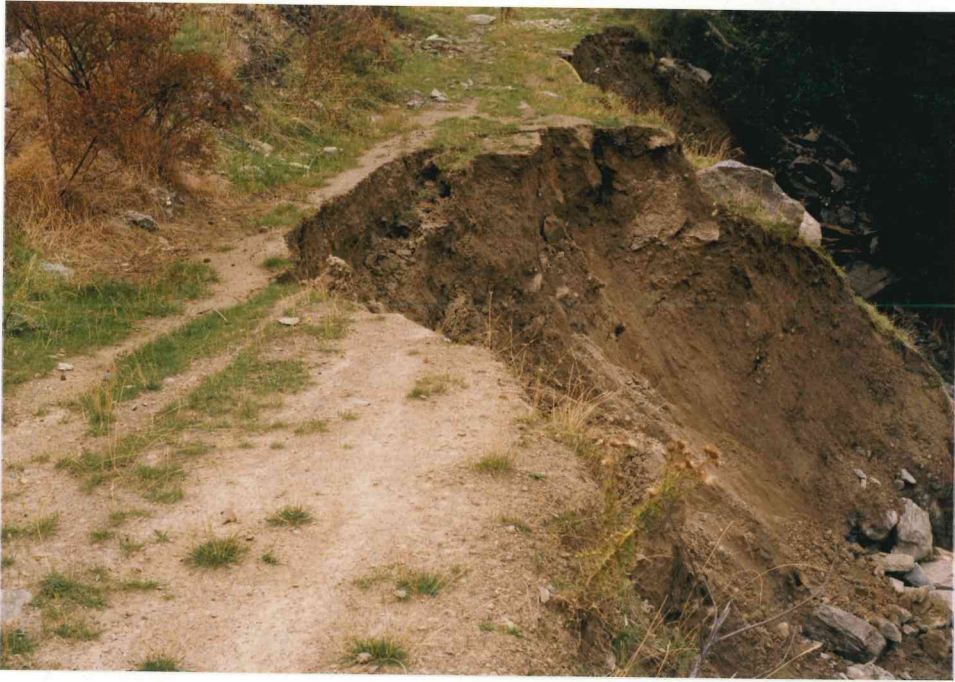
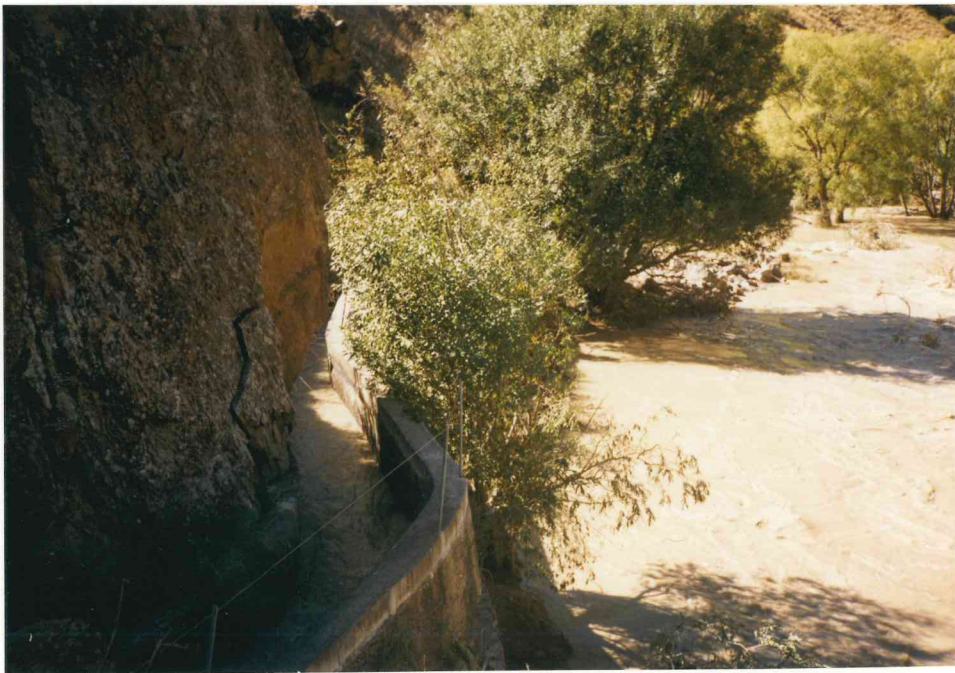
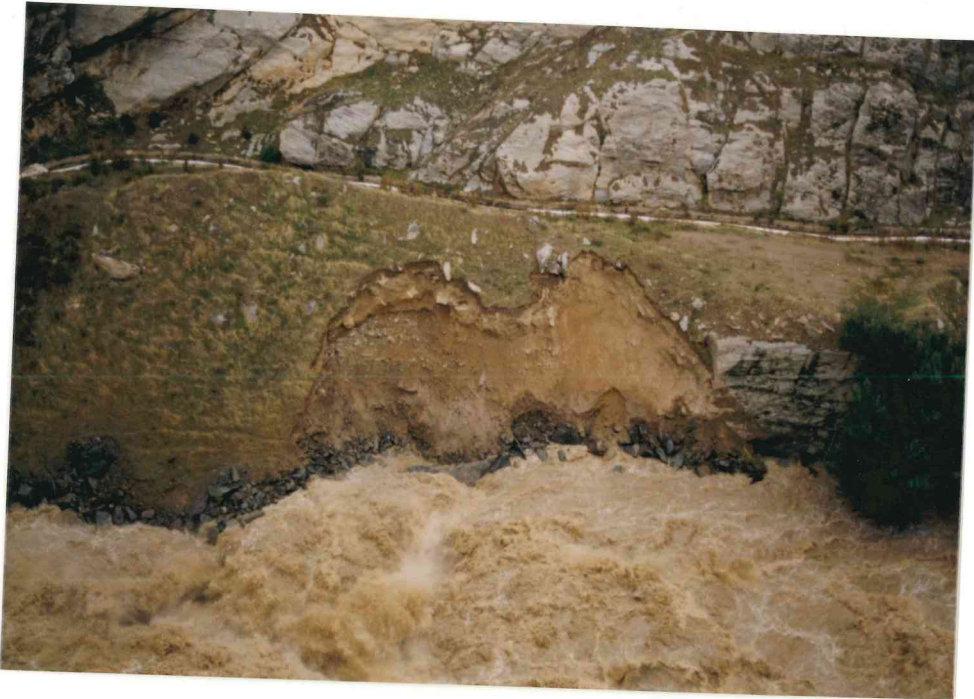
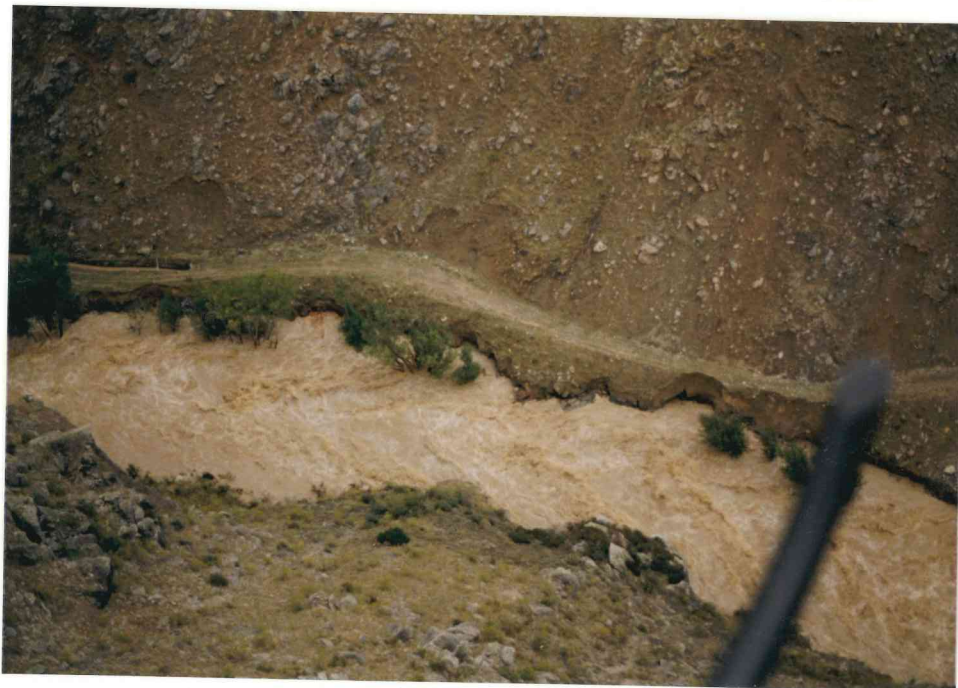
The Chatto Creek Gorge access track has suffered significant undermining and erosion, and although there is no immediate danger to the integrity of the race system, the long term stability is of some concern. The access track in parts can now only be traversed by motorcycle and it is clear further engineering input is required prior to remedial works being undertaken.

Chatto Creek Gorge
Photograph highlighting extent of erosion and
undermining to access track

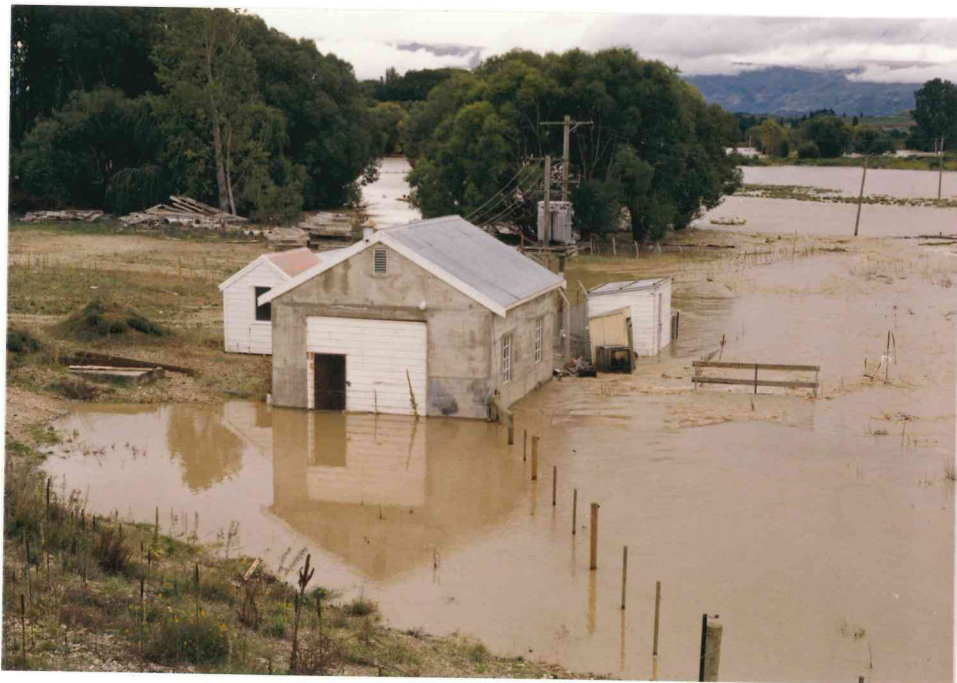
87065/10

The Galloway pumphouse escaped major damage with only the small pump being partly submerged and therefore requiring dismantling and drying out. Costs to completely dismantle and clean the small pump and to repair/replace the fuses, contacts, and the main switch is assessed at approximately \$2,000.

Galloway Pumphouse during flooding

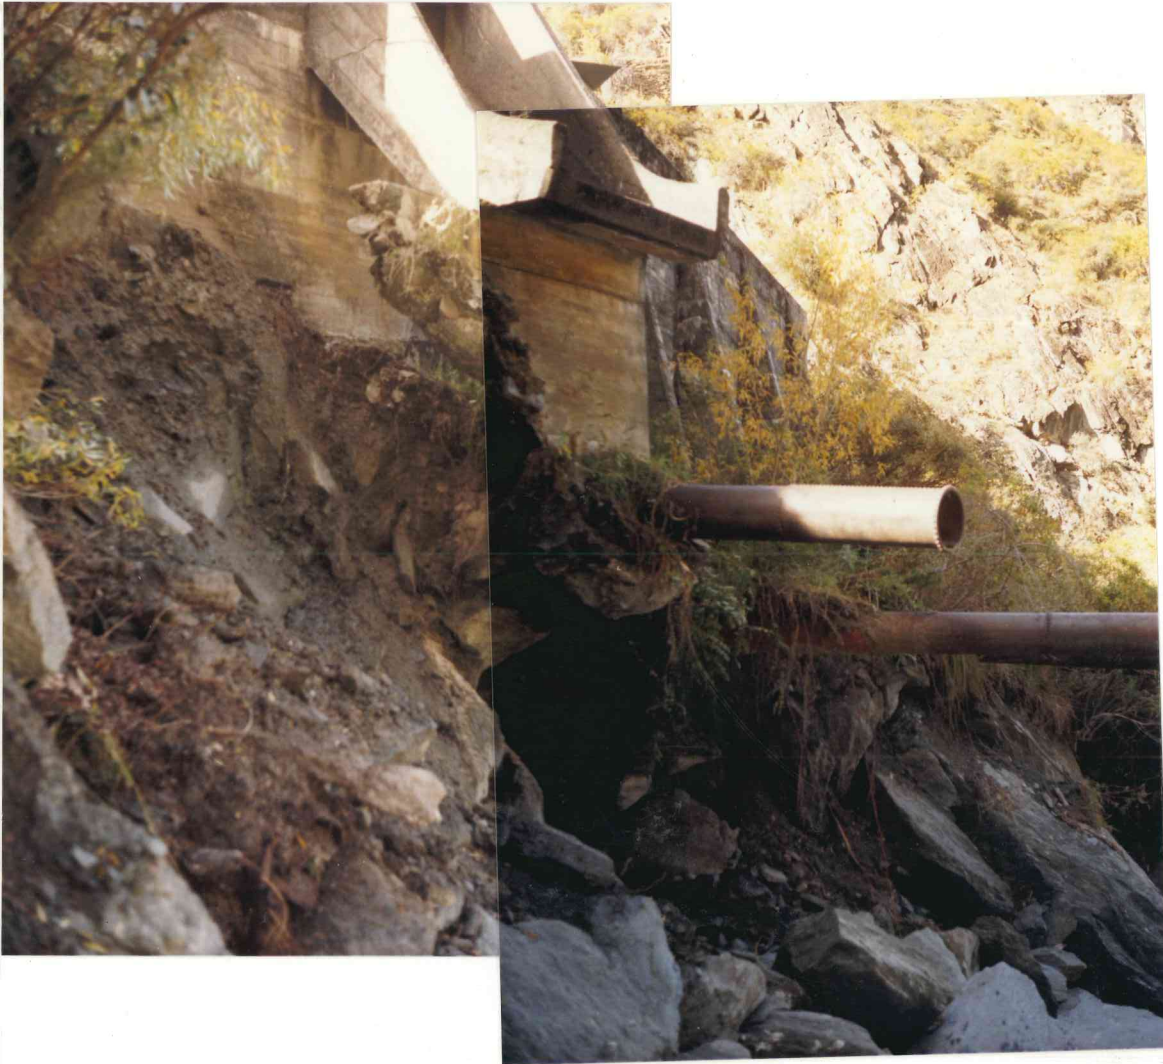
View from the Arrow river looking directly towards the desilting structure. The bywash structure is reliant entirely on support gained from the 'flushing' pipes and the river has significantly undermined the toe of the batter.

The concrete bywash structure fixed to the side of the desilter appears now to be reliant entirely on the support gained from the steel desilting outlet pipes.
