Ministry of Works
and Development
ALEXANDRA RESIDENCY

CENTRAL OTAGO IRRIGATION SCHEMES

FLOOD DAMAGE REPORT

9-11 MARCH 1987

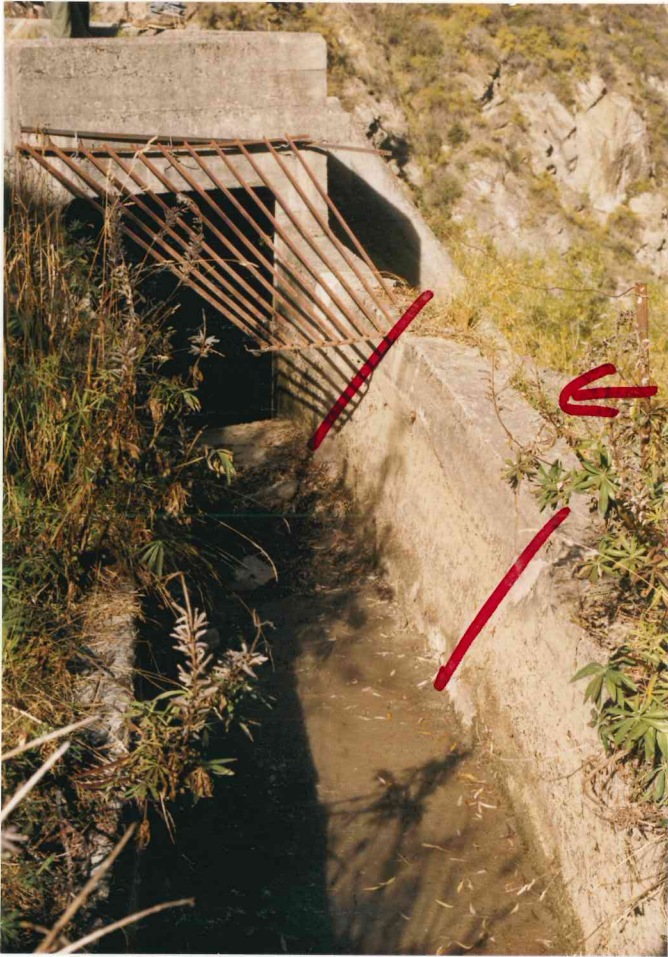
View of the race inlet to the desilting structure. The area marked has moved and as a result of the downstream erosion there is now little lateral support.

A section of the true right hand side has moved and as a result of the erosion on the downstream side, there is now little lateral support and it is very conceivable this section could fail entirely.

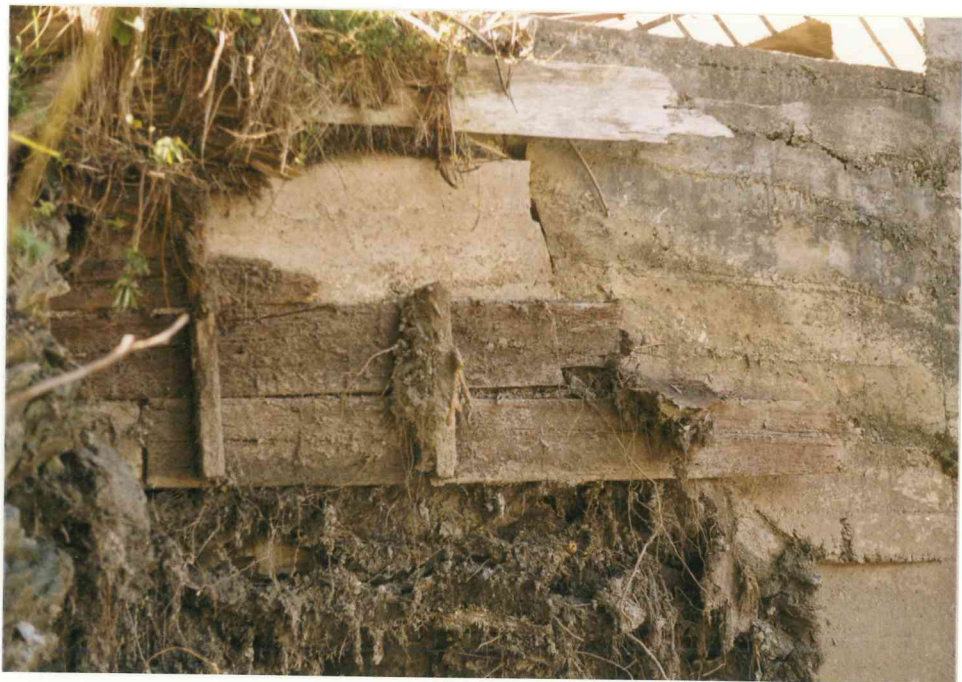
View of the above area from the downstream or river side.

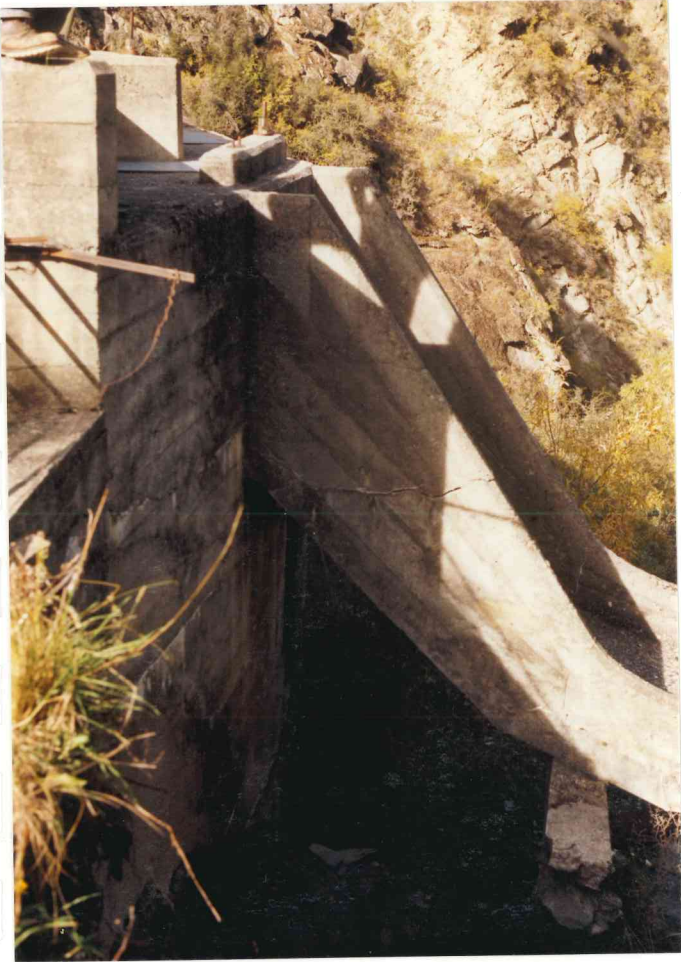
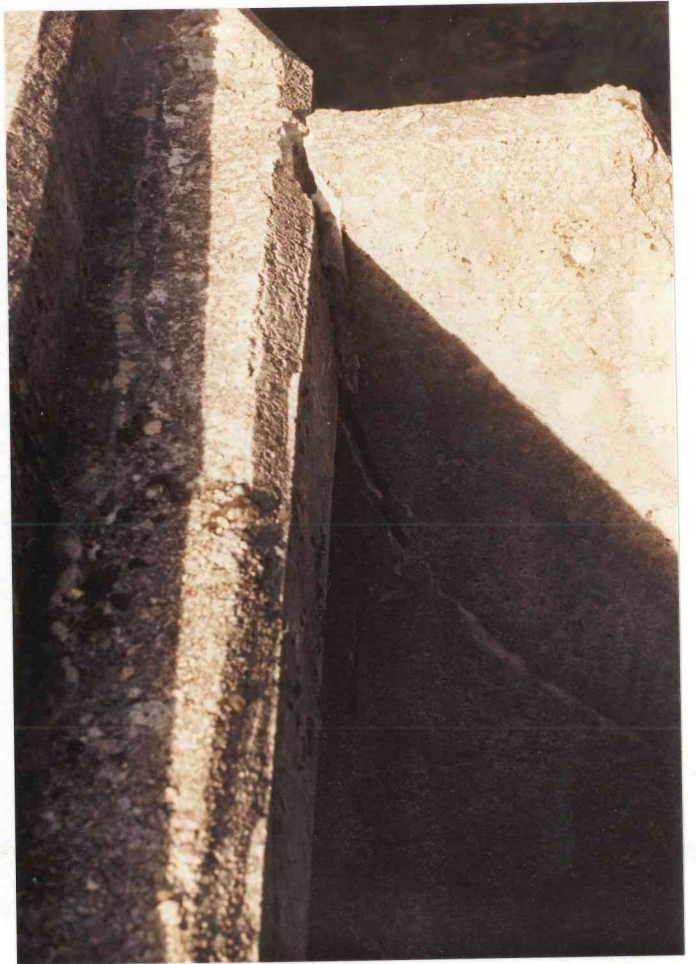
View of the concrete bywash structure highlighting the severe cracking and movement to date.

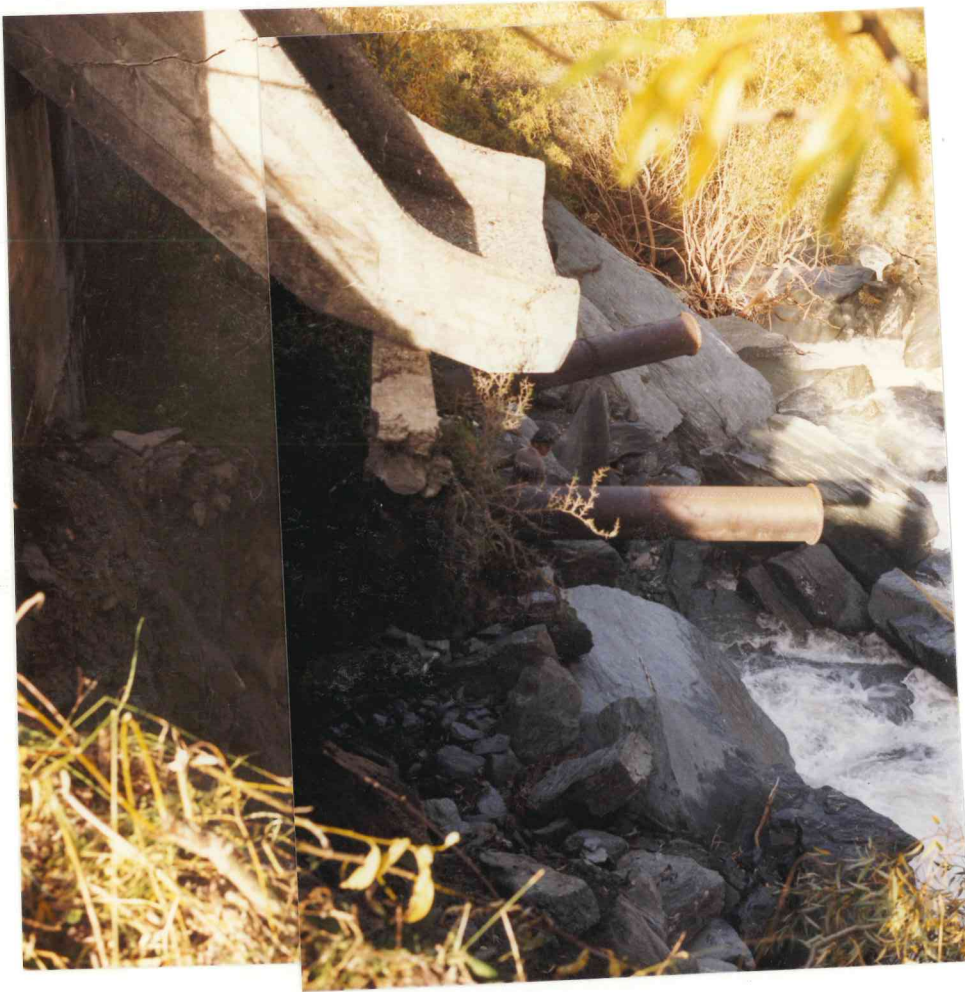
Photographs highlighting the extent of erosion damage to the toe of the batter on which the desilter structure is located.

A site visit by Messrs D Patterson, Q McCarthy and M Robins (Chairman of the Arrow Scheme) confirmed the Arrow desilter structure sustained damage as a result of the toe of the batter on which the desilter is located, being severely eroded during high river flows.

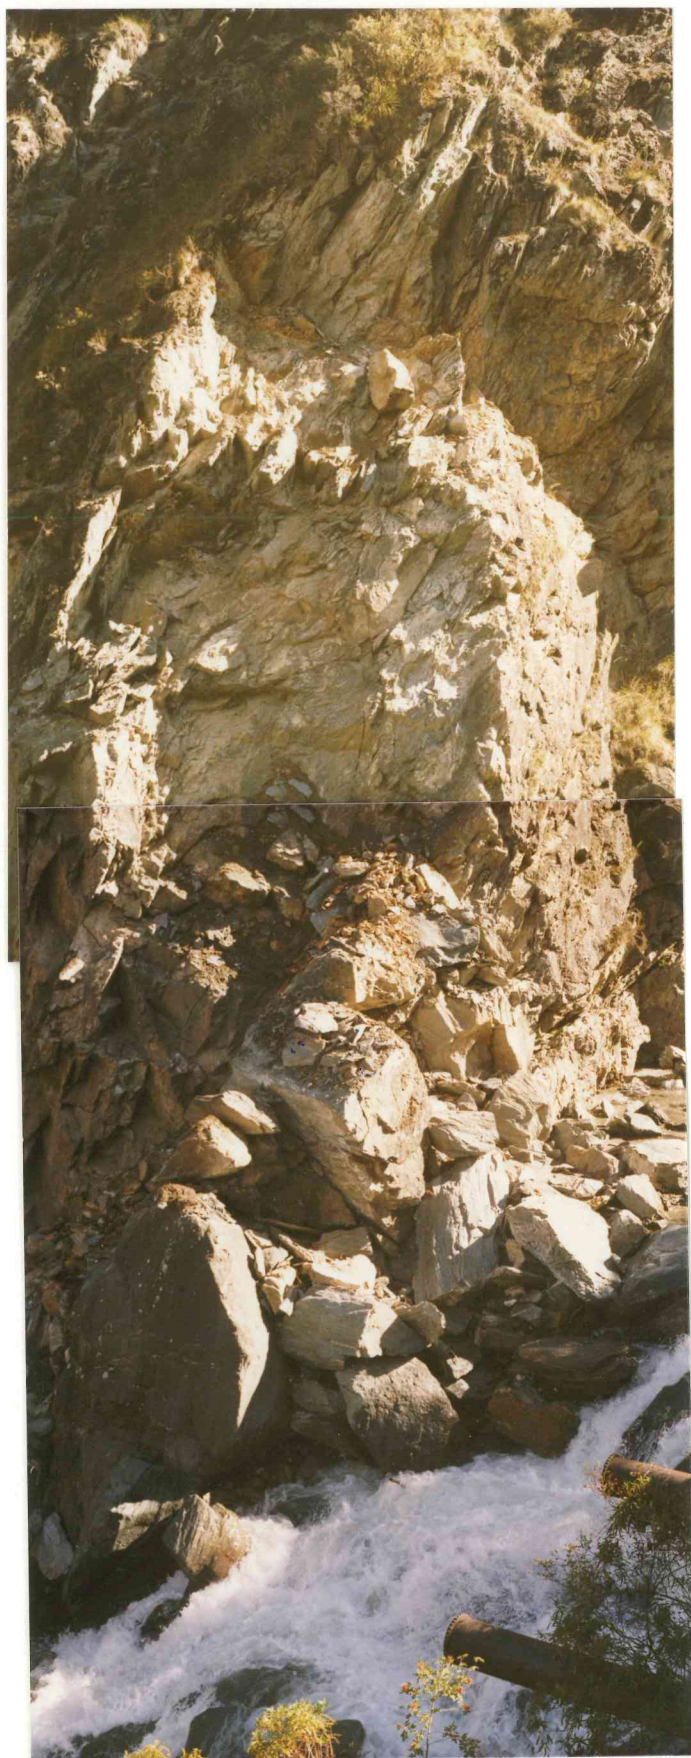
View of the slip material which has forced the river further to the true left hand side. Obviously the slip material should be cleared and used as Rip-Rap protection at the base of the concrete structure.

It appears the erosion damage was largely due to a slip on the right hand side forcing the flow of water further towards the left hand bank or desilter side.
