Ministry of Works and Development

FALLS DAM SITE VISIT REPORT

Inspection 24 April 1985

Author: D.W. Richards

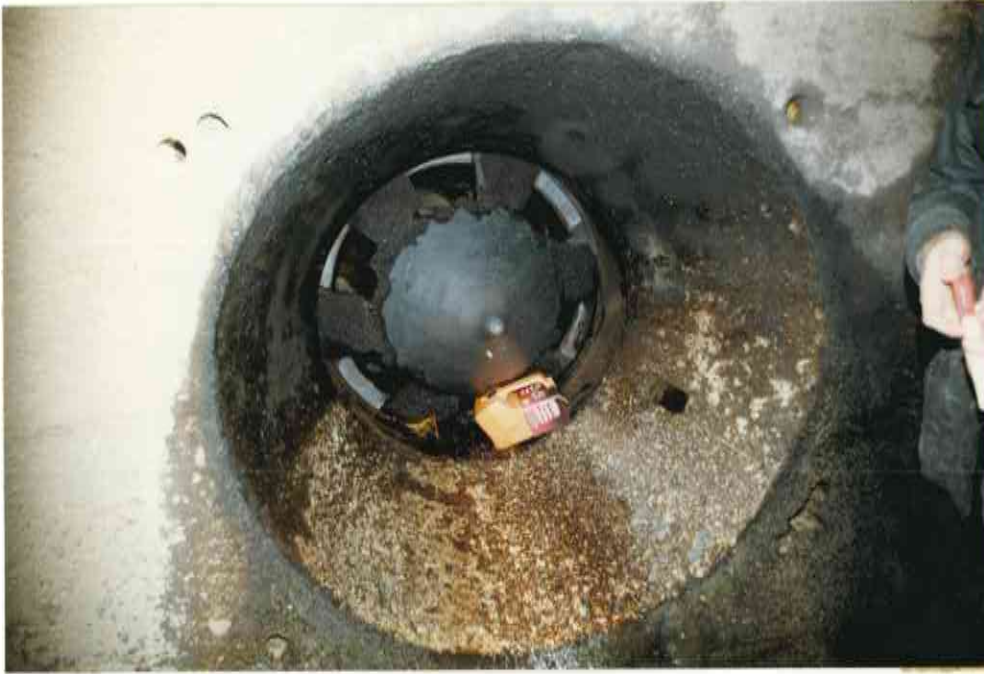
An inspection was made of the nosing cone where the needle valve discharges into the spillway tunnel and extensive cavitation damage was seen. It is probable that the nosing cone could be lost in the relatively near future. The remainder of the working parts that could be seen looked to be in good order.

Photo 3 : Needle valve nosing cone damage.

3. NEEDLE VALVE NOSING CONE DAMAGE

It is recommended that a search be made to find the pattern and that a new nosing cone be ordered immediately. This could be installed after the 1985/86 season.

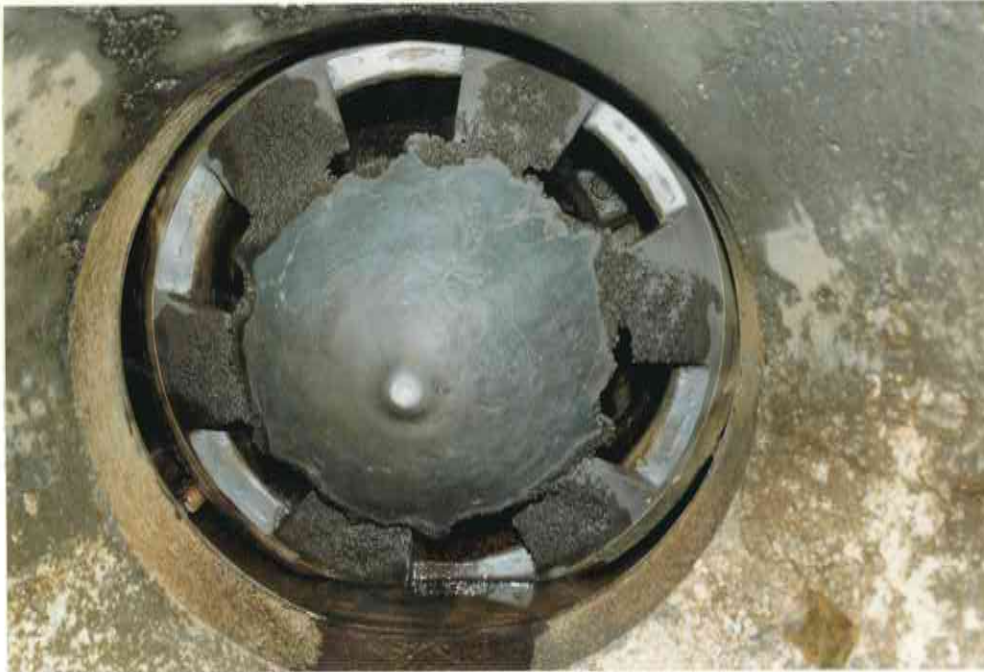
Photo 4 : Close up of cavitation damage on the needle valve nosing cone.

4. CLOSE UP OF CAVITATION DAMAGE ON THE NEEDLE VALVE NOSING CONE

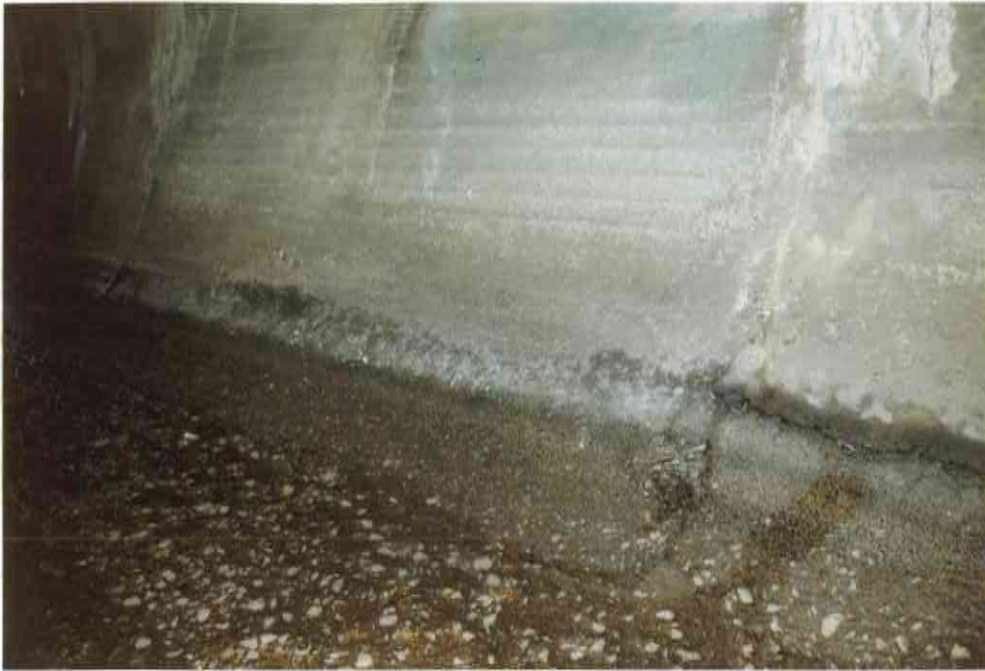
5. JT 4/5 TR

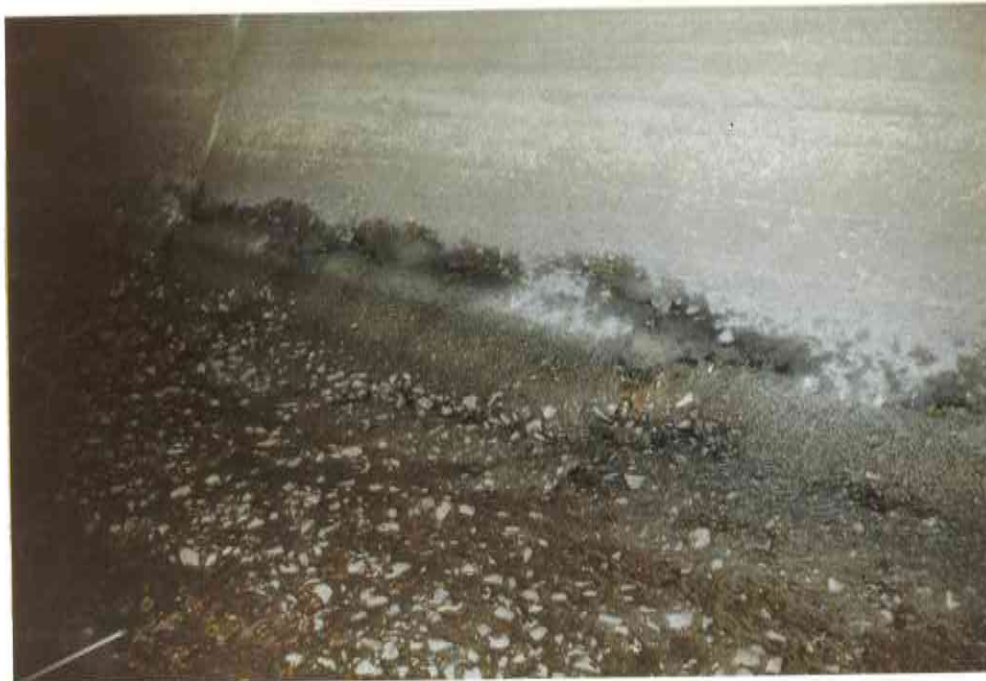
8. I/W_Jt TR. TL SIMILAR BUT NOT AS SEVERE

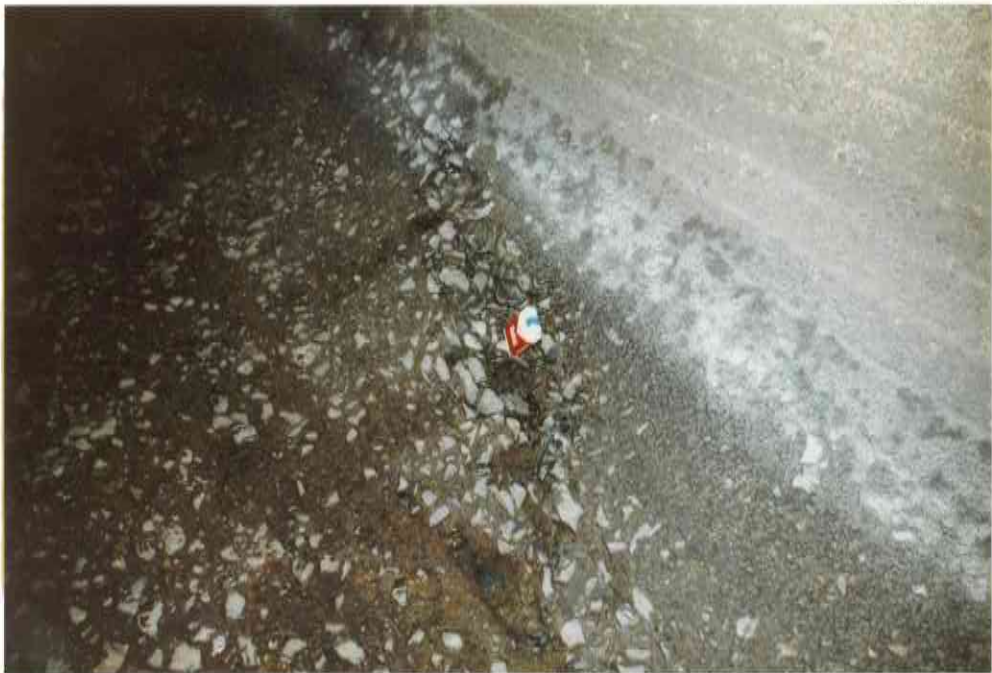
10. I/W jt TR, EROSIAN 130mm DEEP, 200mm WIDE 1.1m LONG

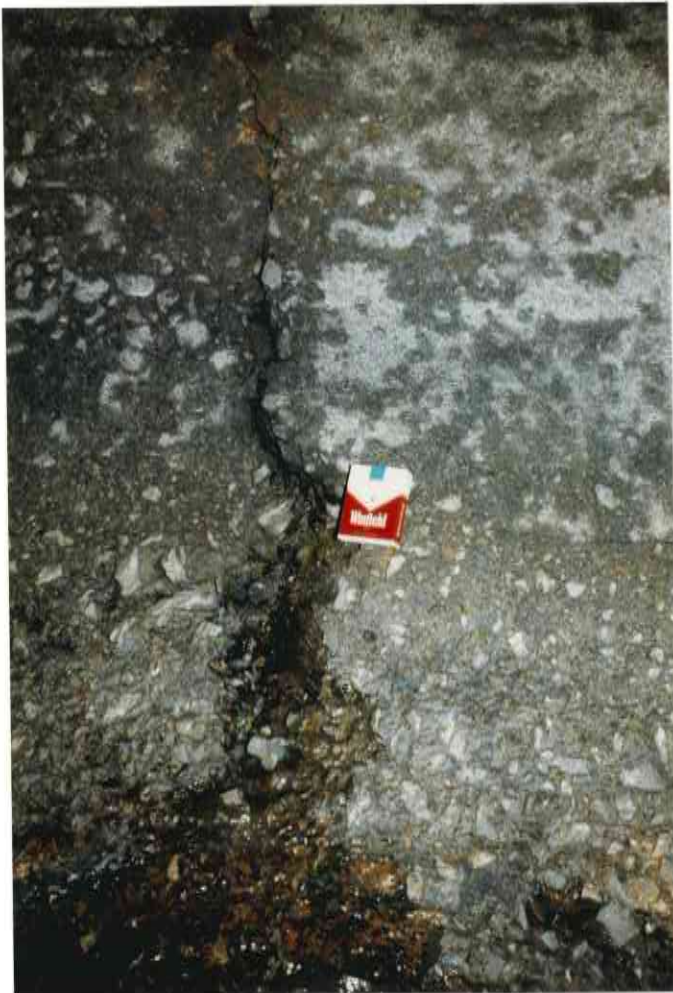
14. TYPICAL OPEN JOINT (Jt 16/17)
BETWEEN PANELS

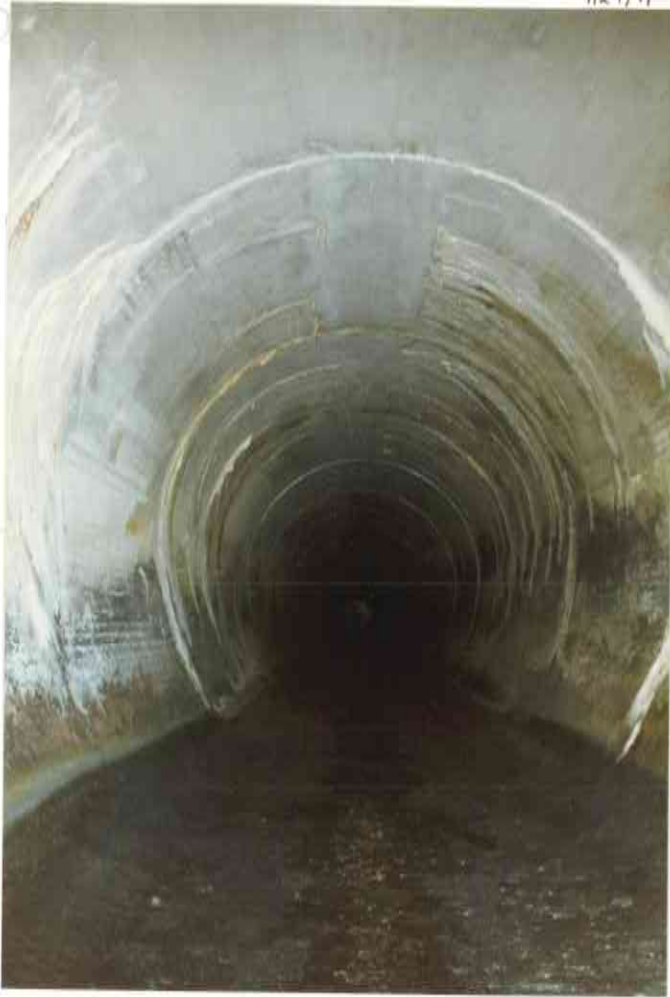
15. TYPICAL OF TUNNEL VIEWED U/S

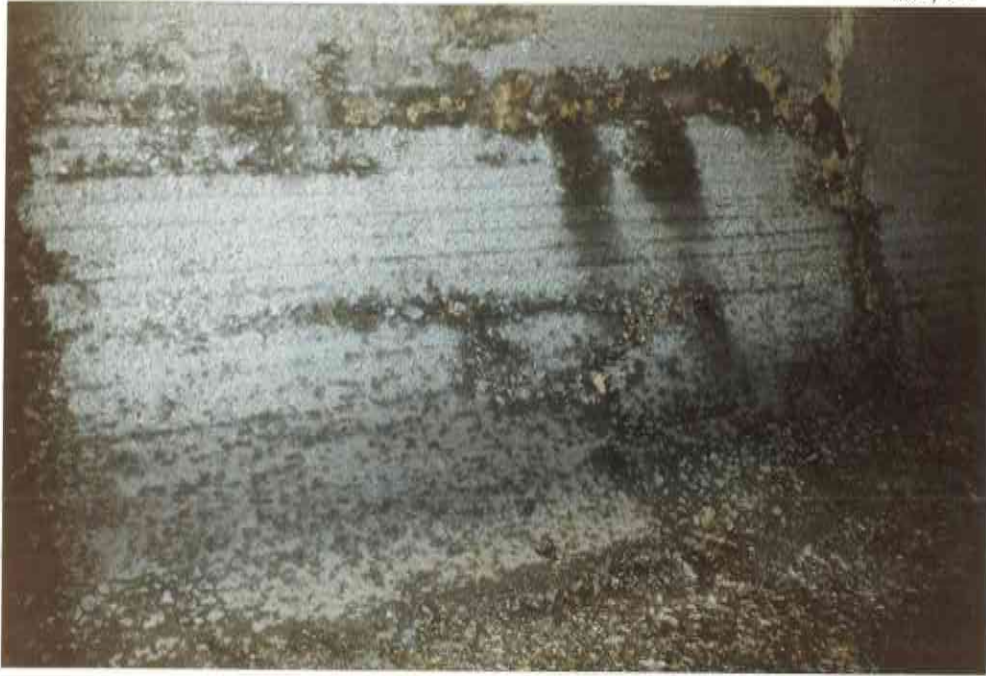
Photo 17: TL hor jt 1.8 m above invert with old patching failing, showing also general lining condition.

17. TL HOR jt 1.8m ABOVE INVERT WITH OLD PATCHING FAILING, SHOWING ALSO GENERAL LINING CONDITION

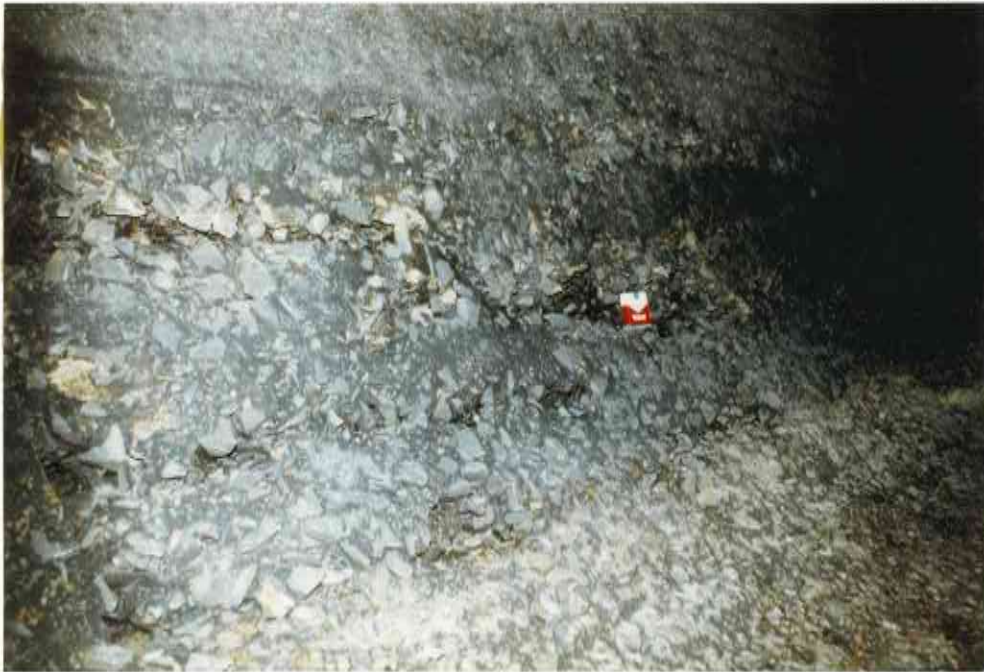
18. WALL TL SEVERE EROSION UP TO 1.2m ABOVE INVERT

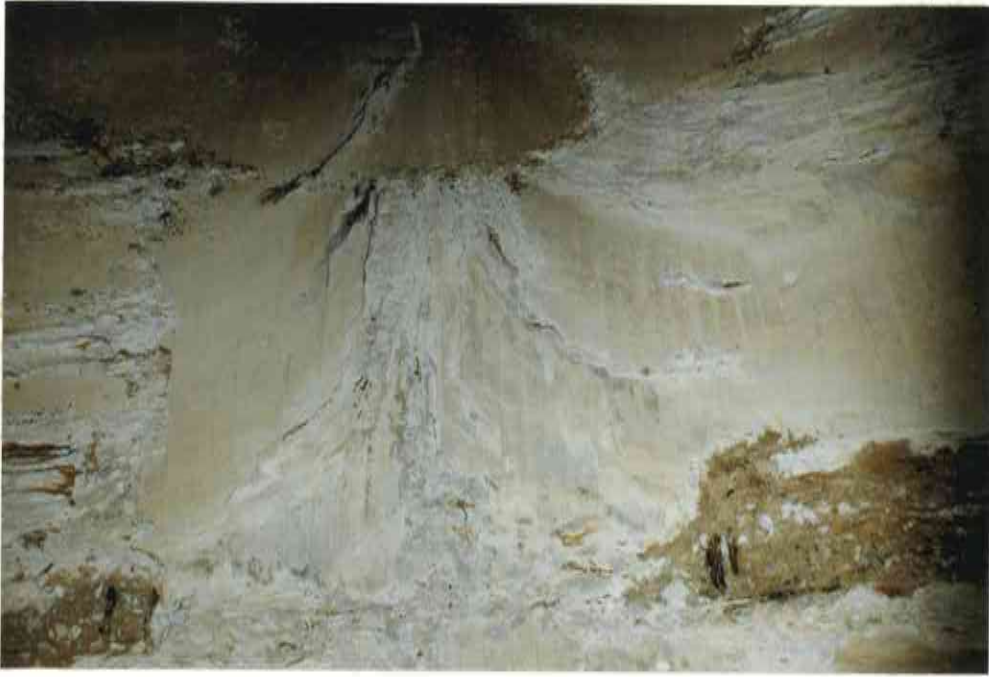
26. CROWN OF PANEL 32 SHOWING STEEL EXPOSURE AT JT 31/32
AT BOTTOM

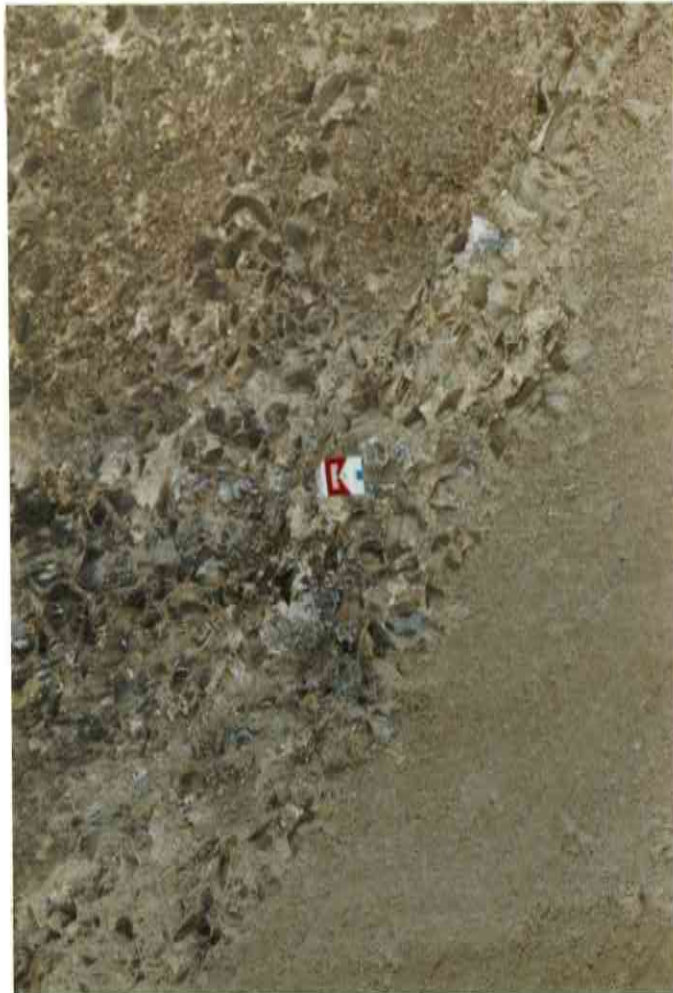
27. CLOSE UP OF TL MID-HEIGHT CONSTRUCTION jt

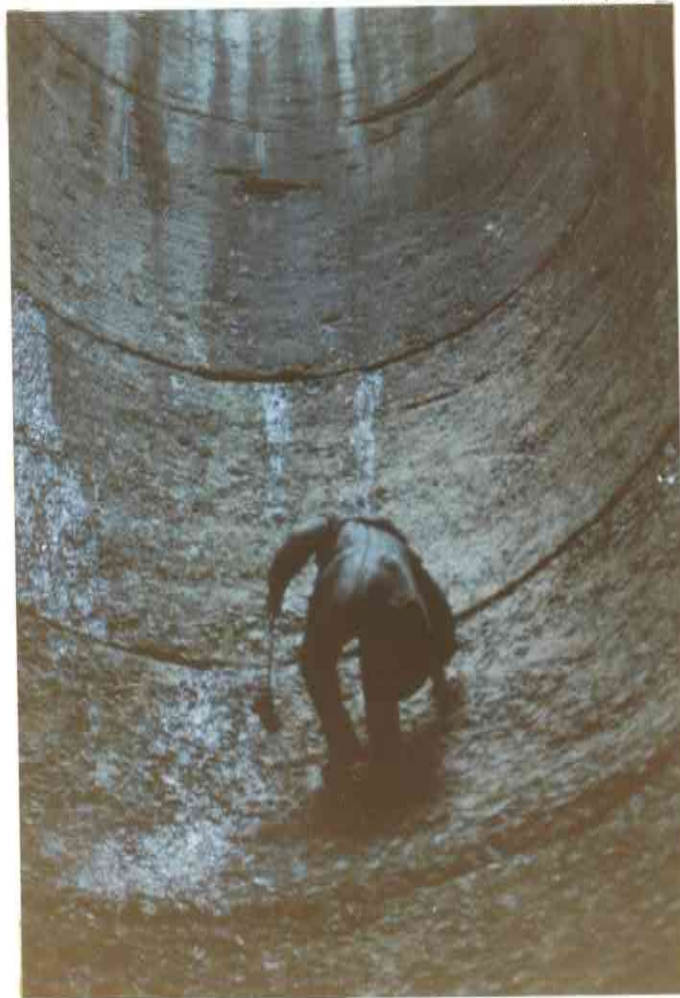
33. VIEW UP TO THROAT OF SPILLWAY (AT TOP jt 36/37). G ELLIOT
STANDING ON INVERT OF PANEL 34

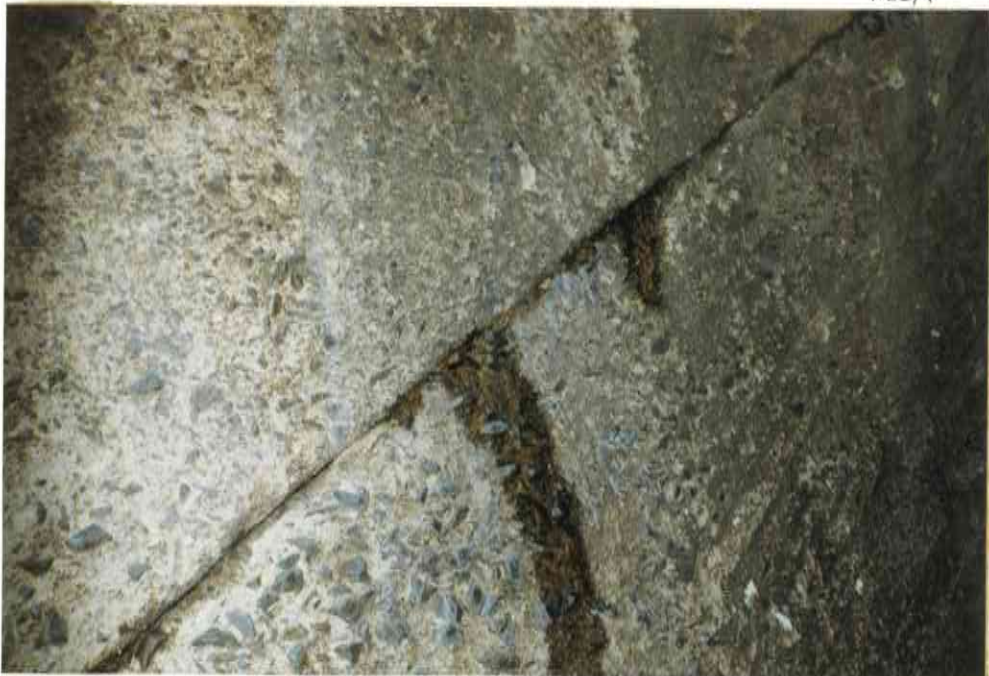
35. JE 34/35 TL

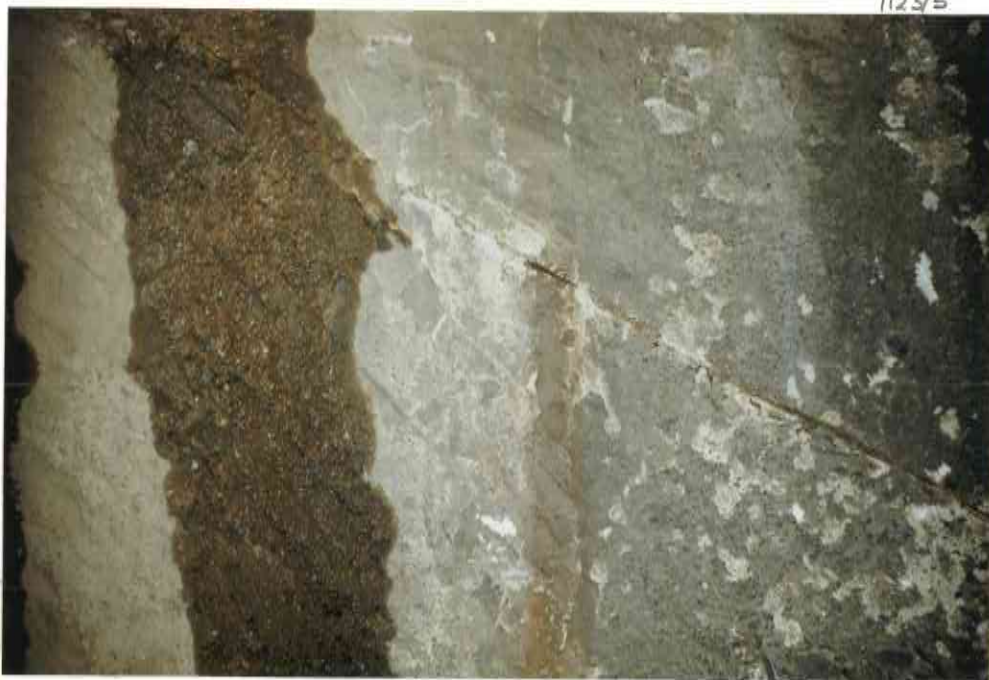
36. Jt 34/35 TR

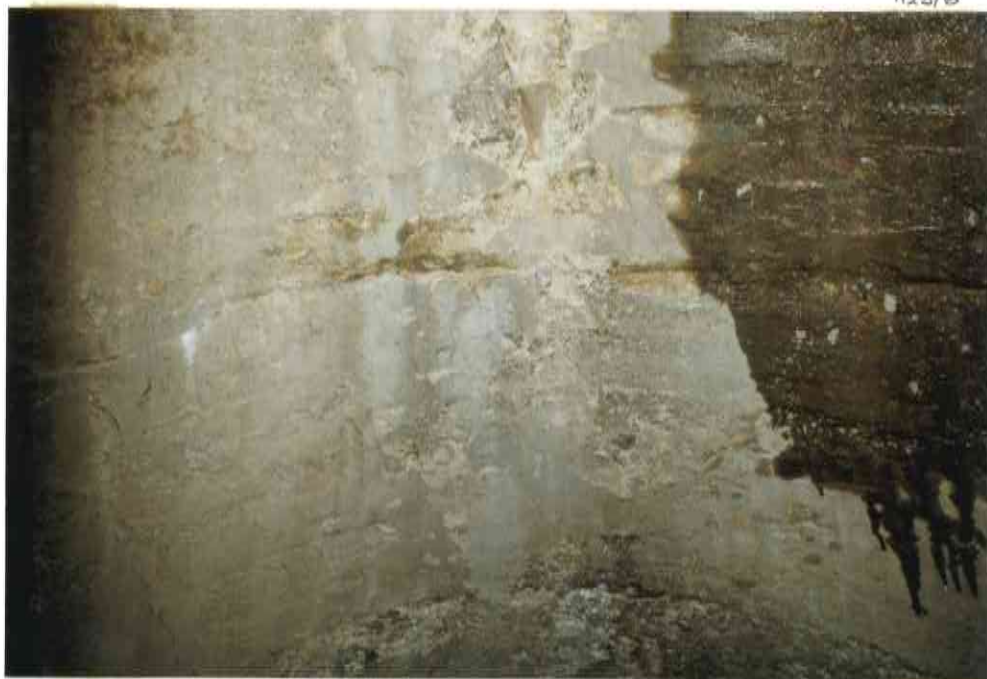
37. Jt 34/35 CROWN (D/S)

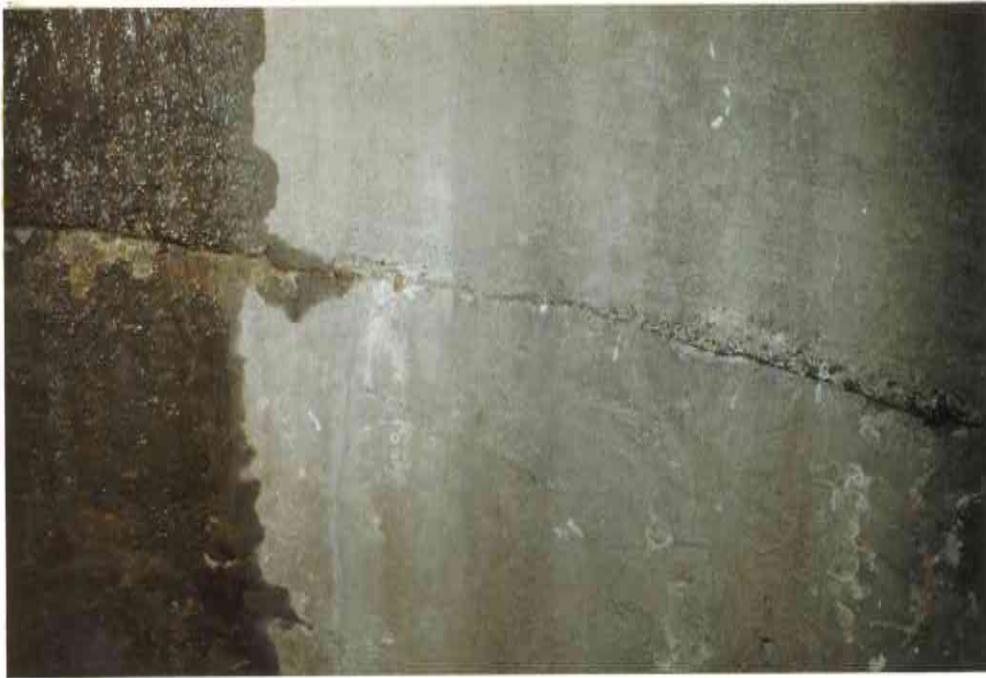
41. Jt 35/36 TR; STEEL EXPOSED

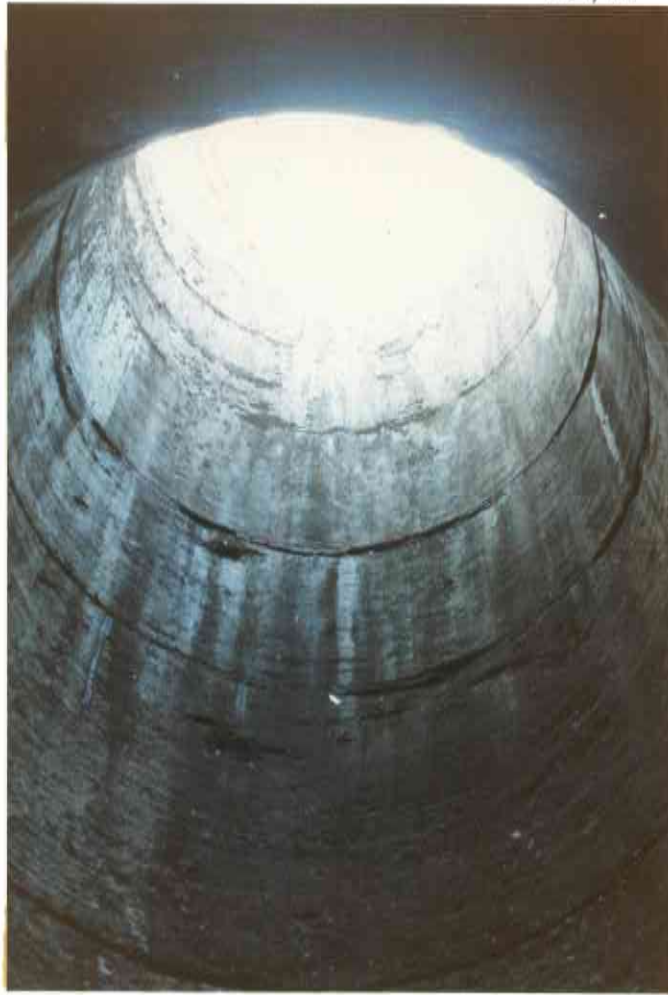
- Photo 42: View of invert (u/s) from below showing local damage on panel 36.
 Photo 43: Jt 36/37 invert (u/s) (composite of 2)
 Photo 44: Jt 36/37 crown (d/s)
 Photo 45: Jt 36/37 TL
 Photo 46: Jt 36/37 TR

42. VIEW OF INVERT (U/S) FROM BELOW SHOWING LOCAL DAMAGE ON PANEL

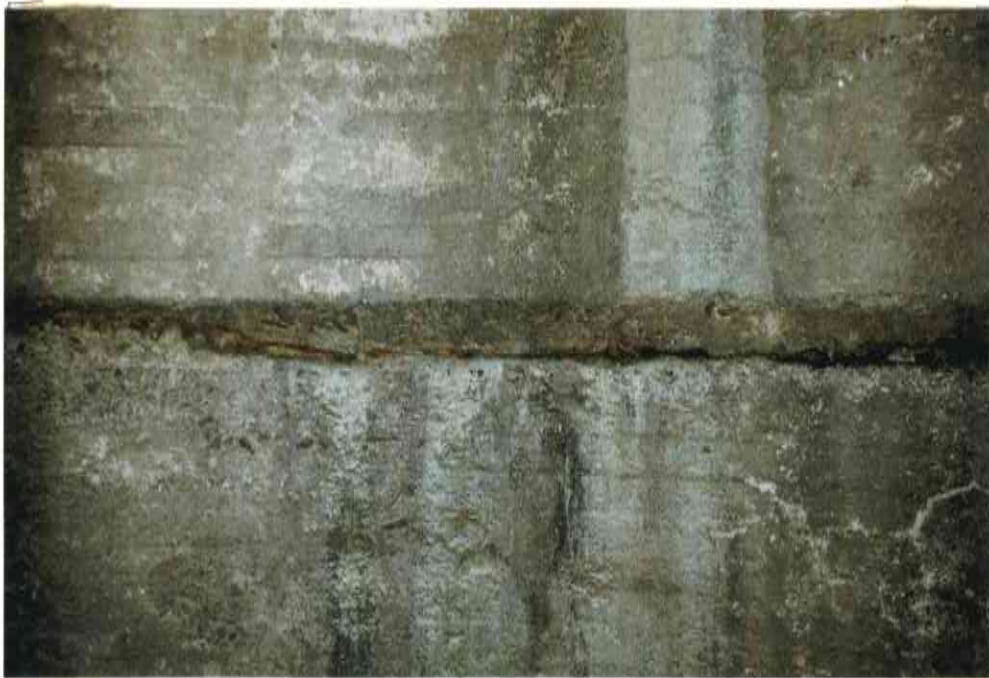
49. Jt 37/38 TL, NOTE STEEL

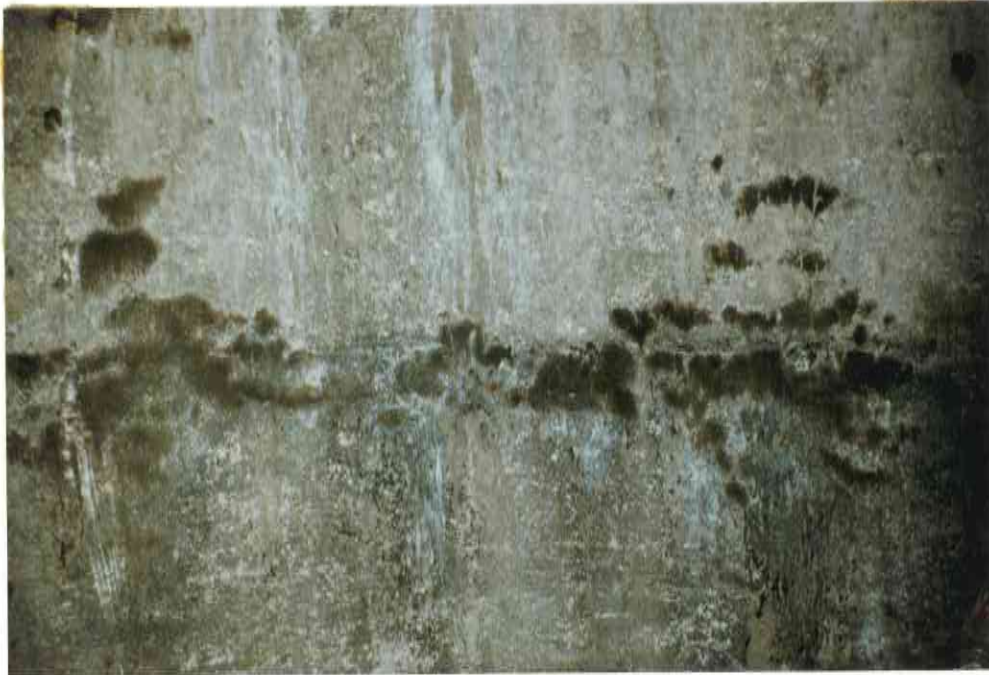
- General Good, minor erosion of plaster only all around. No work required.
- Photo 51: Jt 38/39 u/s, good
 Photo 52: Jt 38/39 d/s, plaster could need replacement
 Photo 53: Jt 38/39 TL, minor attention required
 Photo 54: Jt 38/39 TR, some spalling of plaster, no steel exposed.

51. Jt 38/39 U/S, GOOD

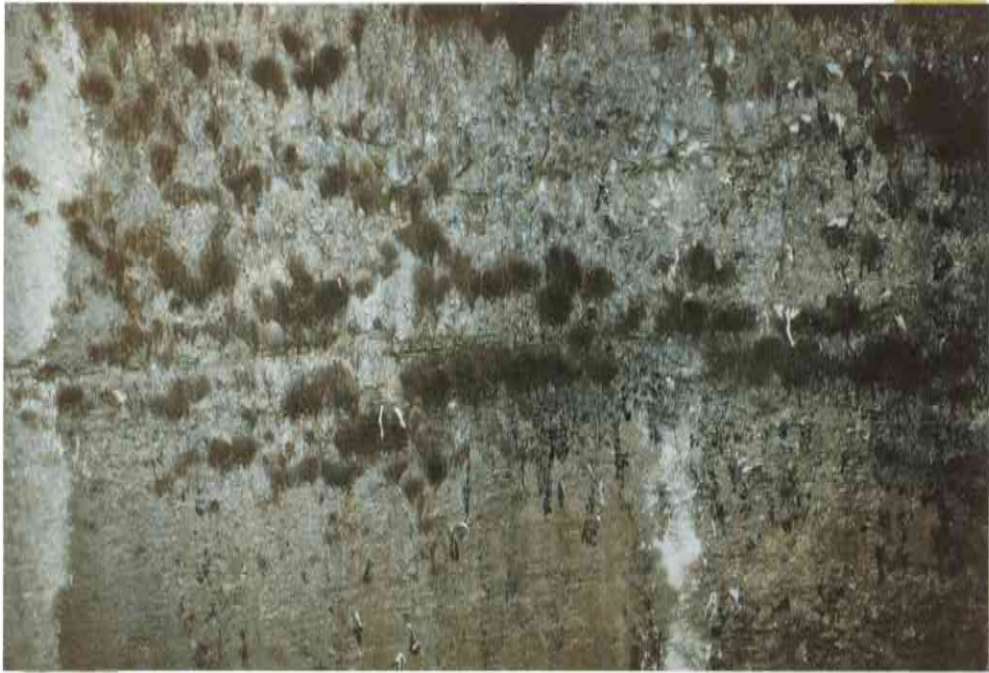
52. JF 38/39 R/S, PLASTER COULD NEED REPLACEMENT

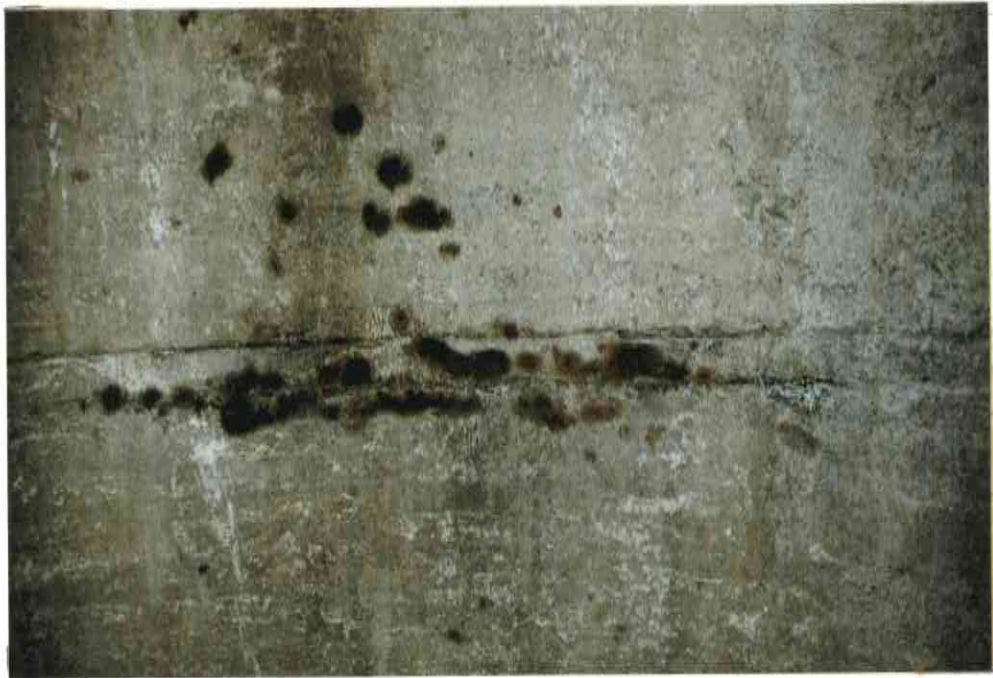
53. JF 38/39 TL, MINOR ATTENTION REQUIRED

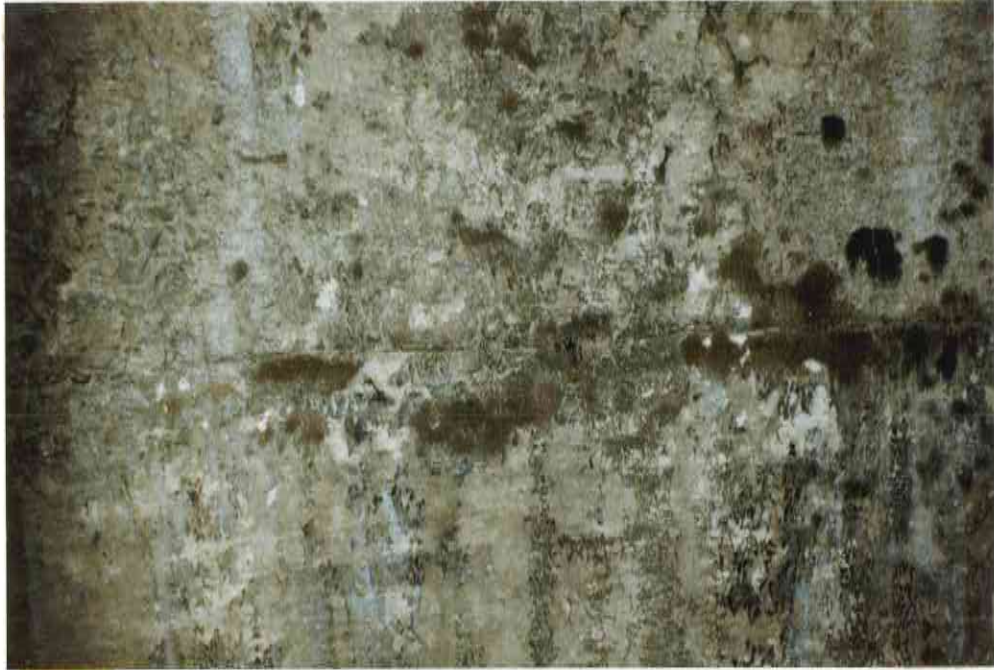
54. Jt 38/39 TR, SOME SPALLING OF PLASTER, NO STEEL EXPOSED

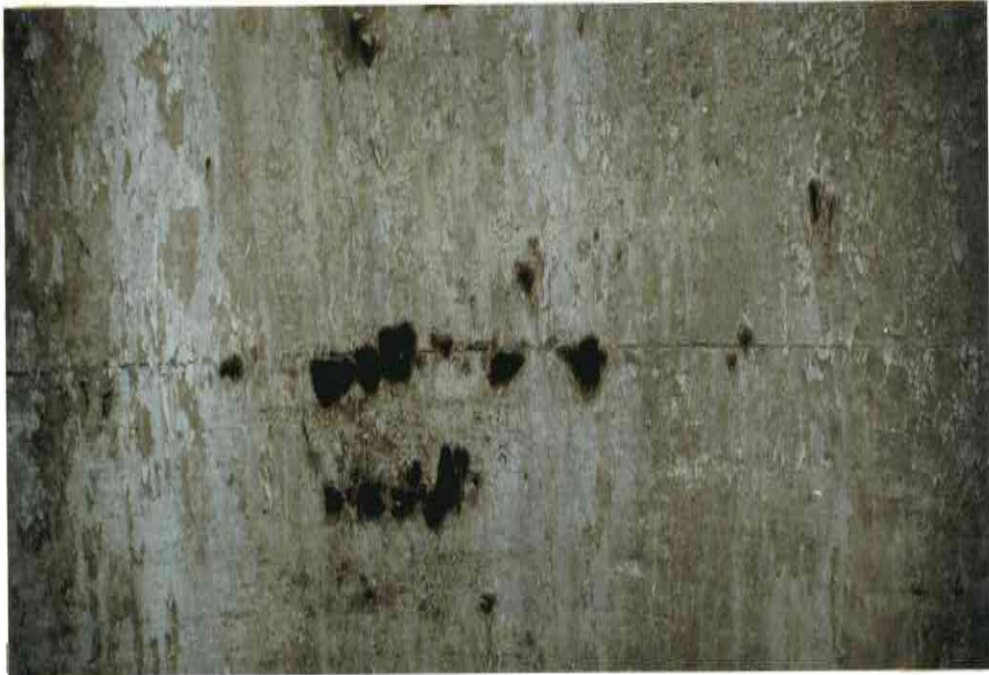
Photo 55: Jt 39/40 u/s, good joint, minor opening of joint 25 mm max. Minor patching, no undercutting.
 Photo 56: Jt 39/40 d/s, more significant spalling, no
 Photo 57: Jt 39/40 TL, good, minor erosion below jt 1.5 m long, patch with minor undercut.
 Photo 58: Jt 39/40 TR, minor spalling, surface patching.

55. Jt 39/40 U/S, GOOD JOINT, MINOR OPENING OF JOINT 25mm MAX, MINOR PATCHING, NO UNDERCUTTING

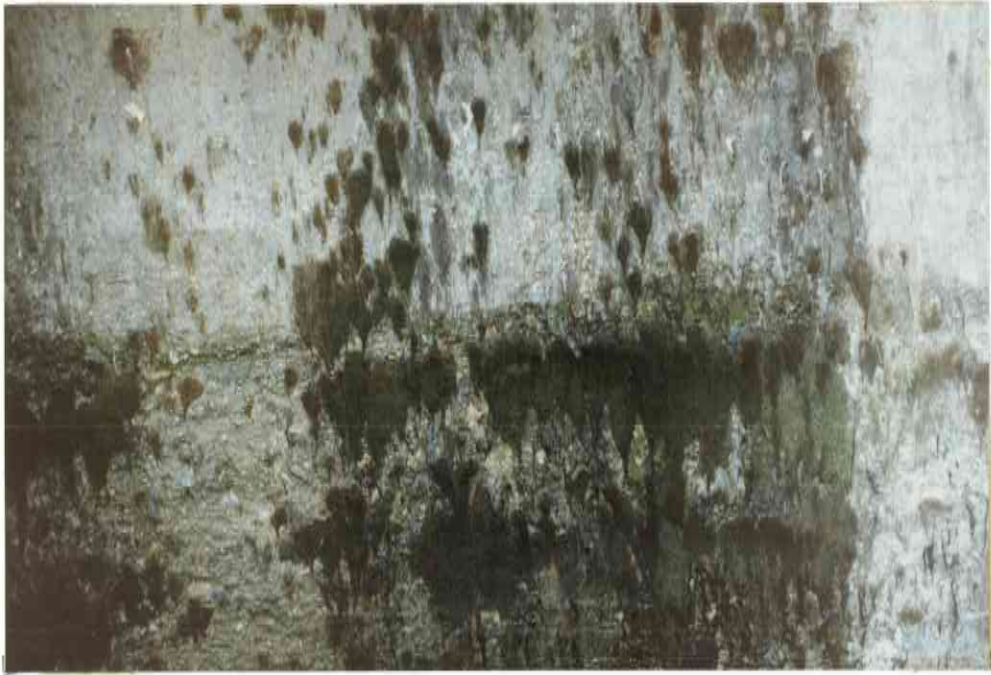
56. J# 39/40 D/S, MORE SIGNIFICANT SPALLING, NO

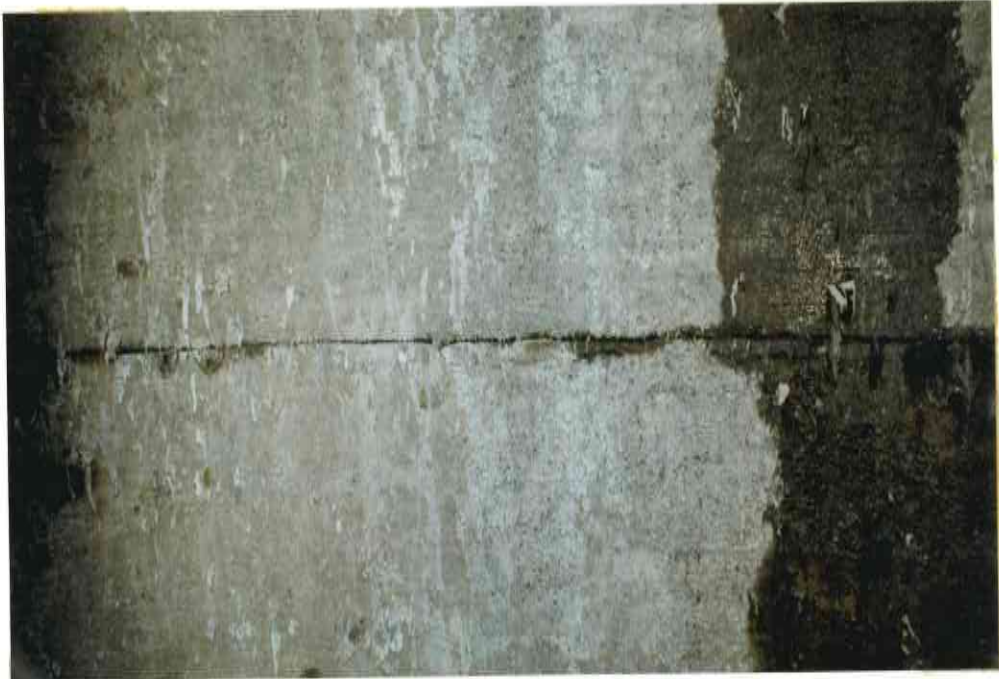
57. J# 39/40 T/L, GOOD, MINOR EROSION BELOW
JE 1.5m LONG, PATCH WITH MINOR UNDERCUT.

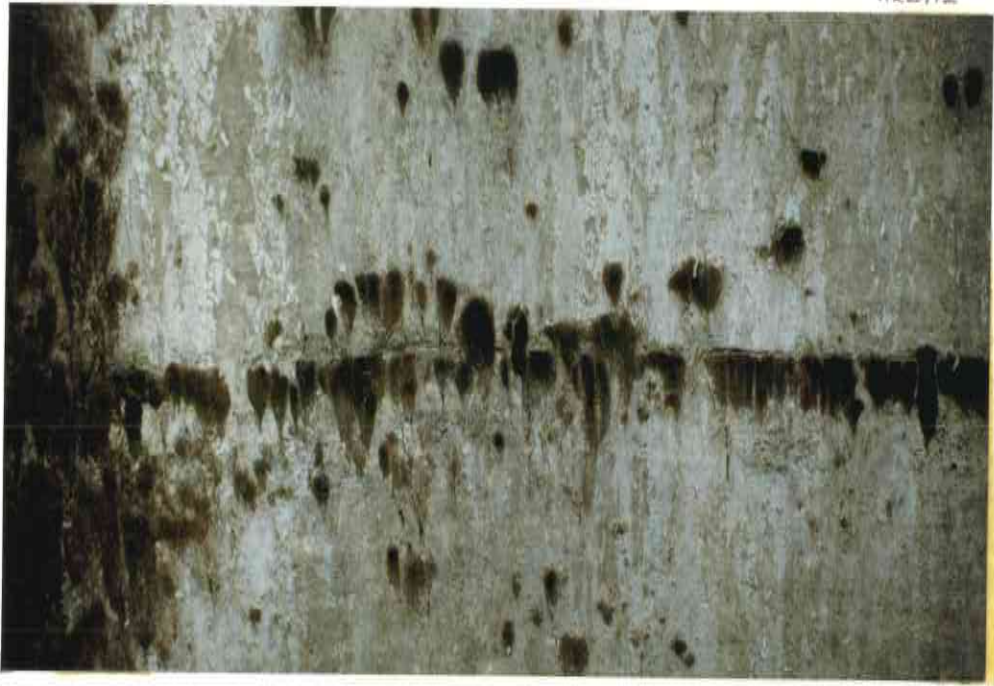
58. J+ 39/40 TR, MINOR SPALLING, SURFACE PATCHING

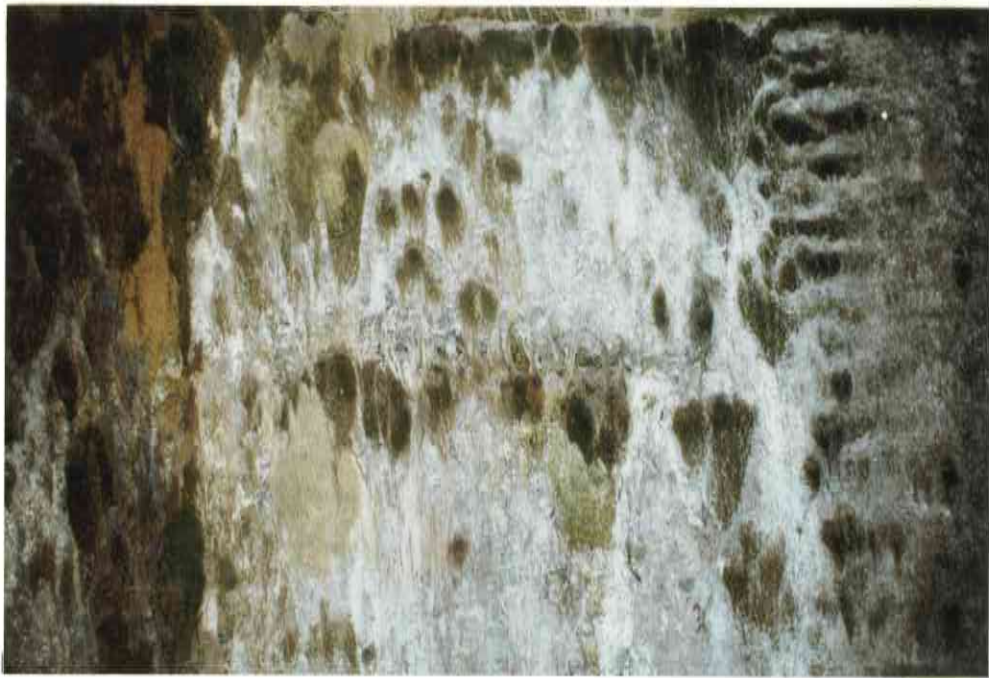
General Spillway flares out significantly, overall condition of panels good generally except for defect TR.
 Side TR Possible construction jt (or concrete gone off too much when placed?), 1.5 m long, 100 mm wide and 150 mm deep, patch required.

59. PANEL 40 TR DEFECT

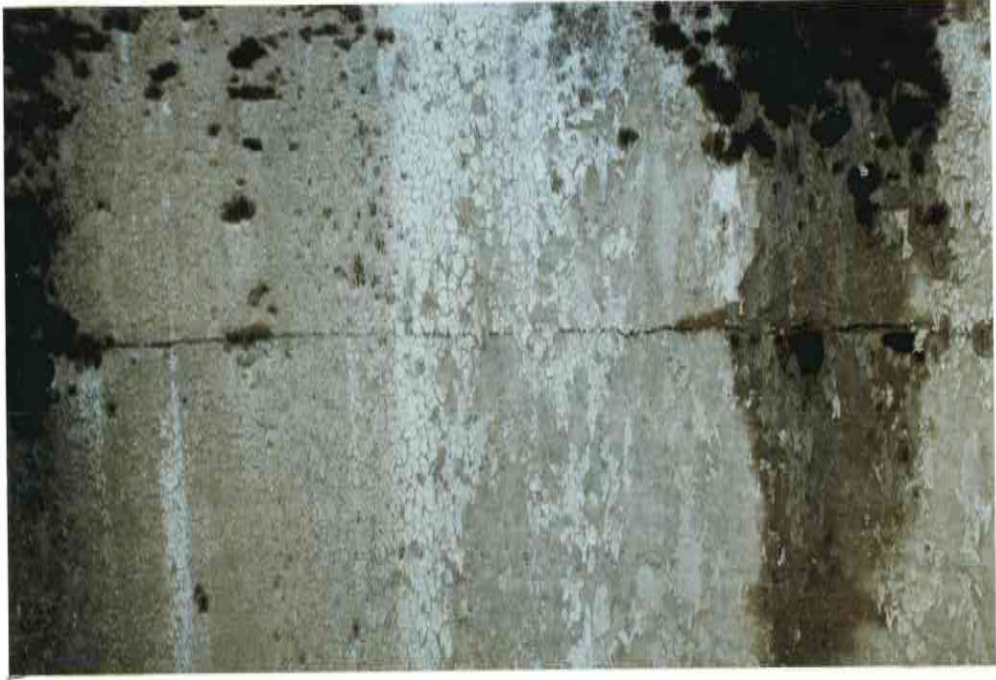
Photo 59: Panel 40 TR defect
 Photo 60: Jt 40/41 u/s, good, minor local spalling 300 mm long
 Photo 61: Jt 40/41 d/s, open 12-15 mm, spalling very minor
 Photo 62: Jt 40/41 TL, spalling 75 mm, no steel exposed, patching required. Note falsework keys above in panel 41 need filling
 Photo 63: Jt 40/41 TR, joint eroded 350 mm deep, 100 mm wide and 4 m long. Steel exposed, 450 mm centres, 50-100 mm cover generally

60. JF 40/41 U/S, GOOD, MINOR LOCAL SPALLING 300mm LONG

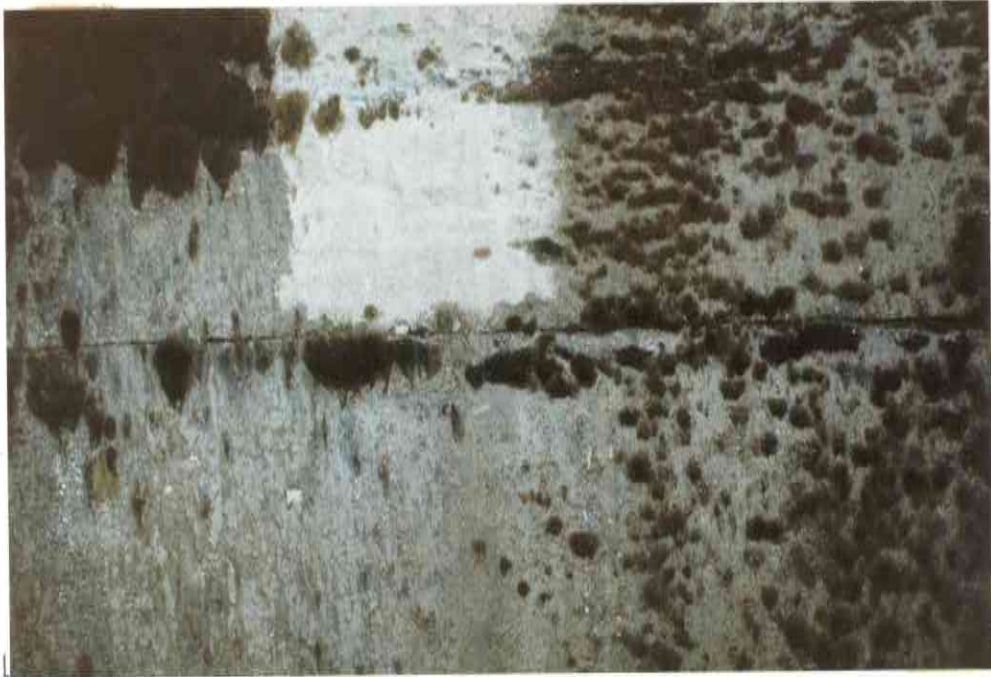
61. JF 40/41 D/S, OPEN 12-15mm SPALLING VERY MINOR

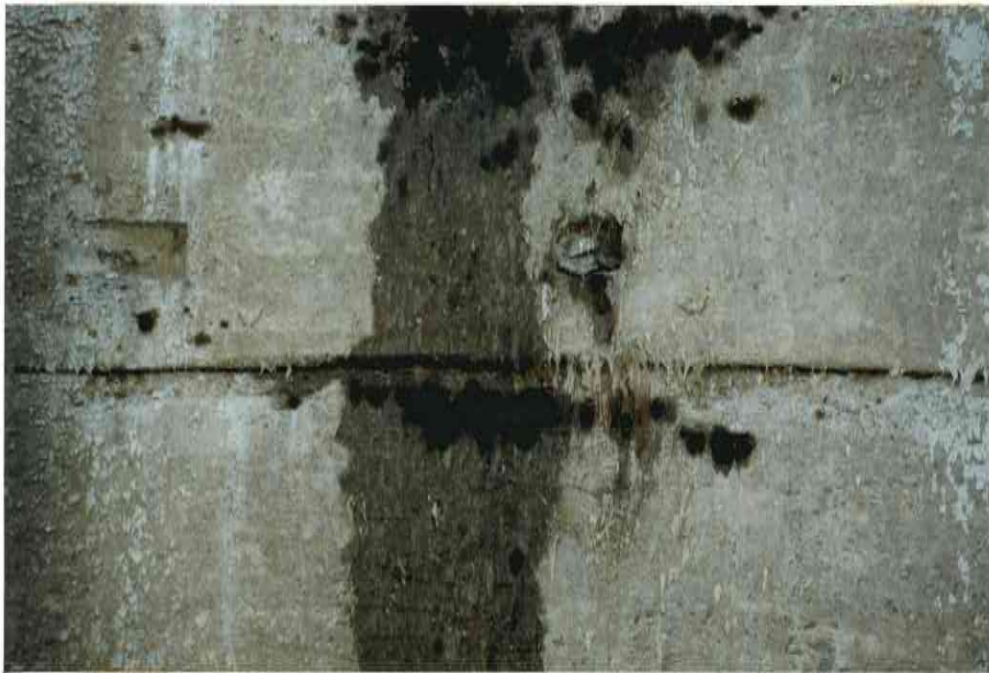
62. J# 40/41 TL, SPALLING 75mm, NO STEEL EXPOSED, PATCHING REQUIRED, NOTE FALSE WORK KEYS ABOVE IN PANEL 41 NEED FILLING

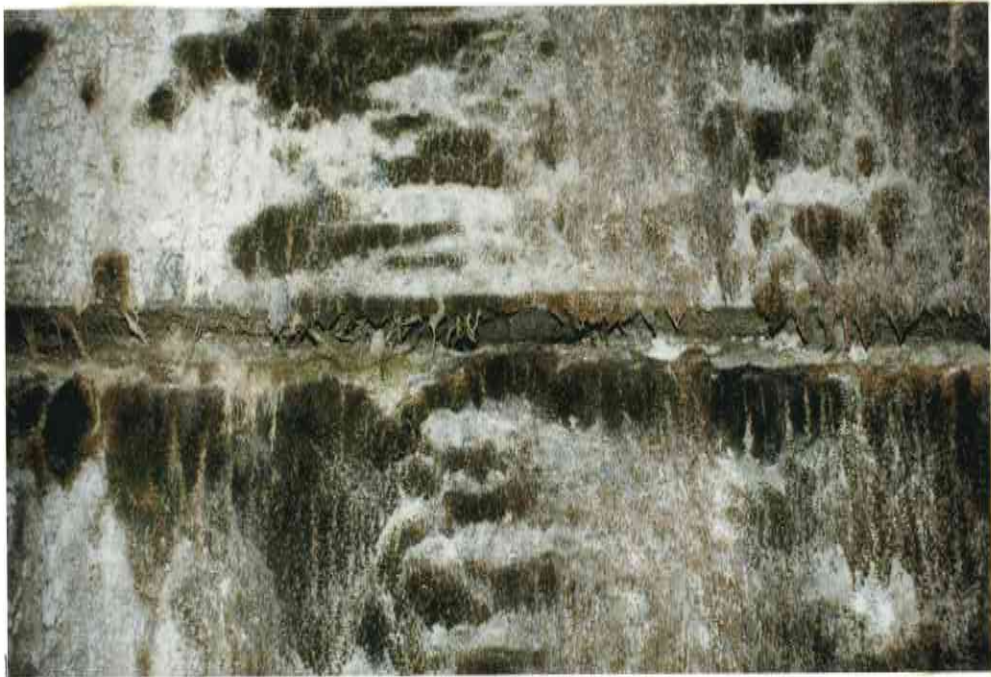
63. J# 40/41 TR, JOINT ERODED 350mm DEEP, 100mm WIDE + 4m LONG, STEEL EXPOSED, 450mm CENTRES, 50-100mm COVER GENERALLY

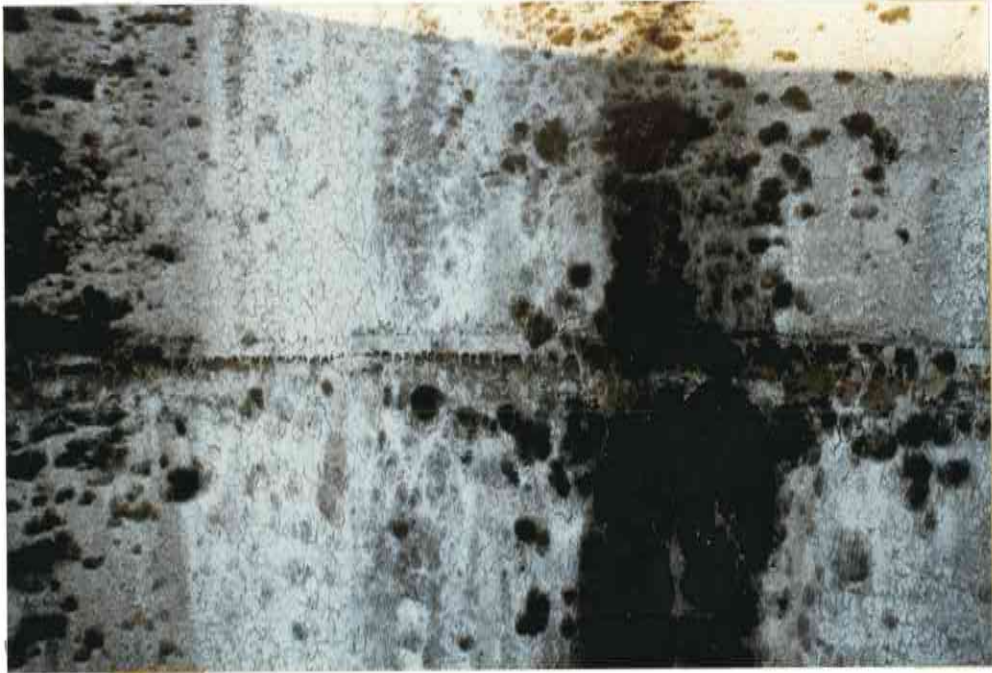
- Photo 64: Jt 41/42 u/s, infill plaster lost.
 Photo 65: Jt 41/42 d/s, horizontal steel exposed, 600 mm wide, 4 m long and full panel depth. Urgent repair.
 Photo 66: Jt 41/42 TL, severe erosion, steel exposed, bedrock exposed. Urgent repair. Vertical steel half inch at 450 mm centres, horizontal steel 3/4 inch. Steel anchorages of one inch bar. Slab thickness 150 mm, max aggregate size 75 mm. Joint infill wedge very loose.
 Photo 67: Jt 41/42 TR, erosion 150 mm deep, 200 mm wide, 3 m long.
 Photo 68: View from above showing damage at jt 41/42 u/s and TL (photos 64 and 66) and at jt 42/43 u/s (photo 72).

64. JT 41/42 U/S, INFILL PLASTER LOST

The most urgent repairs are those noted for panel 43 and joints 43/44 and 41/42. It is recommended that these joints be cleaned, broken back to provide a concrete key and be filled with a stiff mortar.
