Ministry of Works and Development

FALLS DAM SITE VISIT REPORT

Inspection 24 April 1985

Author: D.W. Richards

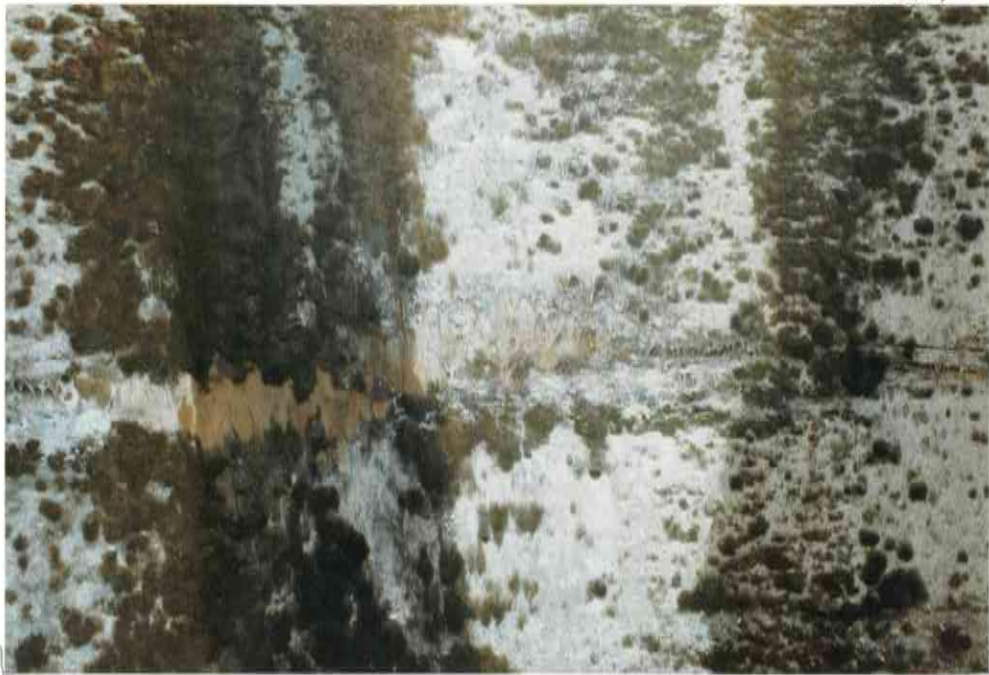
- Photo 64: Jt 41/42 u/s, infill plaster lost.
 Photo 65: Jt 41/42 d/s, horizontal steel exposed, 600 mm wide, 4 m long and full panel depth. Urgent repair.
 Photo 66: Jt 41/42 TL, severe erosion, steel exposed, bedrock exposed. Urgent repair. Vertical steel half inch at 450 mm centres, horizontal steel 3/4 inch. Steel anchorages of one inch bar. Slab thickness 150 mm, max aggregate size 75 mm. Joint infill wedge very loose.
 Photo 67: Jt 41/42 TR, erosion 150 mm deep, 200 mm wide, 3 m long.
 Photo 68: View from above showing damage at jt 41/42 u/s and TL (photos 64 and 66) and at jt 42/43 u/s (photo 72).

65. JT 41/42 D/S, HORIZONTAL STEEL EXPOSED, 600mm WIDE, 4m LONG + FULL PANEL DEPTH. URGENT REPAIR

The most urgent repairs are those noted for panel 43 and joints 43/44 and 41/42. It is recommended that these joints be cleaned, broken back to provide a concrete key and be filled with a stiff mortar.

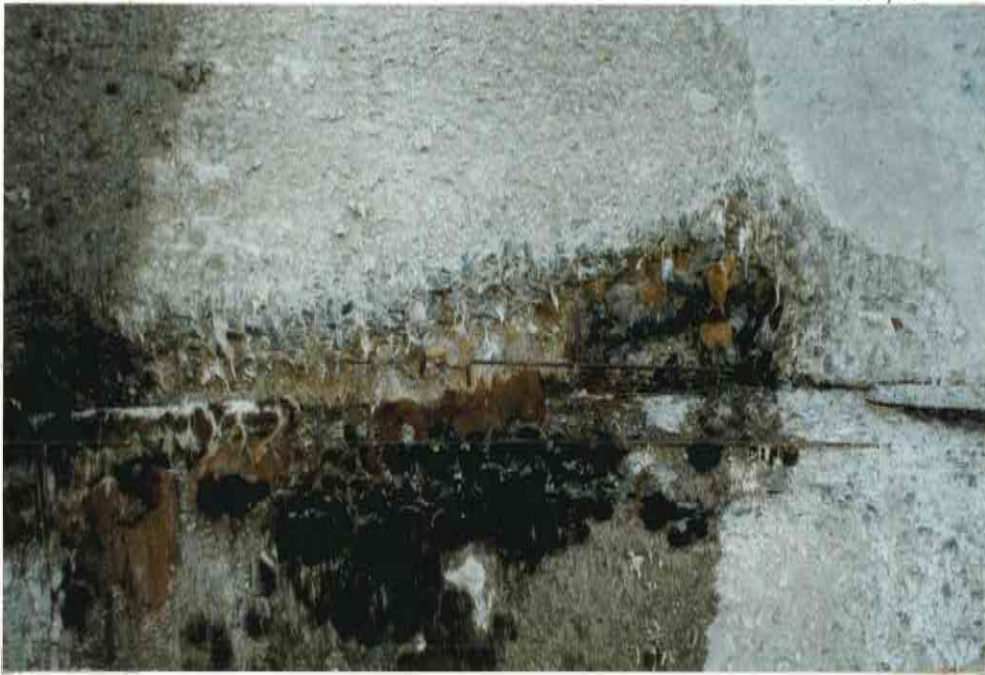
66. Jt 41/48 TL, SEVERE EROSION, STEEL EXPOSED, BEDROCK EXPOSED. URGENT REPAIR. VERTICAL STEEL HALF INCH AT 450mm CENTRES. HORIZONTAL STEEL 3/4 INCH, STEEL ANCHORAGES OF ONE INCH BAR. SLAB THICKNESS 150mm. MAX AGGREGATE SIZE 75mm JOINT INFILL WEDGE VERY LOOSE

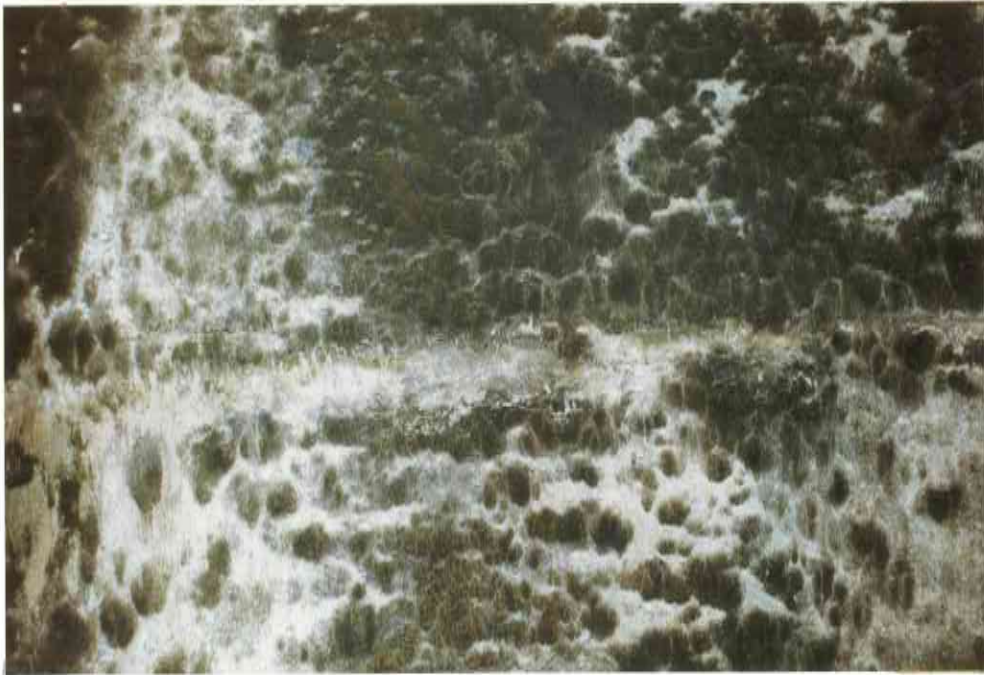
67. Jt 41/42 TR, EROSION 150mm DEEP, 200mm WIDE 300mm LONG

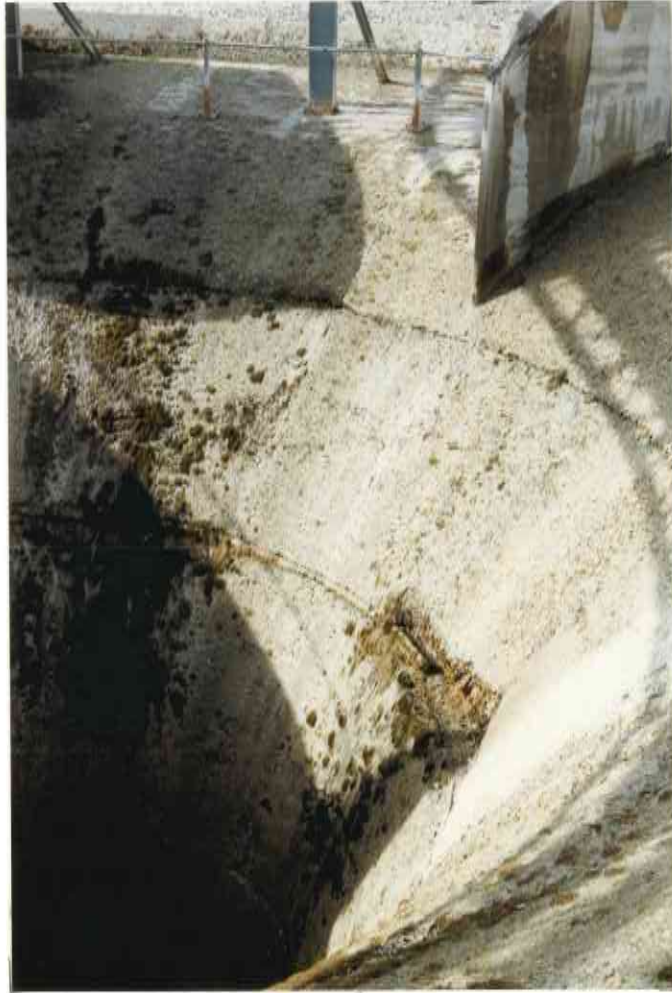
68. VIEW FROM ABOVE SHOWING DAMAGE AT JT 4/42
L/S AND TL AND AT JT 42/43 L/S

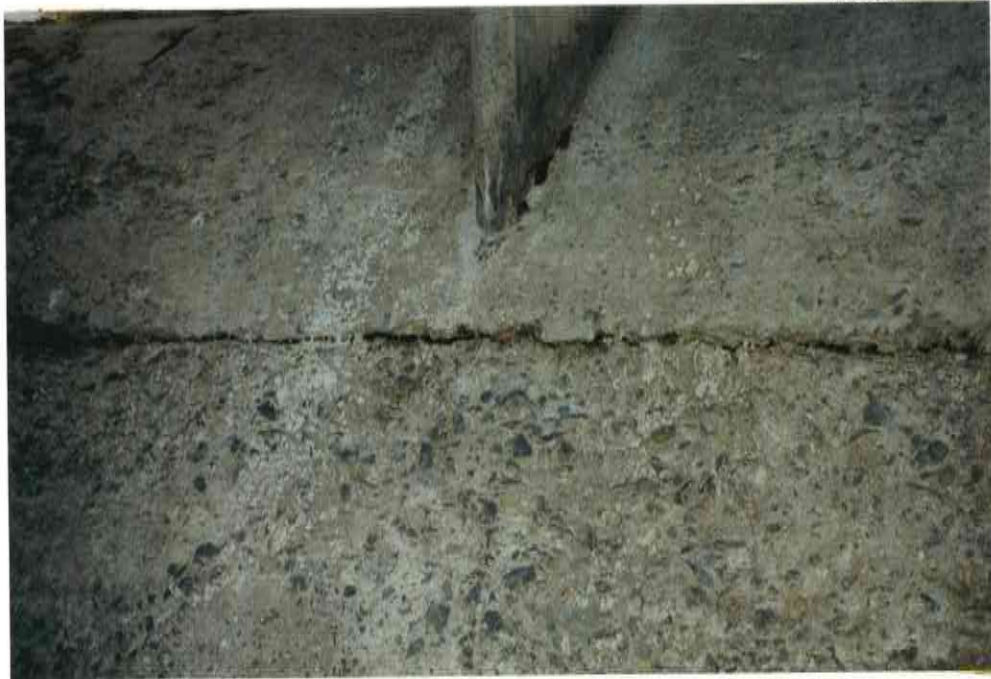
69. JT 42/43 TL, ERODED 50mm WIDE, 100-150mm
DEEP

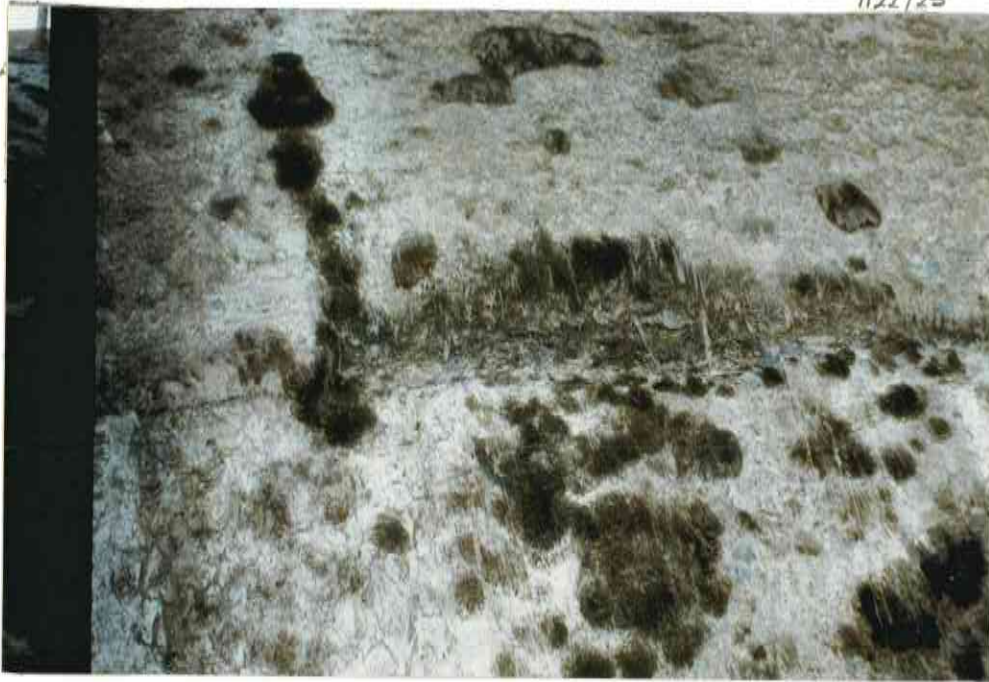
72. JF 42/43 U/S, EROSION 300mm WIDE, 150-200mm DEEP AND 3m LONG, STEEL EXPOSED, PATCHING REQUIRED

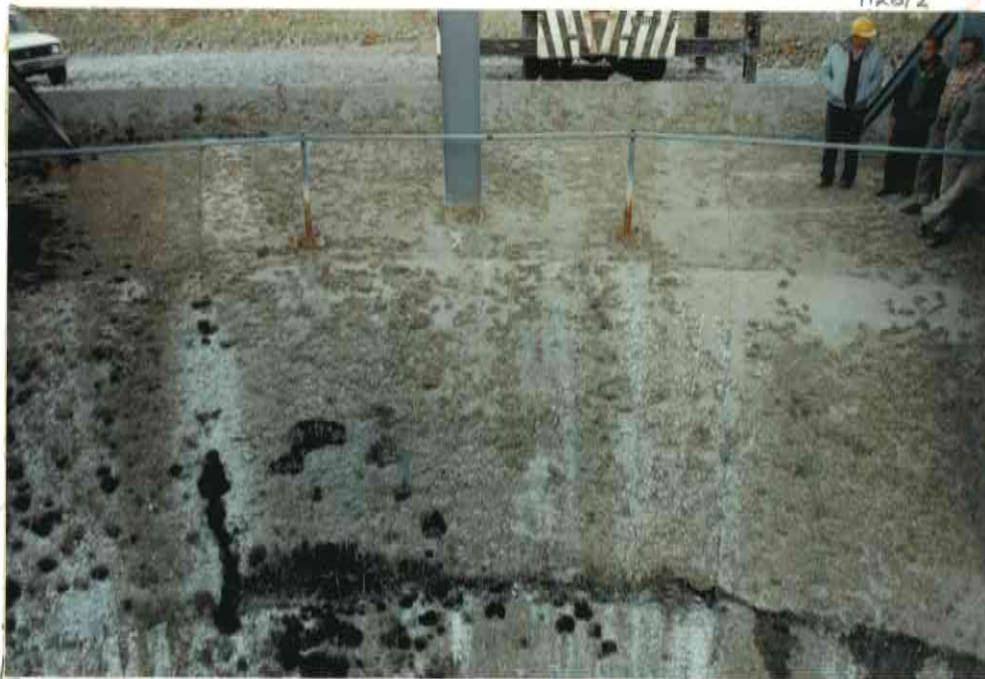
- Photo 73: Bay 1, aggregate exposed 70% area, no steel exposed in panel.
 Photo 74: Bay 2, similar to bay 1.
 Photo 75: Bay 3, more severe erosion, especially down from Jt 43/44. Urgent repair of jt.
 Photo 76: Bay 4, substantial deterioration of central section. Urgent repair.

73. BAY 1, AGGREGATE EXPOSED 70% AREA
NO STEEL EXPOSED IN PANEL

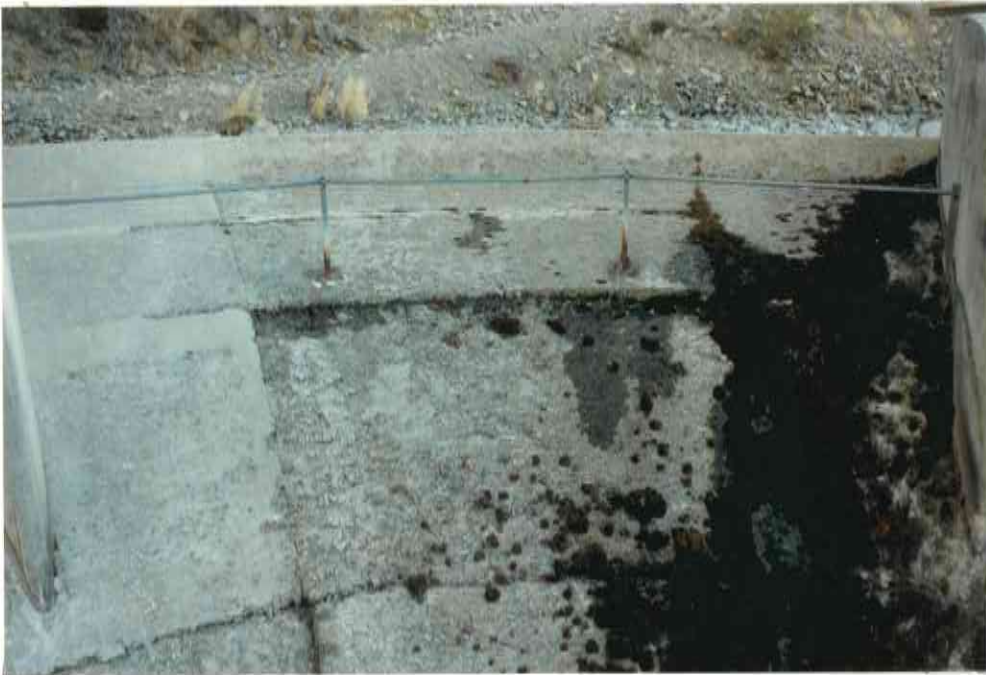
75. BAY 3 MORE SEVERE EROSION, ESPECIALLY DOWN FROM J# 43/44. URGENT REPAIR OF IT.

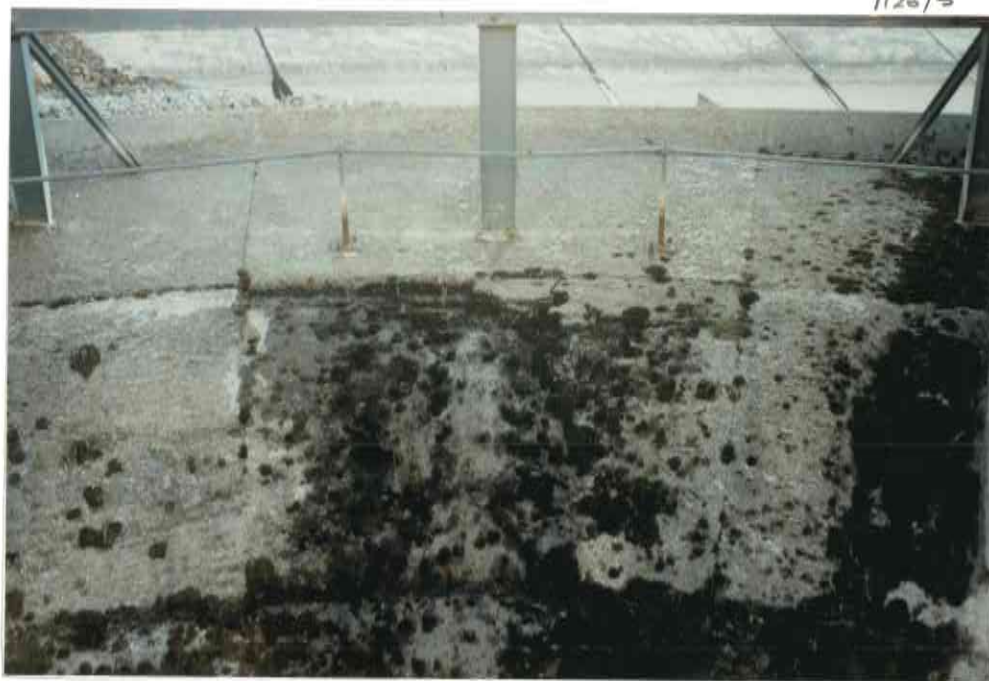
76. BAY 4 SUBSTANTIAL DETERIORATION OF CENTRAL SECTION . URGENT REPAIR

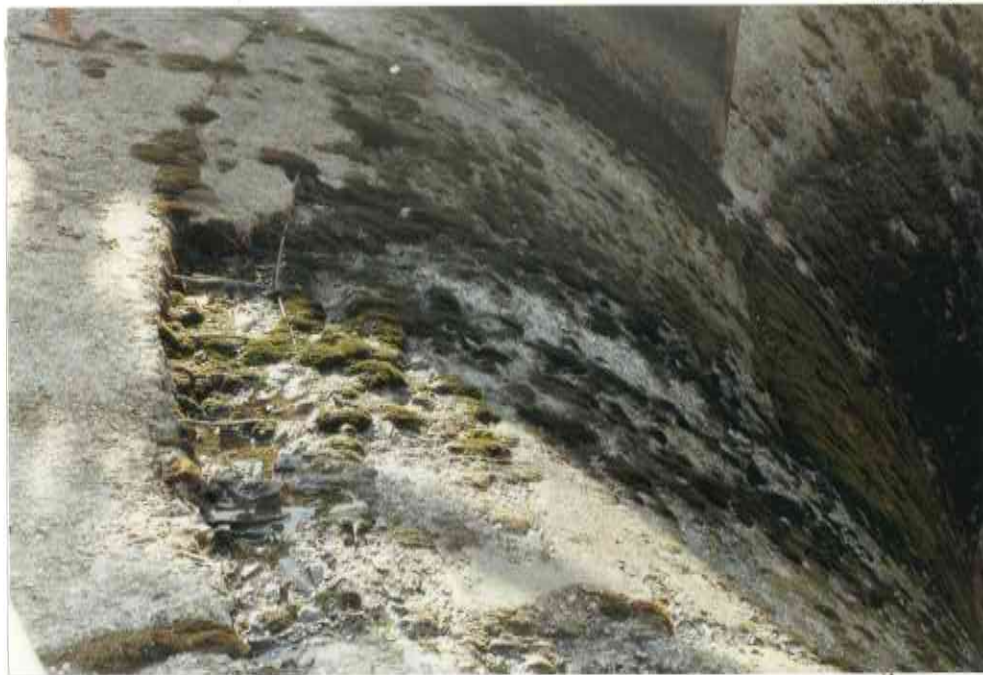
- Photo 77: Close up of damage at jt 43/44 bay 4.
 Photo 78: Bay 5, minor spalling vertical construction
 jt, generally good.
 Photo 79: Bay 6, minor spalling, worse than bay 5, not
 severe, minor patching only.

77. CLOSE UP OF DAMAGE AT Jt 43/44 BAY 4

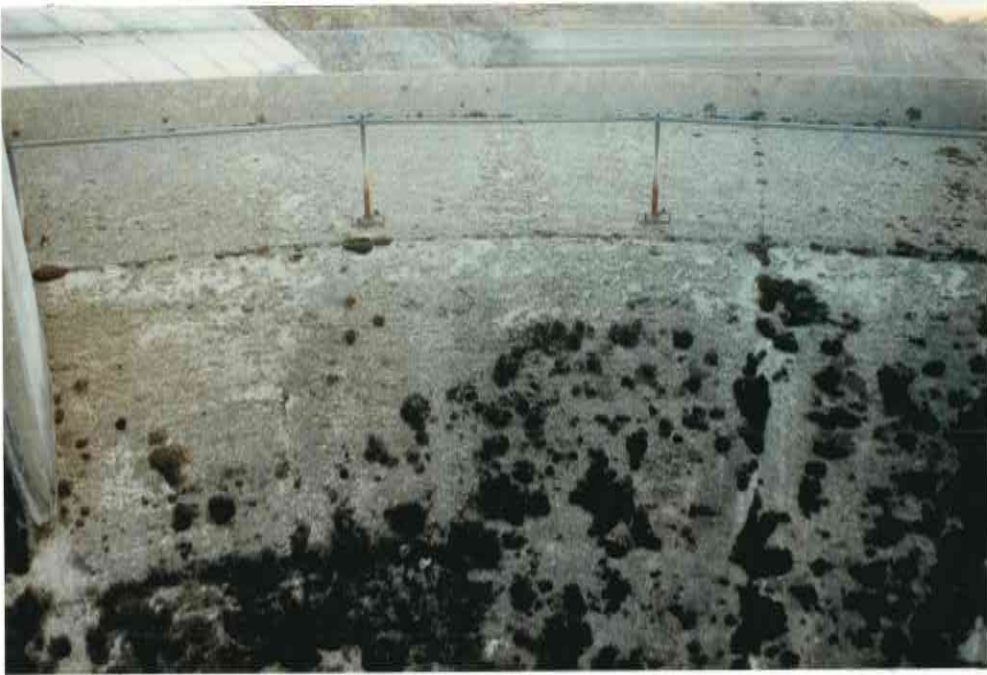
78. BAY 5, MINOR SPALLING VERTICAL CONSTRUCTION Jt. GENERALLY GOOD

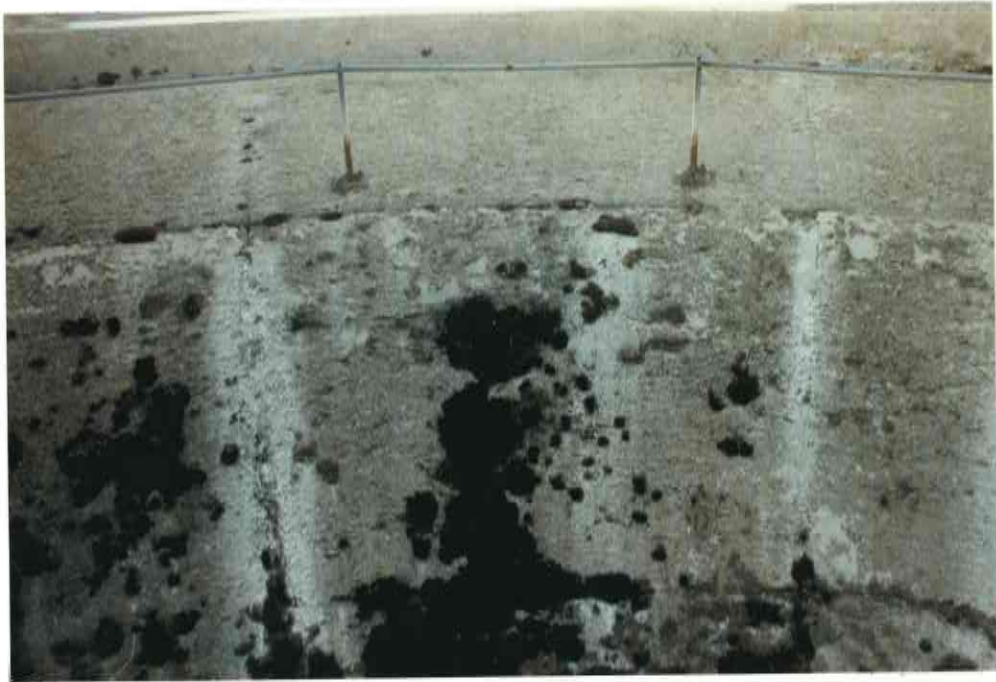
79. BAY 6, MINOR SPALLING, WORSE THAN BAY 5, NOT SEVERE, MINOR PATCHING ONLY

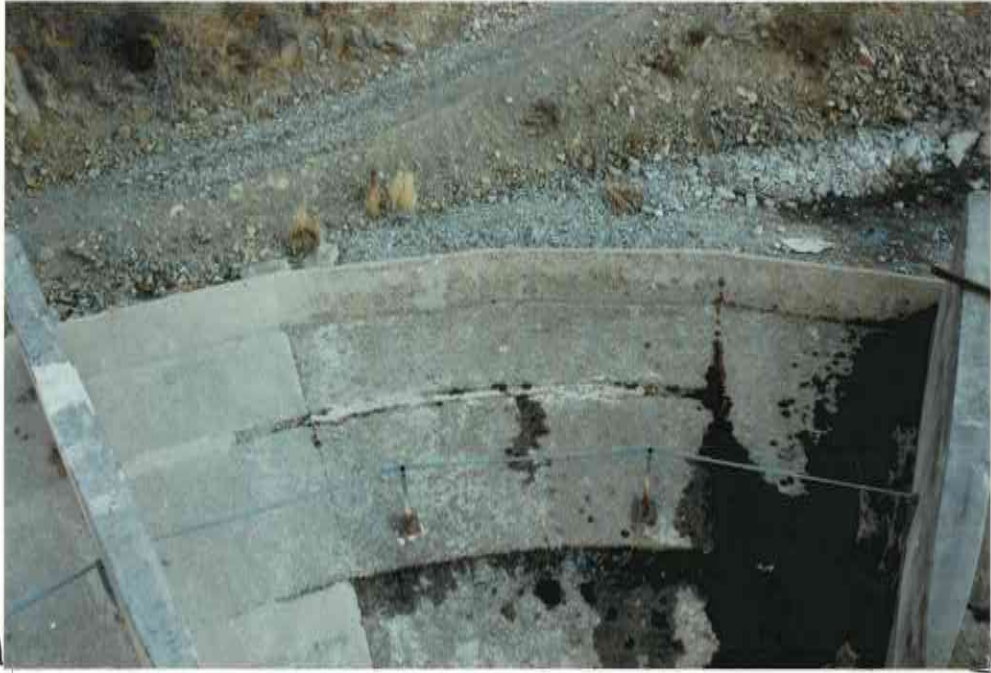
- Photo 80: Bay 1
 Photo 81: Bay 2
 Photo 82: Bay 3, repair poor construction jts mid panel.
 Photo 83: Bay 4
 Photo 84: Bay 5
 Photo 85: Bay 6

82. BAY 3, REPAIR POOR CONSTRUCTION OF MID PANEL

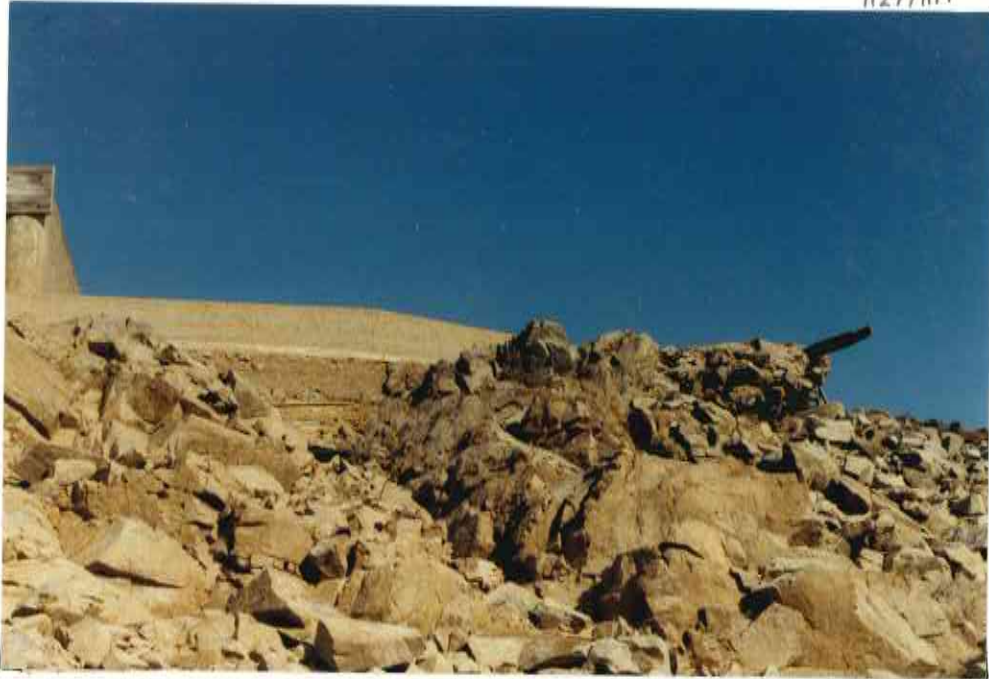
The spillway intake is generally cut into solid rock but it does appear that the outer lip of the spillway at one point has had to be built up. The slope away from the spillway into the reservoir is strewn with loose rock, most of which is probably excess cuttings from the excavations. The rock outcrops, where they could be seen, appear to be sound and there is no evidence that the spillway is in danger.

- Photo 86: View up to foundation at Bay 5, rock at centre
 of photo mostly in situ
 Photo 87: Loose rock slope below Bay 5, in situ rock top
 left and top right
 Photo 88: Access track passed spillway

86. VIEW UP TO FOUNDATION AT BAY 5, ROCK AT CENTRE OF PHOTO MOSTLY IN SITU

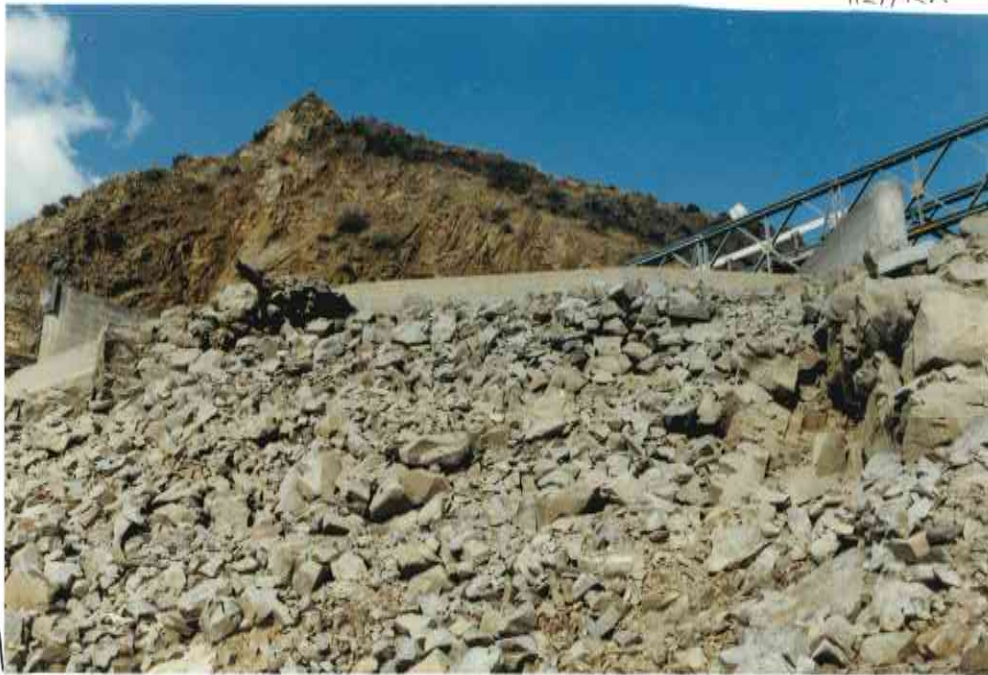
87. LOOSE ROCK SLOPE BELOW BAY 5, IN SITU ROCK TOP LEFT + TOP RIGHT

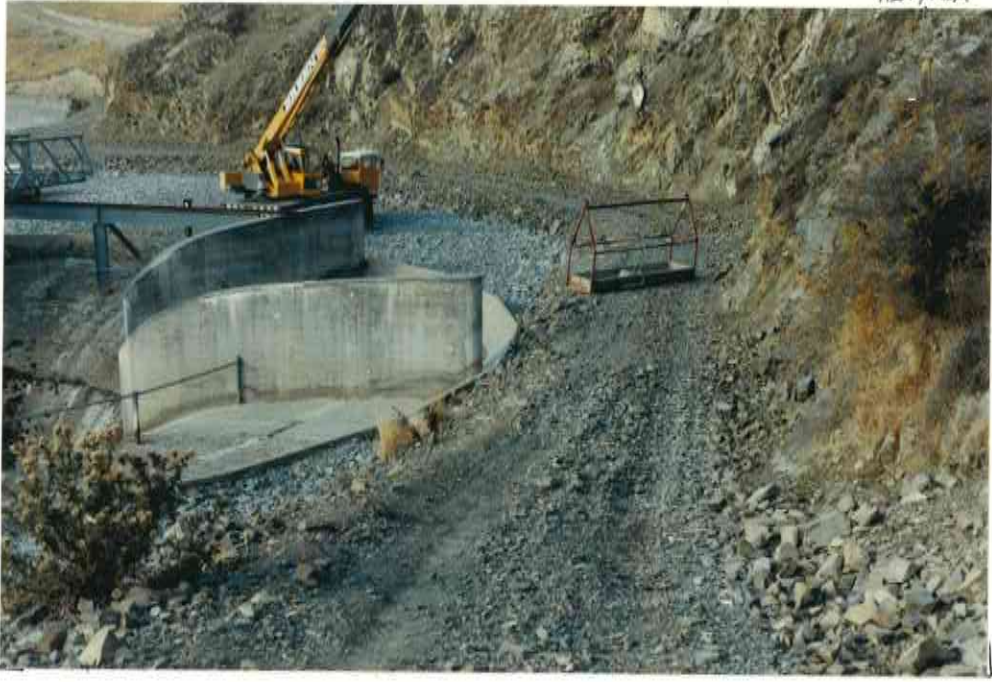
88. ACCESS TRACK PASSED SPILLWAY

A new farmer's access track has at some time recently been installed between the spillway and the rock cutting face. This track has been constructed by building up the surface of the cutting area with granular material. It is recommended that the level of this track where it passes the spillway and for at least 10 m on either side, be lowered to at least that of the intake wall and preferably down to platform level so that water can be taken in from all sides evenly and not be restricted as it presently is. The present situations could promote serious damage to the spillway in high flood conditions because of the asymmetrical inflow pattern inducing dynamic effects.

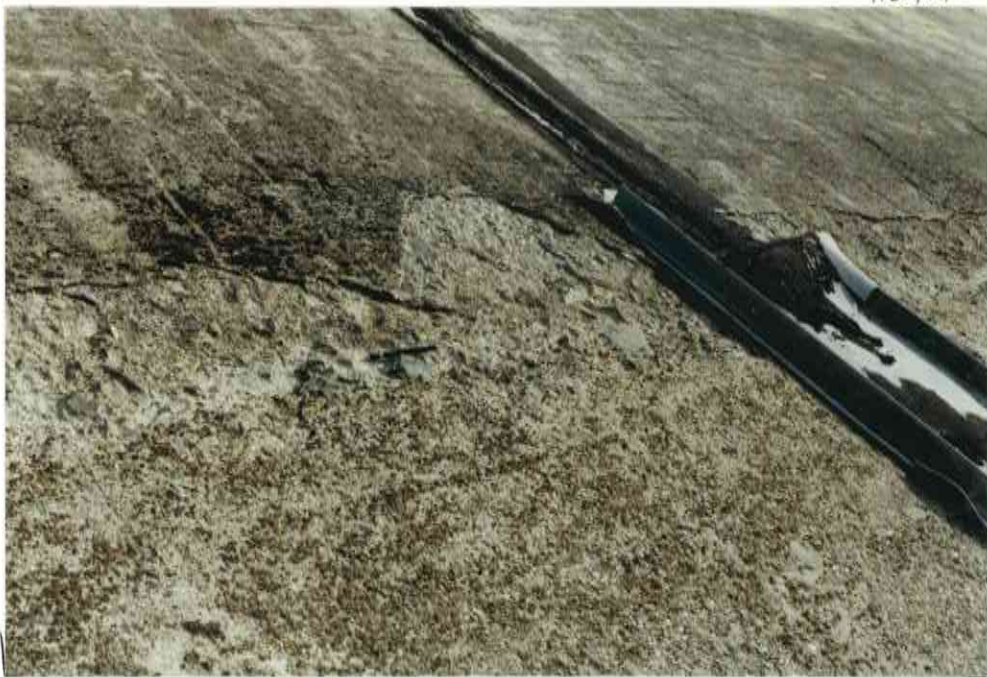
Photo 91: Close up of surface damage at normal water level between first and second panels

91. CLOSE UP OF SURFACE DAMAGE AT NORMAL WATER LEVEL BETWEEN FIRST + SECOND PANELS

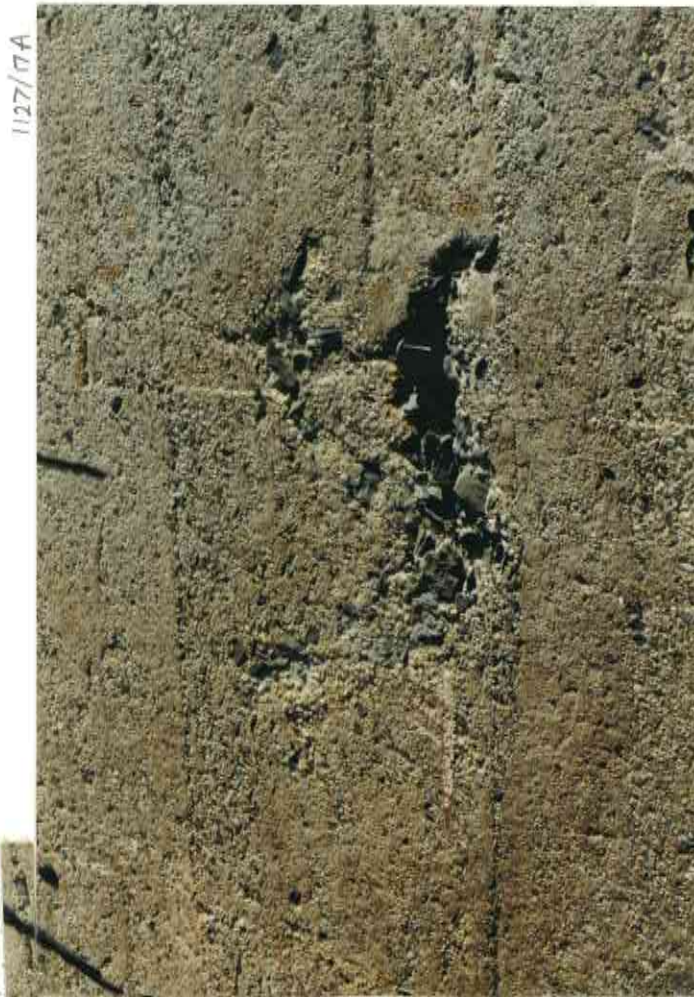
92. CONCRETE SURFACE DAMAGE NEAR THE ABUTMENT MIDWAY DOWN
SECOND HORIZONTAL PANEL ROW

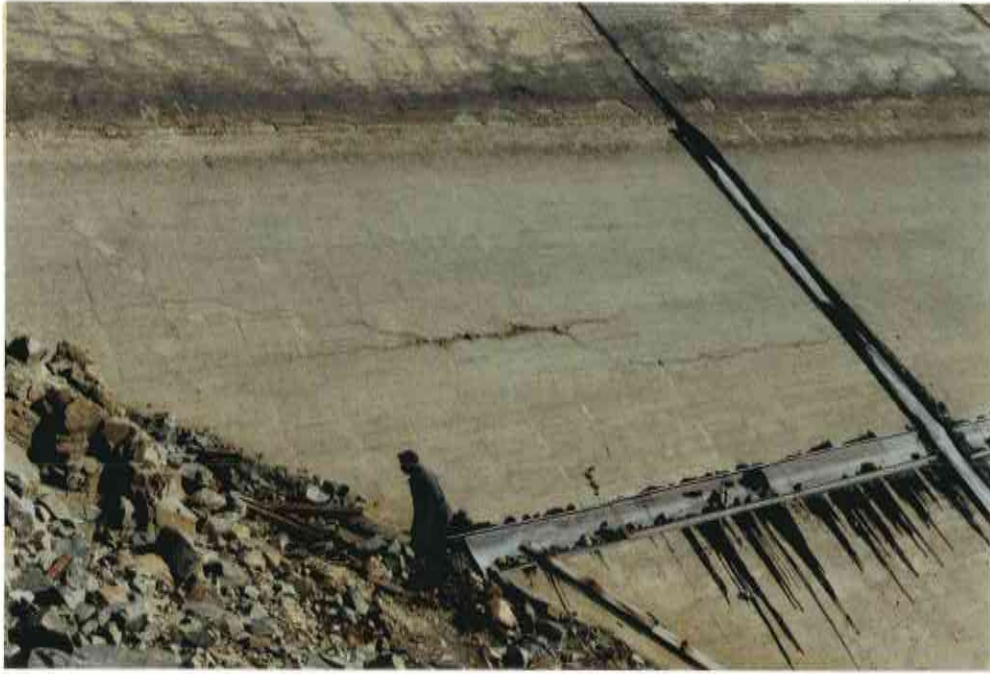
93. SECOND OF TOP PANELS NOW SHOWING DAMAGE
AT NORMAL WATER LEVEL + HORIZONTAL CRACK
ABOVE FIRST HORIZONTAL JOINT

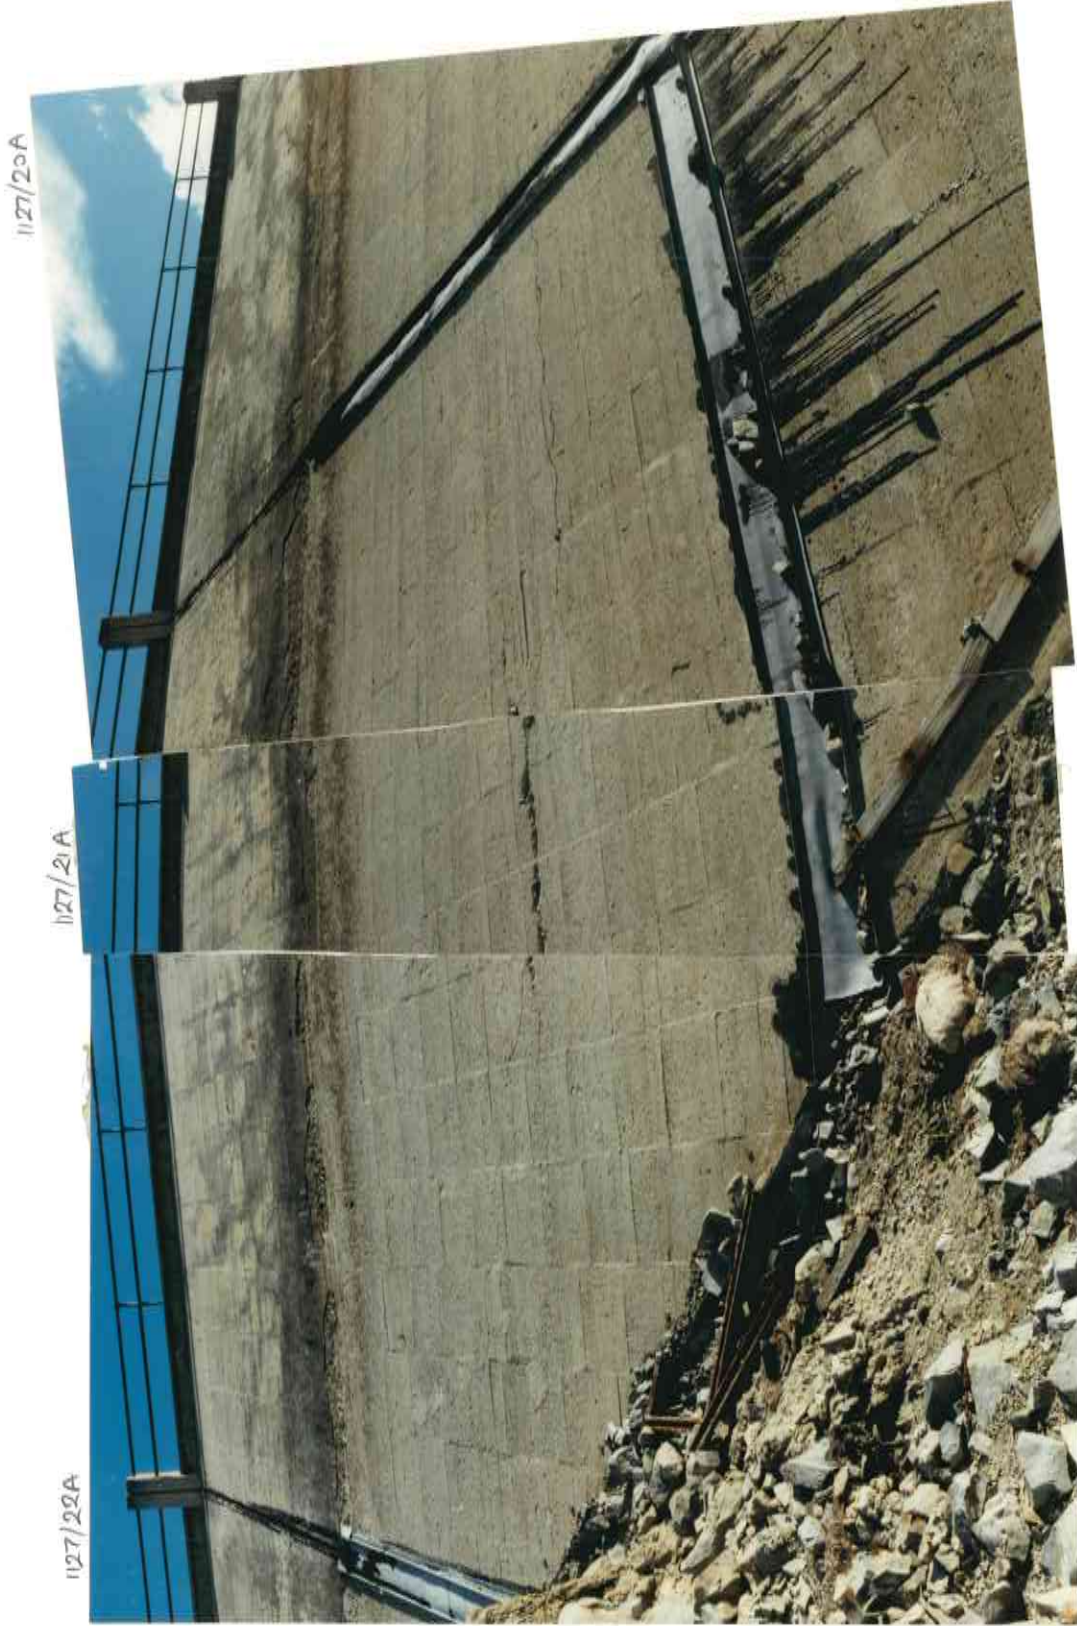
94. SECOND OF TOP PANELS NOW SHOWING DAMAGE AT NORMAL WATER LEVEL + HORIZONTAL CRACK ABOVE FIRST HORIZONTAL JOINT

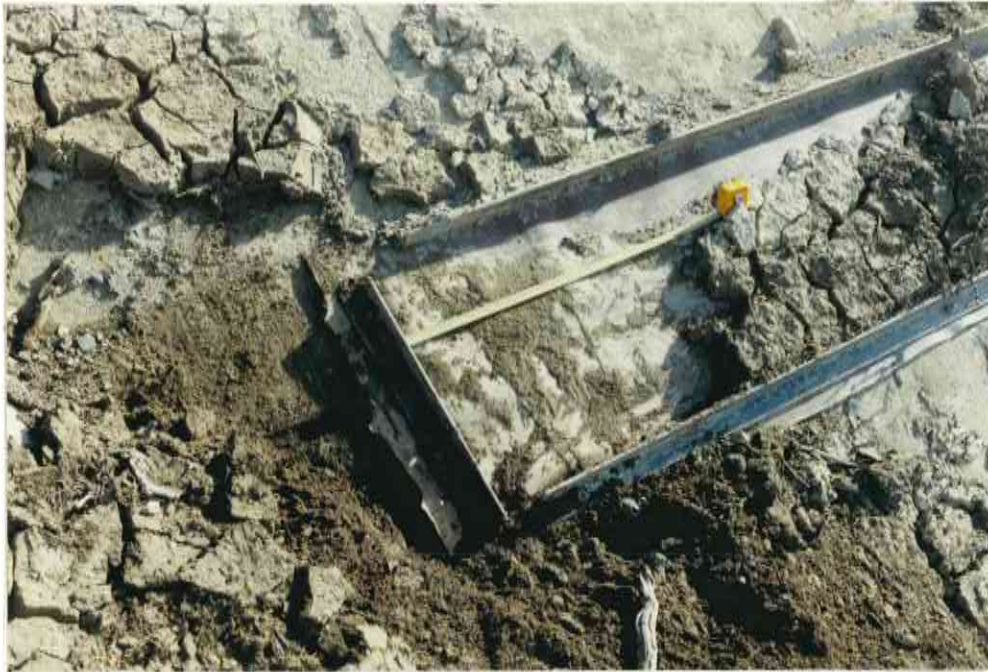
95. END OF SECOND HORIZONTAL JOINT WHERE IT COMES INTO THE TL ABUTMENT SHOWING HOW THE RUBBER STRIPS ARE HELD DOWN

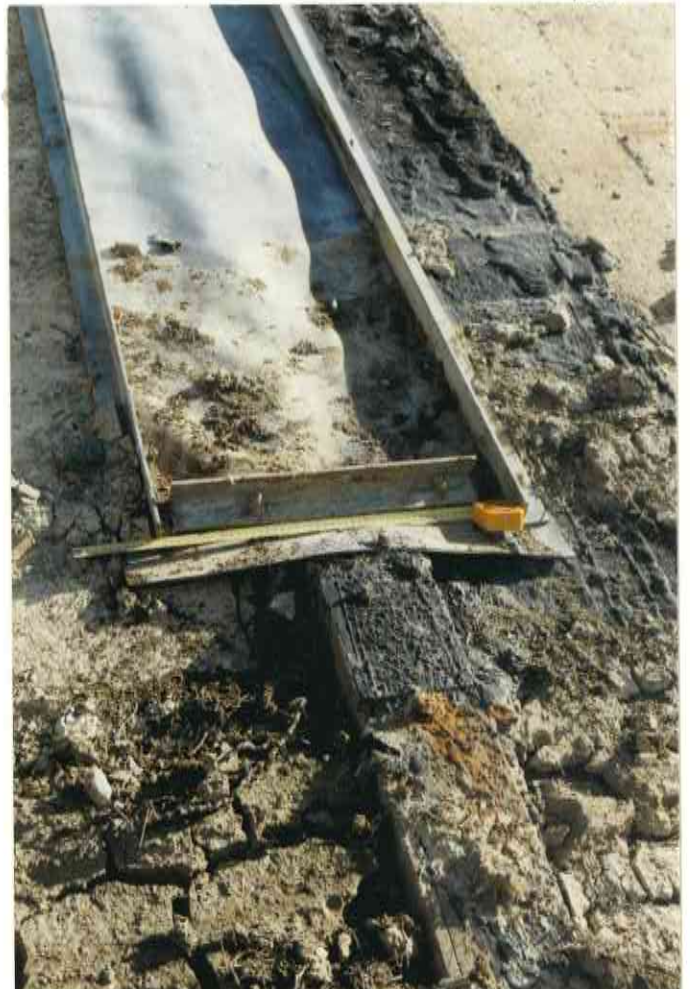
96. VERTICAL JOINT BETWEEN THE SECOND AND THIRD PANELS
