NATIONAL WATER AND SOIL
CONSERVATION AUTHORITY

**REFURBISHMENT OF
OMAKAU
IRRIGATION SCHEME
HEADWORKS**

ENGINEERING FEASIBILITY REPORT

Dec 1986

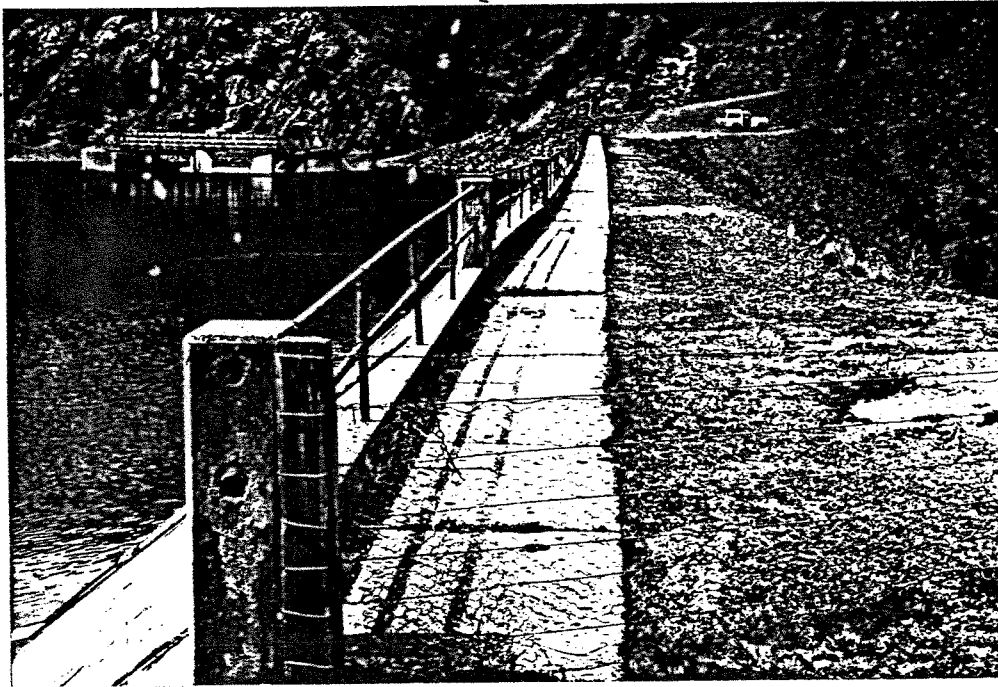
Photograph 1 : Falls Dam

Falls Dam is situated approximately 20 km upstream of Becks on the Manuherikia River. It is a rock fill dam standing 33.5 metres above the stream bed and is faced with a reinforced concrete membrane on the upstream side. (Photograph 1). The flooding spillway is of the Morning Glory Hole type which is excavated through the rock of the left abutment and discharges 75 metres downstream of the toe of the dam. Irrigation water is drawn from the reservoir through a diversion tunnel and a needle valve and is discharged into the spillway tunnel.

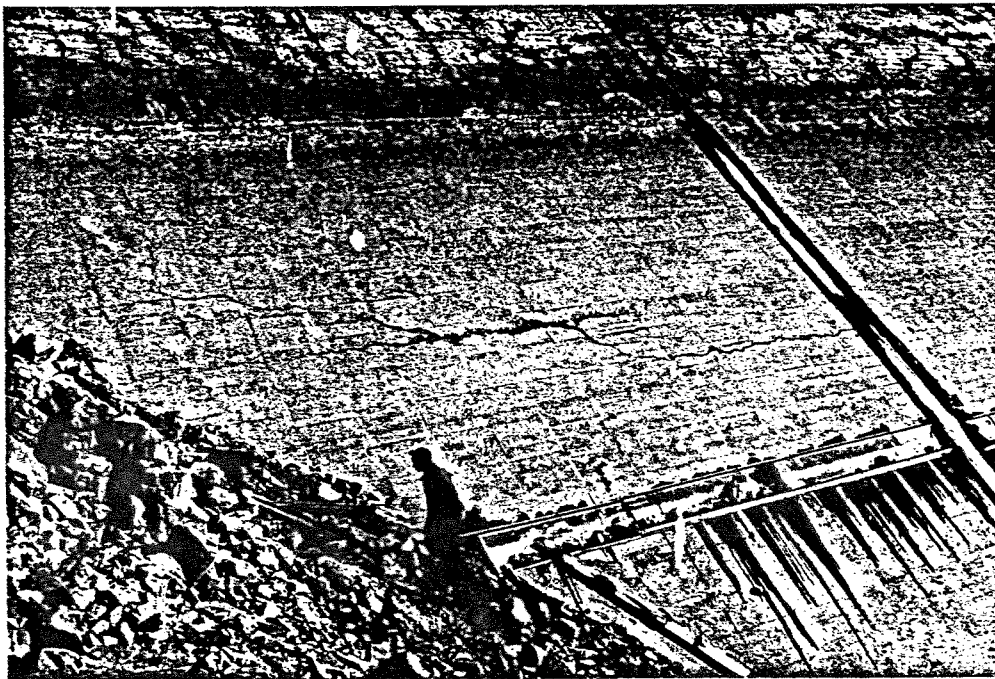
Photograph 2 : Dam Membrane

The dam membrane is in reasonably good condition. Because it is relied on to control the leakage from the dam it is important that the membrane is well maintained. With the dam full the leakage flow was observed and was estimated to be in the order of 10 litres/s. This flow is considered acceptable.

Problems associated with the dam membrane include minor cracking and surface damage generally above normal water level. The cracking of a panel adjacent to the left abutment has been caused by settlement but it is not considered a serious problem. The surface damage to the membrane is due to wave action at normal water-line where the concrete has been eroded, and frost-action above normal water-line where surface spalling has occurred.

The construction joints between the concrete panels are required to be impermeable. At present the joints are sealed by copper strips cast into the concrete, filled with pitch and covered with a neoprene strip, (photograph 2).

When the lake level is low, the pitch heats up and flows down the joints. This has caused bulging and splitting in the neoprene seal. This seal will need to be modified in the near future to prevent movement in the pitch and prevent a potential leakage problem.

It is recommended that although the damage to the membrane is not major, repair work is warranted to ensure the impermeability of the membrane.

It appears that an attempt has been made in the past to repair the spalled areas. The repair concrete is now also spalling. Repairs in the future should utilise latex-modified concrete or a similar material which forms a good bond with old concrete. Furthermore, the water-cement ratio must be controlled to reduce shrinkage effects. Shrinkage in this environment may lead to a weakened bond and the intrusion of moisture. This would subsequently lead to spalling of the repair areas under frost conditions. This concrete should be used for both crack and surface repairs to ensure a durable and lasting repair.

It is proposed that hardwood planks will be used to cover the joints. The insulating properties of the timber should prevent the pitch from melting. This system was originally used when the dam was built and is known to perform well.

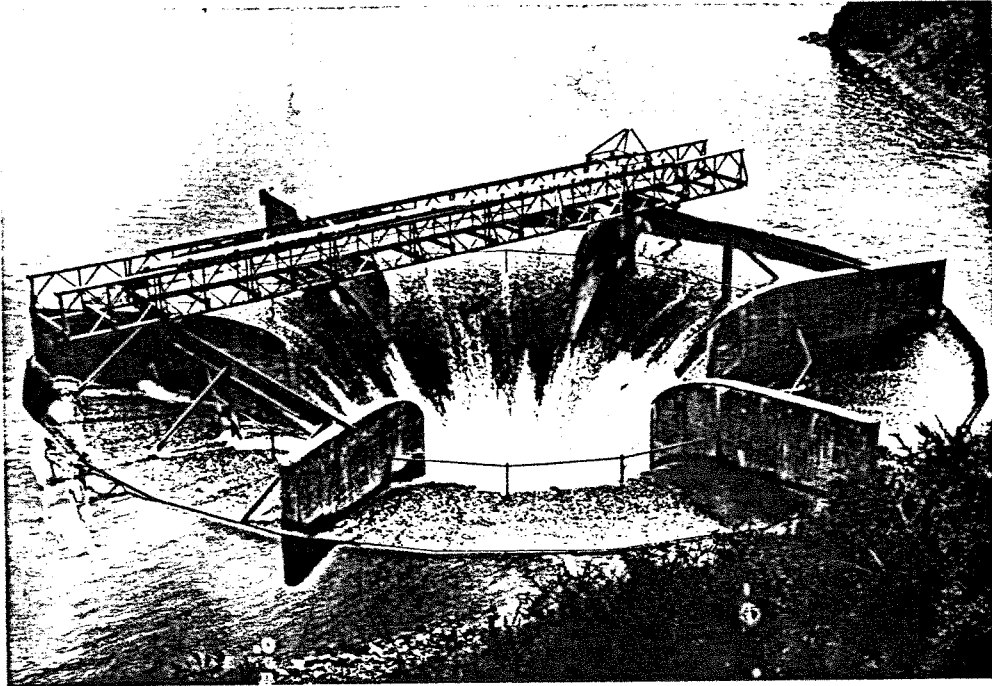
Photograph 3 : Morning Glory Hole Spillway

The concrete lining of the spillway is badly worn in areas, especially around the bell mouth. Some panels have been badly eroded and at the construction joints frost action has aggravated the damage, exposing the reinforcing steel. (Photograph 3 and 4). If repairs are not carried out in the near future further damage will result.

The repairs involve chipping out the damaged areas back to clean concrete or rock and filling with latex-modified concrete. In the bad joints it will be necessary to tie the repair concrete back to the rock with steel rods to ensure the area is sound. Most panels will need some resurfacing to ensure a smooth surface. This will reduce the risk of cavitation. Remedial work to repair the lining is programmed for 1987. This work will be carried out by Operations and Maintenance staff from Alexandra Residency. At present \$15 000 has been budgeted for the most urgent work. However, extensive work will be necessary in the near future to repair all damaged areas throughout the tunnel. A detailed inspection of the spillway was made in 1985 and it is summarised in reference 5.

A farmer's access track has at some time been installed between the spillway and the rock face by the left dam abutment. It is recommended that the level of this track where it passes the spillway and for at least 10 m on either side, be lowered to at least that of the intake wall and preferably down to platform level. This would enable water to be drawn from all sides evenly and not be restricted as it presently is. The present situation could promote serious damage to the spillway in high flood conditions because of dynamic effects.

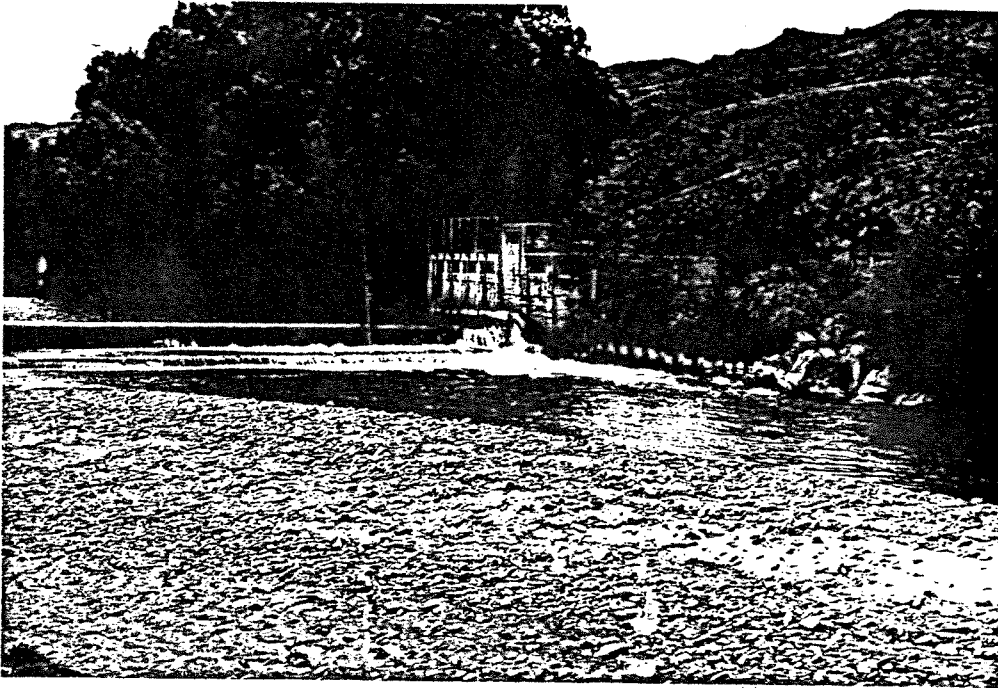
Photograph 5 : Omakau Main Race Intake

The intake is a concrete structure with four steel knife gates set behind the weir. The gates and the structure are in good condition and only minor repairs are required to the concrete work. However, the major problem here is that there is no automatic throttling system to prevent increased flows entering the system when the river rises significantly. In a major flood, more than 3.0 cumecs could flow into the system which is designed for a maximum of only 2.1 cumecs.

When the river is low, the intake acts as a series of weirs. As the water level rises, the weirs drown out and begin to act as orifices. Under normal operation the intake acts as a series of orifices under little head. Generally only two gates are used to achieve a 2.1 cumec flow. As the river rises further, the change in head above the orifices causes a comparatively large increase in flow. The pipeline does not run full until 2.5 cumecs enters the intake and so it does not throttle the flow either.

- a Do nothing at the intake and remedy the situation downstream at the control structure.
- b Total replacement using an overflow weir intake, silt-trap and bywash structure.

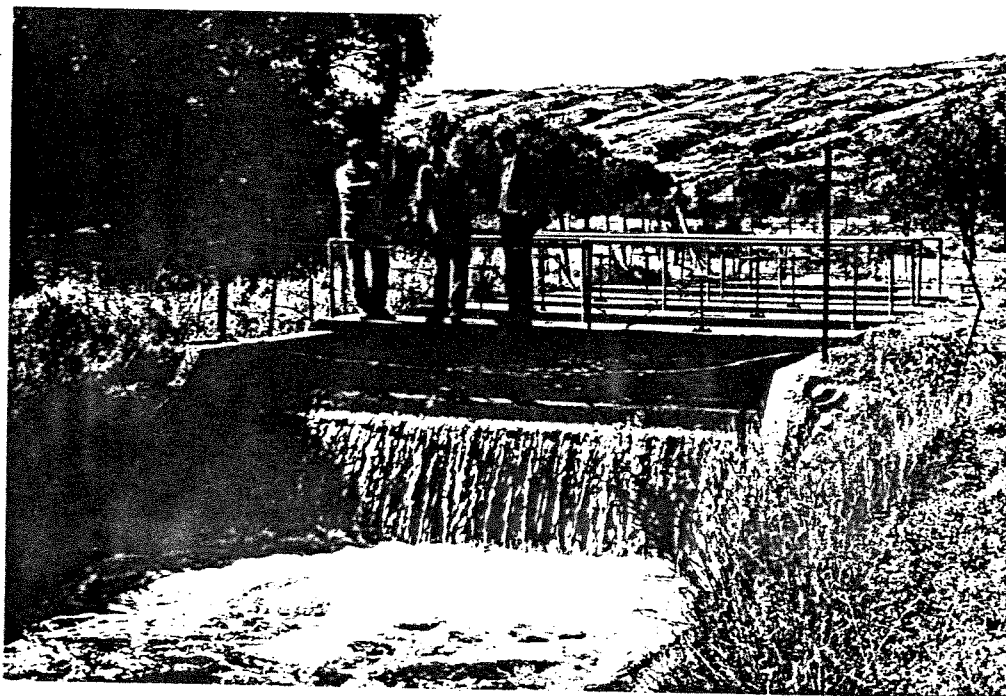
Photograph 6 : Omakau Main Race Control Structure

The concrete work still appears structurally sound. However its silt-scour facility does not function properly. Currently only three of the ten scour holes are operable. These frequently become blocked and require hand-cleaning.

Because of the present operational difficulties it is proposed that a new silt-scour facility be incorporated into the control structure. This would involve removing the existing scour gates and demolishing the scour conduits. The existing scour channel would be extended back to the side wall of the control and three scour gates would be installed in the side wall. Since access must be retained across the channel, a new crossing must be provided.

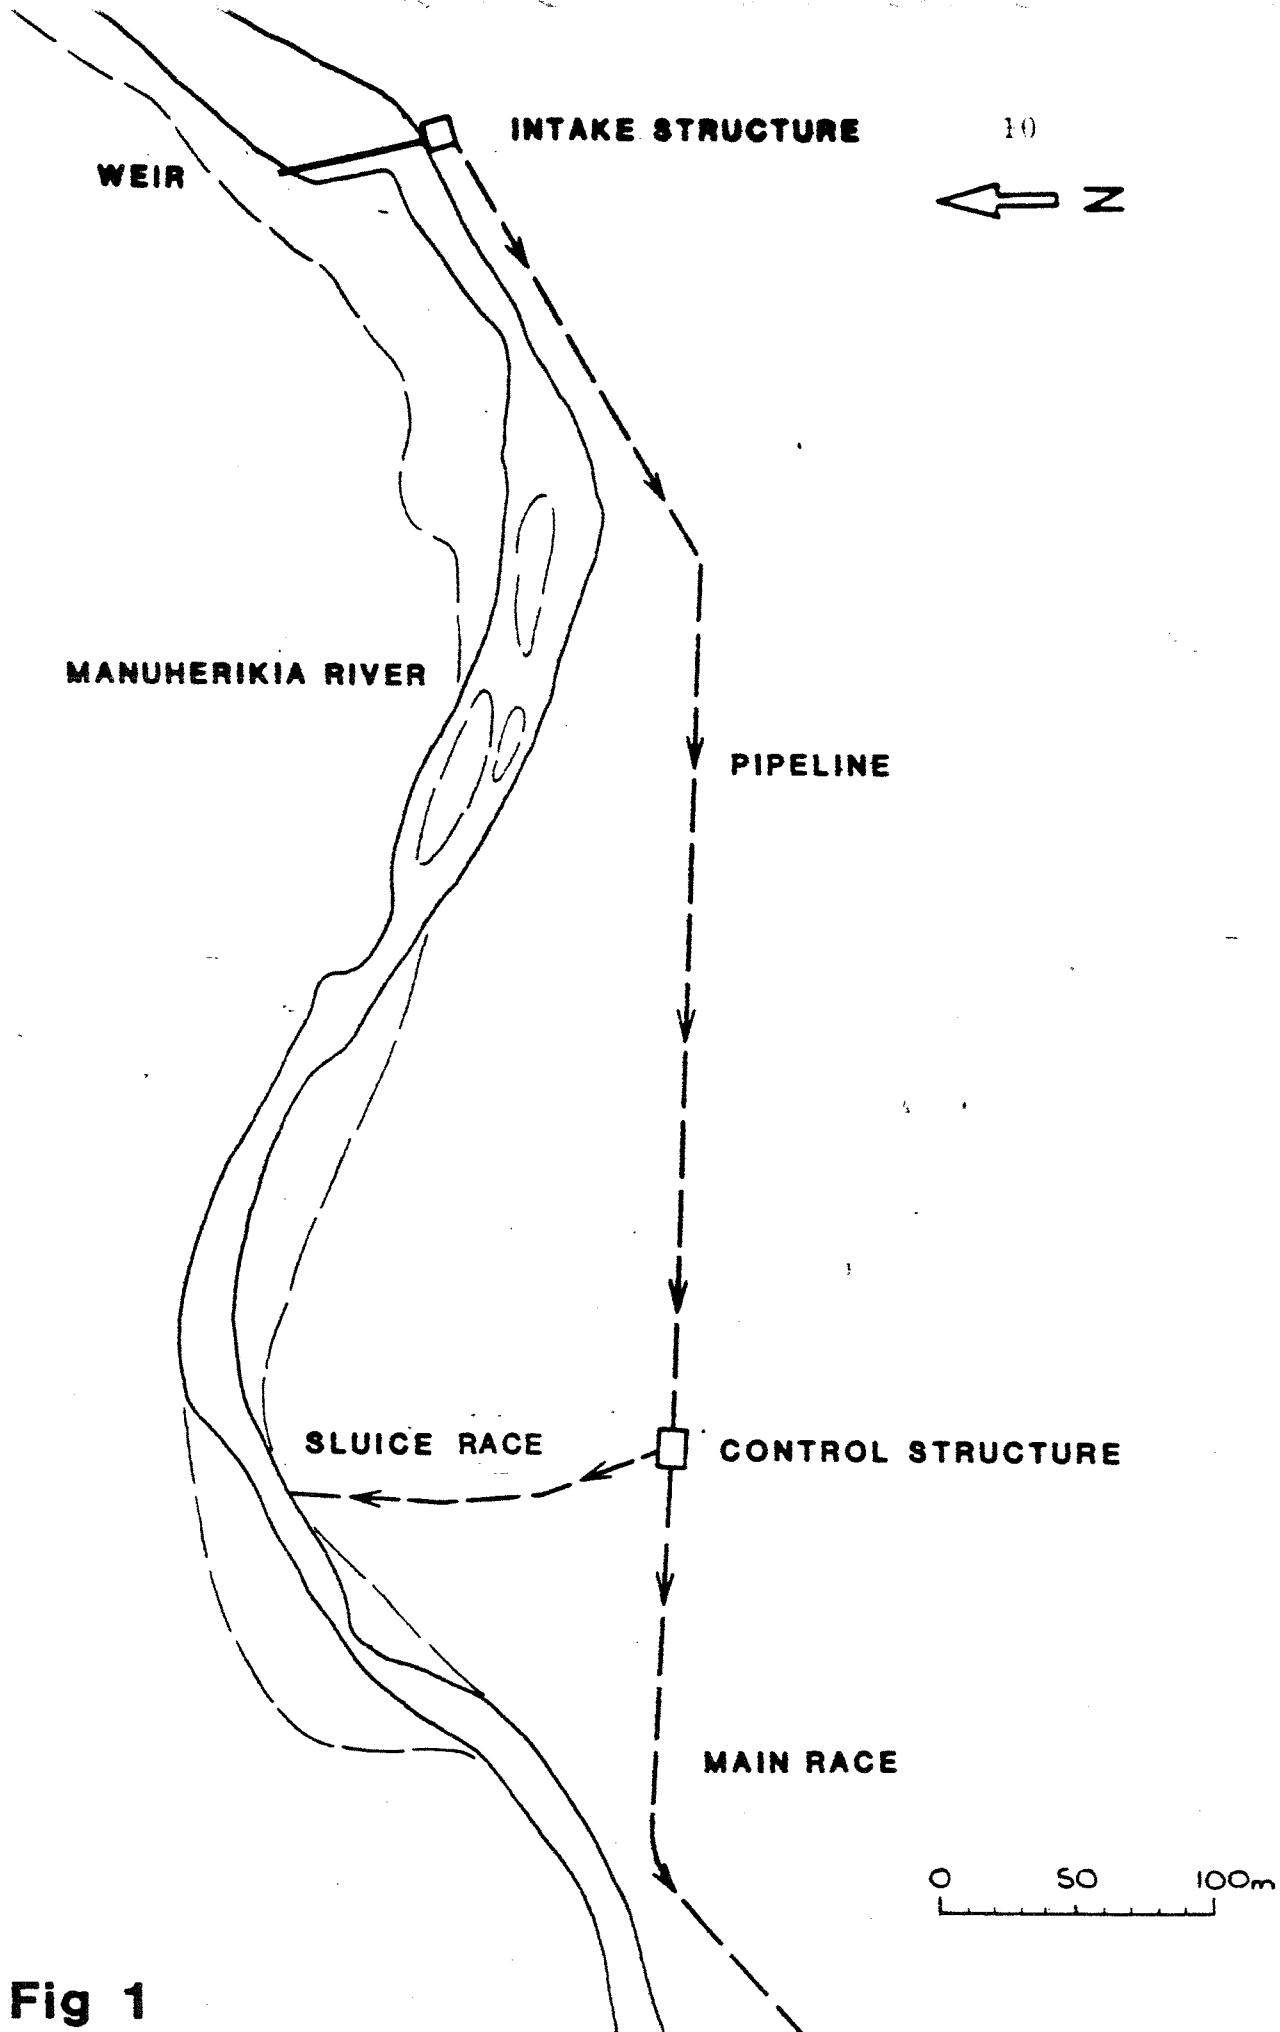
Fig 1
OMAKAU MAIN RACE INTAKE STRUCTURES

The weir, although worn, still appears to be sound. There is evidence of significant scour on the downstream side and this may have been aggravated by the addition of a thick topping slab on part of the apron.

Since the pipeline is normally under no head it is unlikely to fail catastrophically in the next 15 years. However at present there are several open joints and the invert is badly worn.

The only work proposed for the weir is to fill the scour hole with some large rock. The hole should be filled no higher than the surrounding bed level so that the problem does not merely move downstream further. This repair would best be carried out during summer when the river is low.

It is proposed therefore to repair the joints and the invert with either an epoxy mortar or latex-modified concrete to stop leakage and to ensure its integrity in the medium term.

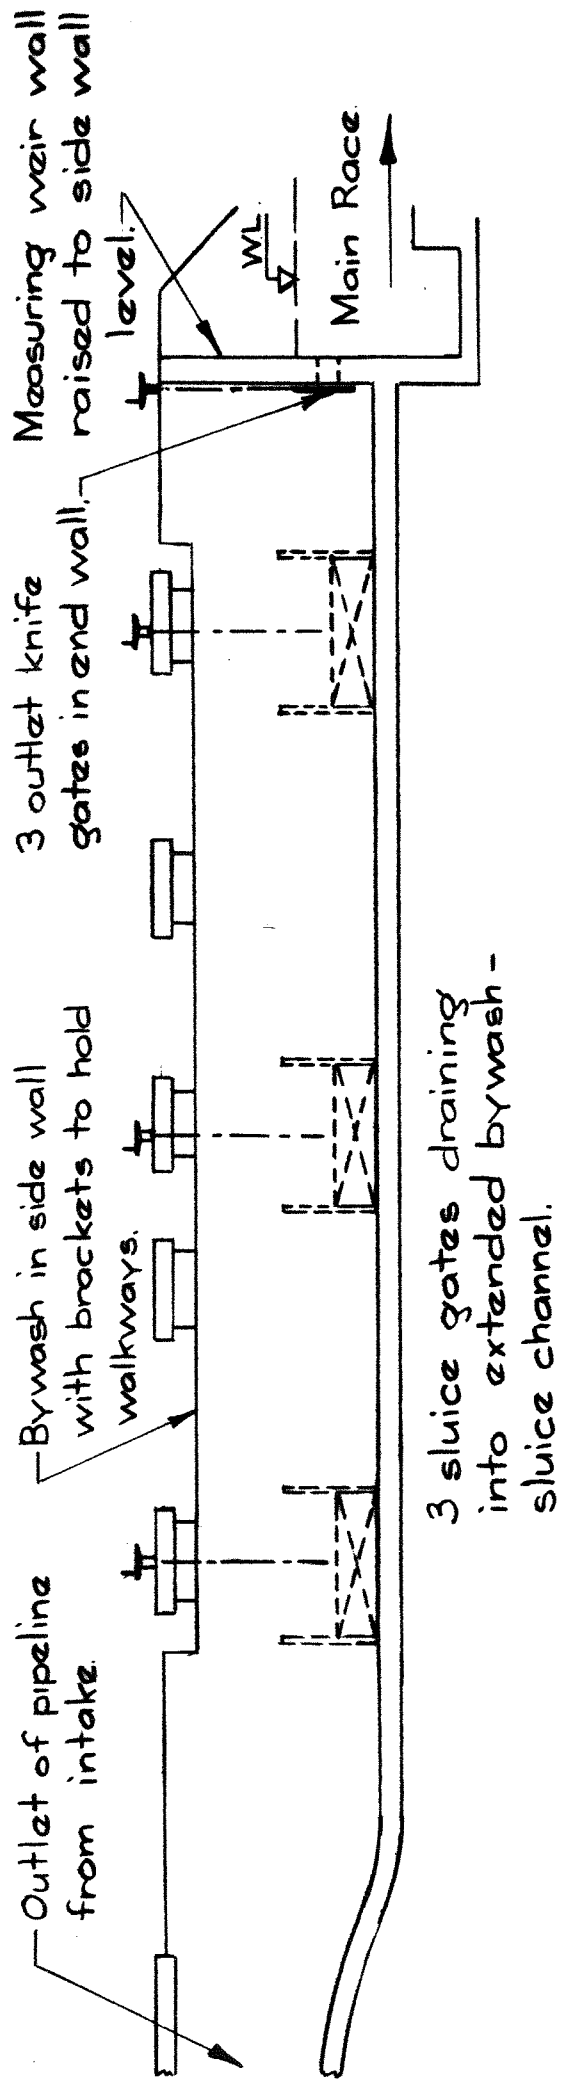
Figure 2

Option 3 is considered the best option. It provides an adequate throttling of the flow under a flood situation and is considerably cheaper than options 1 and 4. There is a good matching of the weir against the gates which results in efficient bywashing and good control of in-race flows.

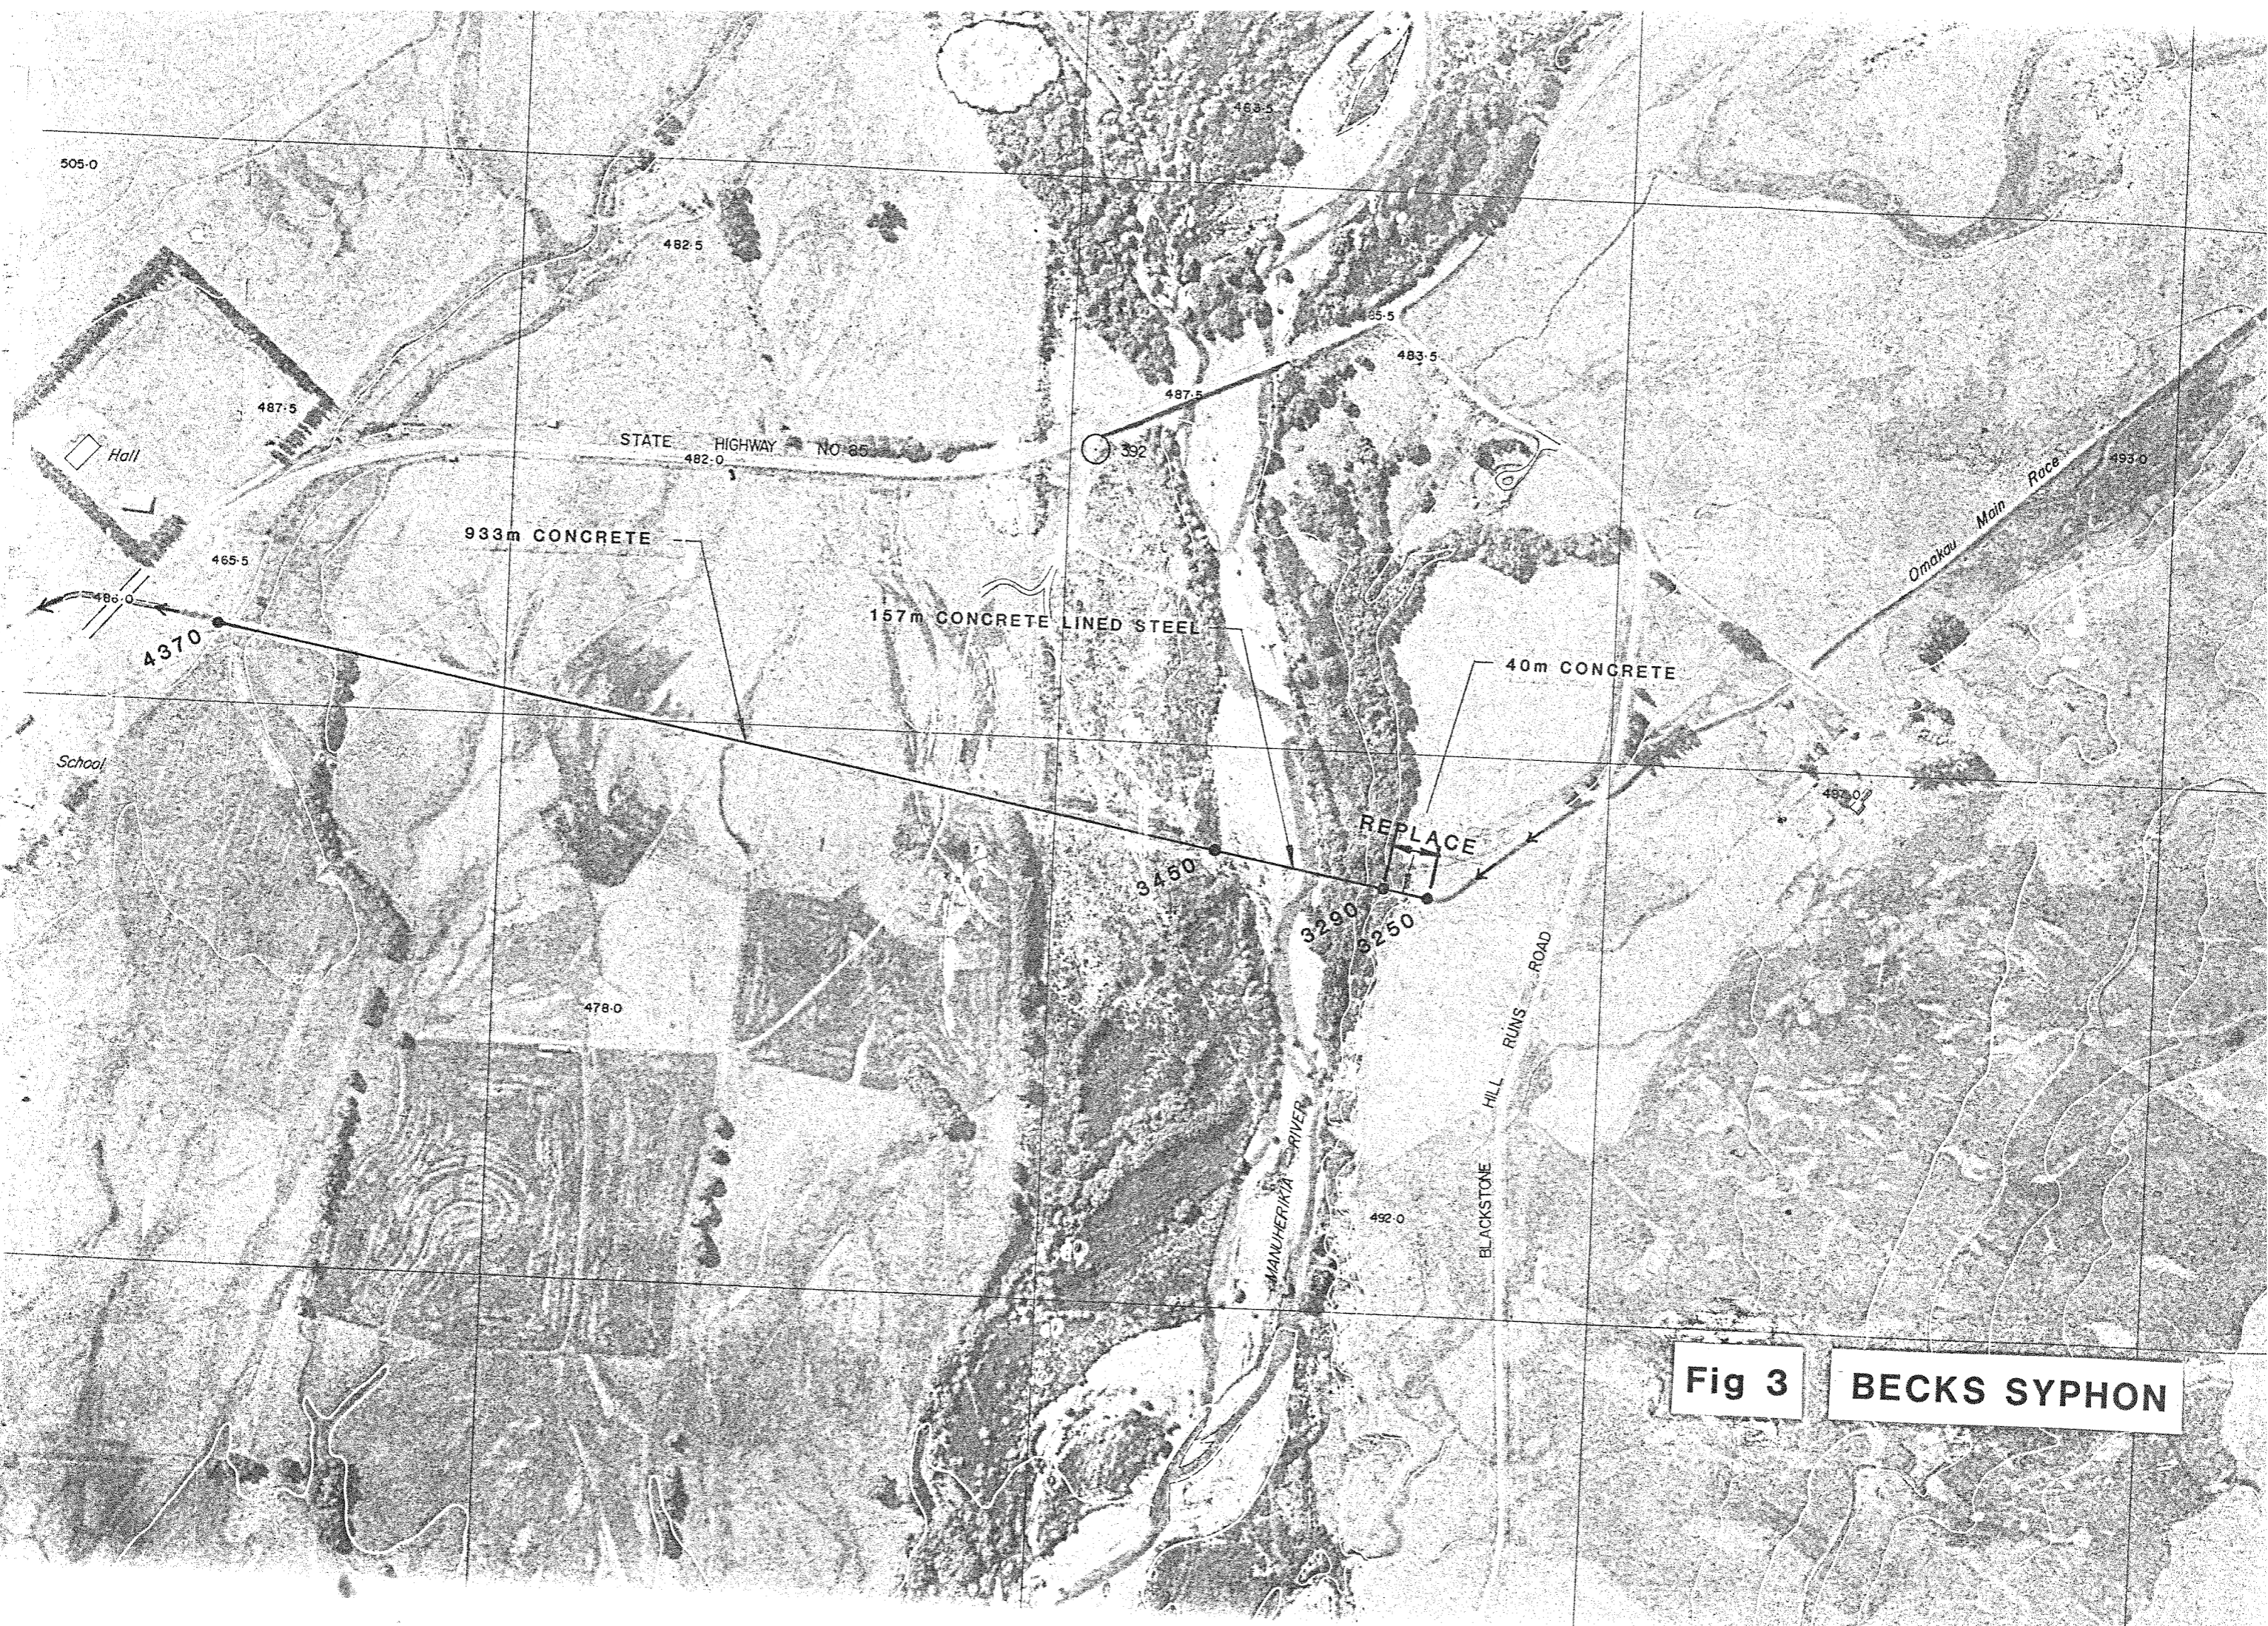
Fig 3 BECKS SYPHON

The first stage is a 40 m long 910 mm diameter concrete section down to the river. This section is leaking badly and it is proposed that it be replaced with RCRRJ pipes. A new intake with improved hydraulic performance should be installed to ensure drowning and reduce air entrainment.

The second stage consists of 157 m of 910 mm diameter concrete-lined steel pipe on concrete pedestals across the river. This section is in a satisfactory condition with little visible corrosion and no significant leakage. This section should last through the refurbishment period given some maintenance to the flanged joints and the expansion joint.

The final section consists of 217 m of 910 mm diameter and 716 m of 1070 mm diameter concrete pipe. This section appears to be in good condition with no obvious signs of leakage. At present, this section needs no work.

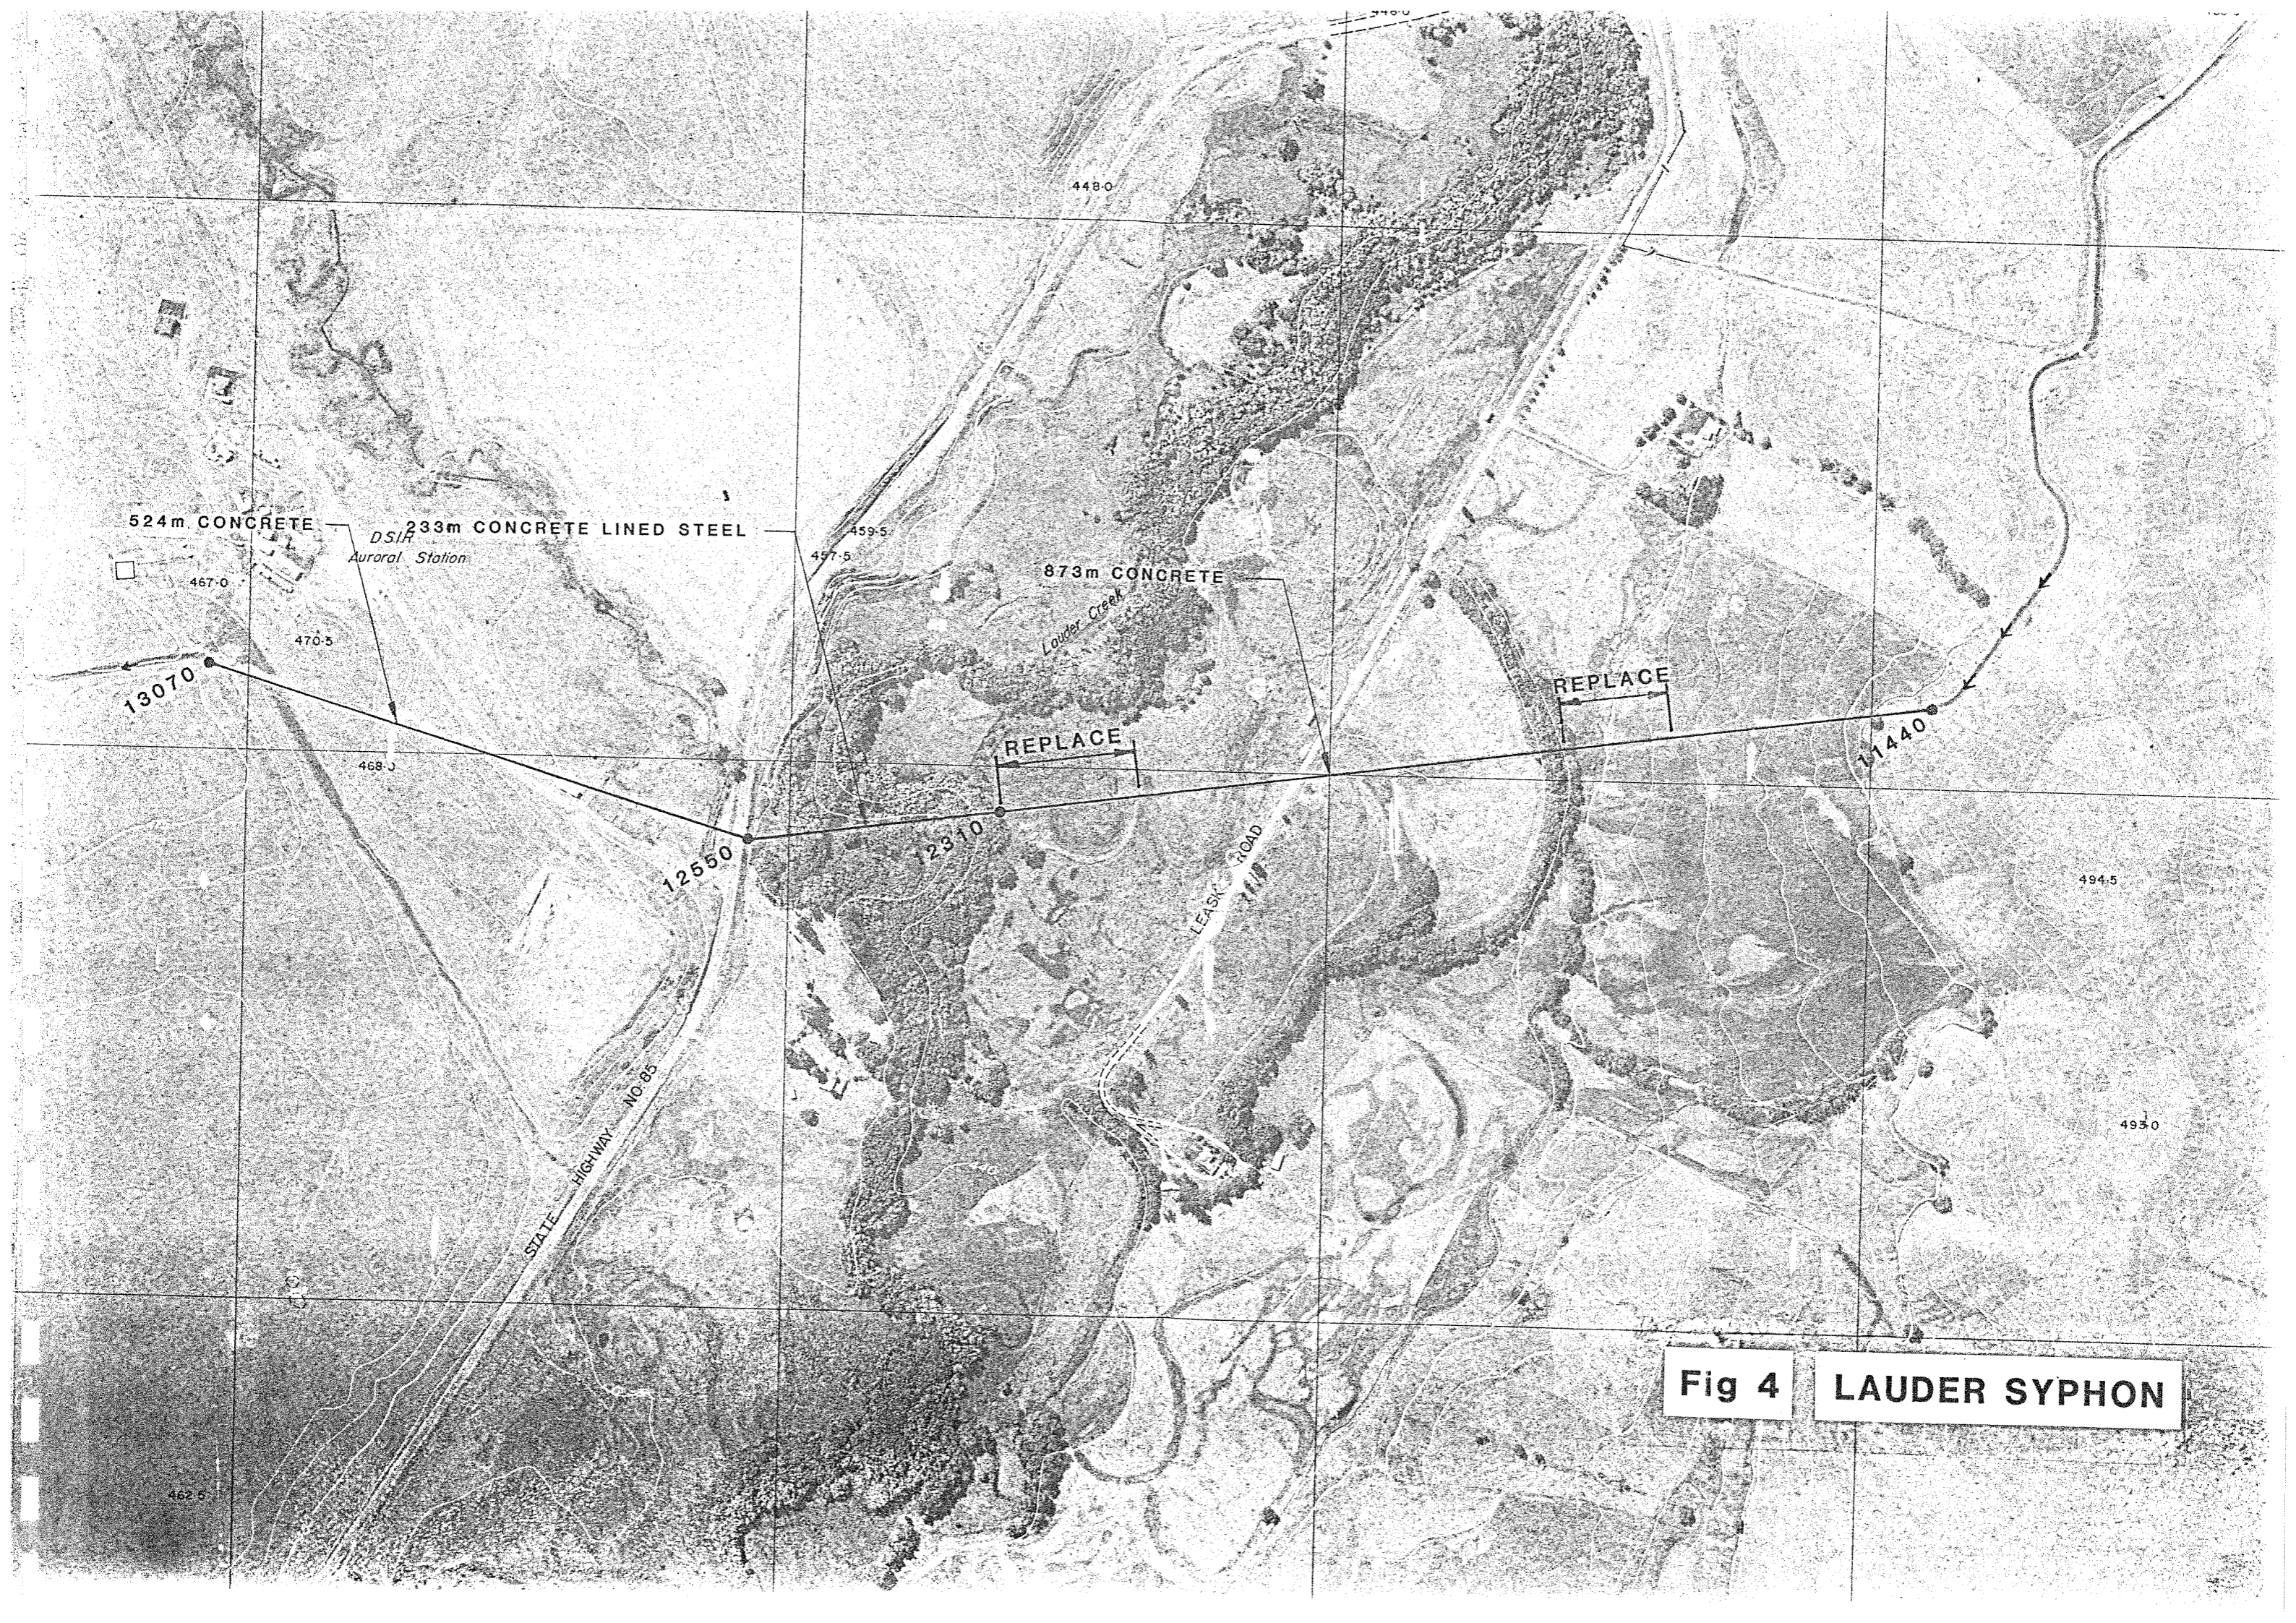
Fig 4 LAUDER SYPHON

The first stage of the syphon is an 873 m long 1070 mm diameter concrete pipeline. Leakage from parts of this section has caused the ground to become swampy. As is the case with most of the concrete syphons on this scheme, the pipes are rigid jointed. The pipes are plain-ended with a concrete coupling and concrete plastered joints. Hardwood pegs were used during construction to centre the couplings. These are now rotting out resulting in leaks. This leakage is saturating the surrounding ground causing the pipes to settle thereby aggravating settlement and leakage. Concrete blocks have been cast around some of the worst joints but these repairs have generally been unsuccessful. Plastering the inside of the joints with an epoxy mortar is another method being used. This is more successful but the joint remains rigid. The repair is susceptible to further cracking if more settlement takes place.

The bottom 70 m of the downhill leg of this section are leaking quite badly and this has resulted in small slumps and large cavities where the bedding and cover material has been washed out. The extent of the undermining of these pipes is not known. It is quite possible that this section

STA 12200-12310 at the end of this section should also be replaced. This length is buried in an embankment about 2 m high and leakage has been aggravated by serious settlement. Numerous concrete blocks have been cast around leaking joints. Many of these blocks are now cracked and leaking badly.

The second stage is a 910 mm diameter concrete-lined steel pipeline 233 m long, crossing the creek on low pedestals. The spread of willow trees across the creek bed has led to aggradation of the bed, reducing the clearance beneath the pipeline. In the past, floodwaters have backed up behind the pipeline, threatening to move it off its pedestals.

The concrete lining is not in good condition. The invert area is badly worn in most pipes, especially towards the joints. In the pipes which were damaged in a blow-out, the lining is in worse condition with large areas of concrete having spalled. The concrete lining however does not greatly affect the performance of the structure and with continued maintenance as required, this section of the pipeline should last through the refurbishment period without replacement.

The third stage of the syphon is a 524 m long 1070 mm diameter concrete pipeline and is in good condition. There are two obvious leaks that need to be repaired. One is under the highway embankment near the bend in the pipe and the other is close to the access road to the DSIR station. These pipes may be cracked and may need to be replaced. Apart from this, no other work is necessary on this section.

could fail in the next few years. This section therefore from a manhole near station 11720 to the bottom of the hill at station 11790 should be replaced.

solution would be either to fix the pipes to the pedestals or to drive railway irons into the riverbed on the downstream side of the pipeline.

It is recommended that a hydrological study be carried out on Lauder-Creek in the vicinity of the syphon. If this study can show that there is a significant risk to the pipeline then it should be moved. A contingency sum for burying the pipeline is included in the estimates, (Appendix 5).
