# Poolburn Dam

Concrete Arch Dam	4,000 cu yd concrete
Completed	1931
Height Above Stream bed	83ft
Radius of dam	230ft
Length of Crest	535ft

## Poolburn Concrete Arch Dam

This account is compiled from the Construction Report by T. M. Ball to the NZ Society of Civil Engineers Proceedings 1933-4 and information obtained from the Public Works Department File held at NZ Archives Dunedin.

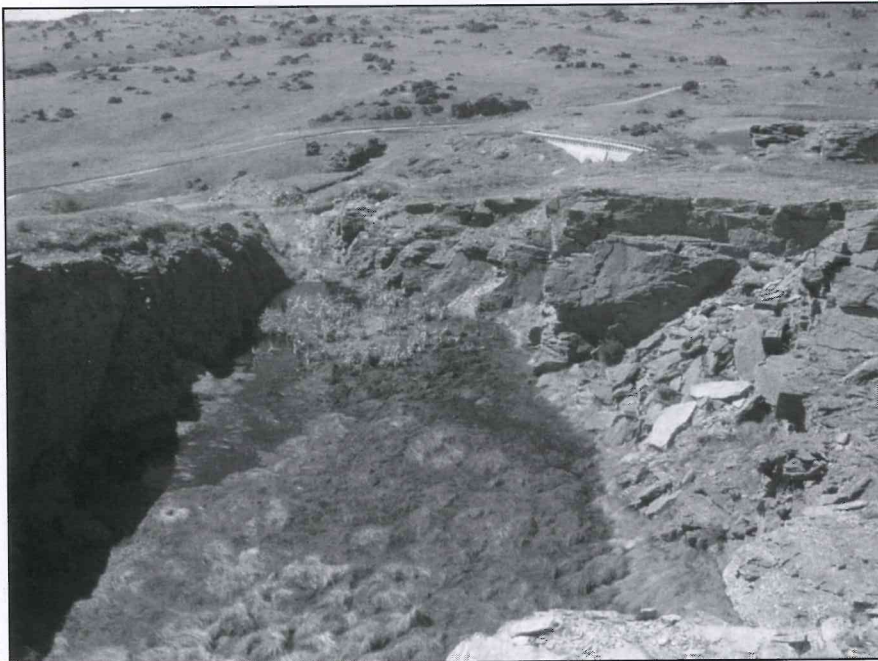
**Looking down from above the quarry used to provide the aggregate for the dam. To the far right of the photograph can be seen the downstream face of the dam and beyond the old Dunstan Road.**

The stone for the concrete was obtained from a quarry located above the left abutment. The hard blue schist crushed into good quality concrete aggregate. A contract party quarried the rock and were paid 4 shillings and 6 pence per yd delivered to the crusher. The Department supplied air drills and compressed air, but the explosives were provided by the contractor and included within the rate. The rock was crushed to a maximum size of a 9 inch cube and taken by a bucket elevator onto the stock pile. A covered 18 inch belt conveyor 250ft long was used to transport aggregate and sand from the stock piles to the mixer.

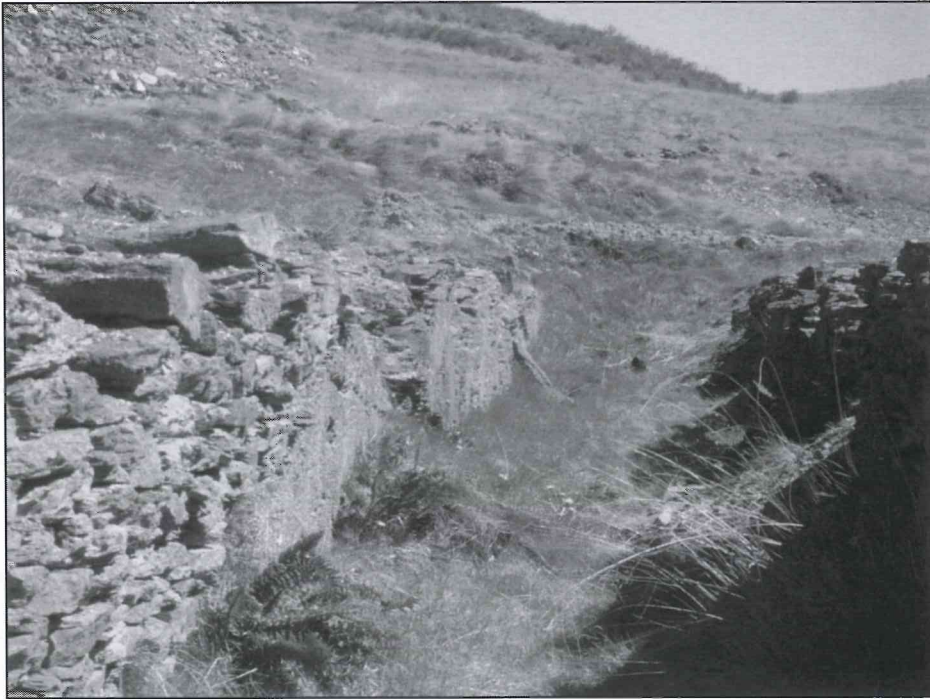
**As it is today looking back up the recess for the covered conveyer used to bring stock-piled aggregate and sand to the mixing bins located at the concrete mixer. At the top left is the discarded stone from the crusher with the quarry above.**

The stone and sand contracts were let in advance of concreting at the site so the conveyor was necessary to save re-handling the stock piles. The conveyor discharged directly into batch hoppers with cement stored in a separate shed. When the correct amount of stone, sand and cement, was measured, it was tipped into the mixer below.
