**MANUHERIKIA IRRIGATION SCHEME
GEOTECHNICAL STUDIES
FOR FEASIBILITY REPORT**

Special Projects Report 1986/28

October 1986

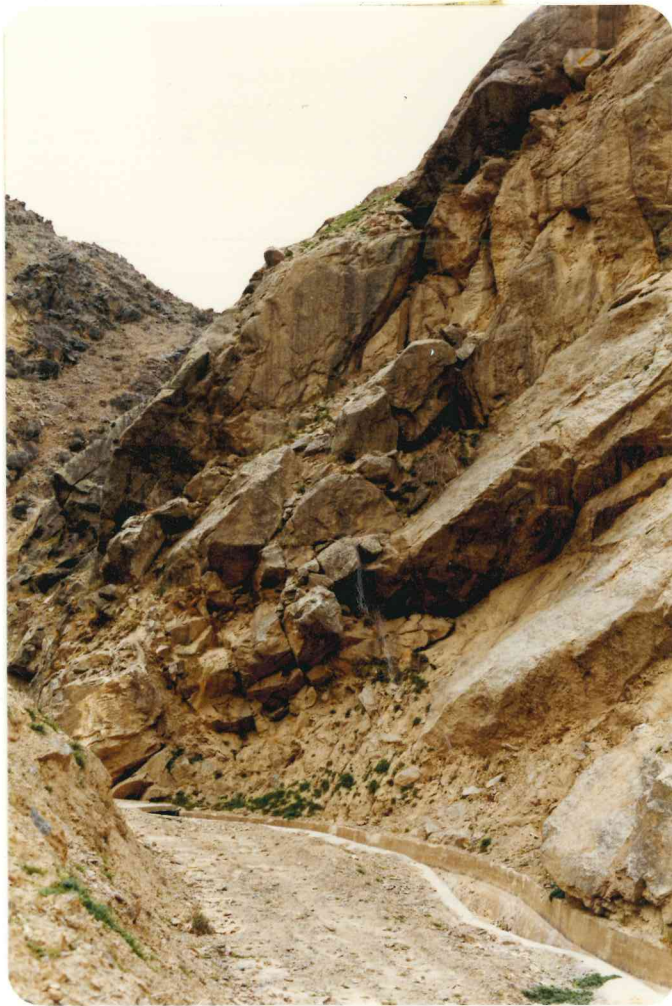
Plate 1
Outcrop of Schist Rock Near
the No 2 Tunnel Portal

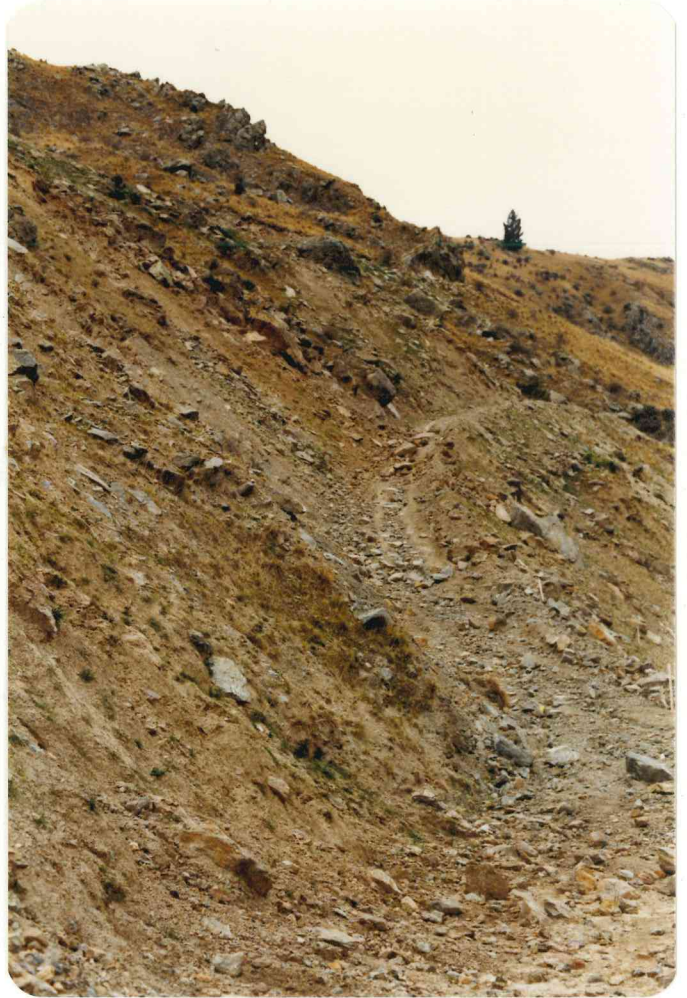
Plate 2
Exposure of Landslide Debris
on Access Track

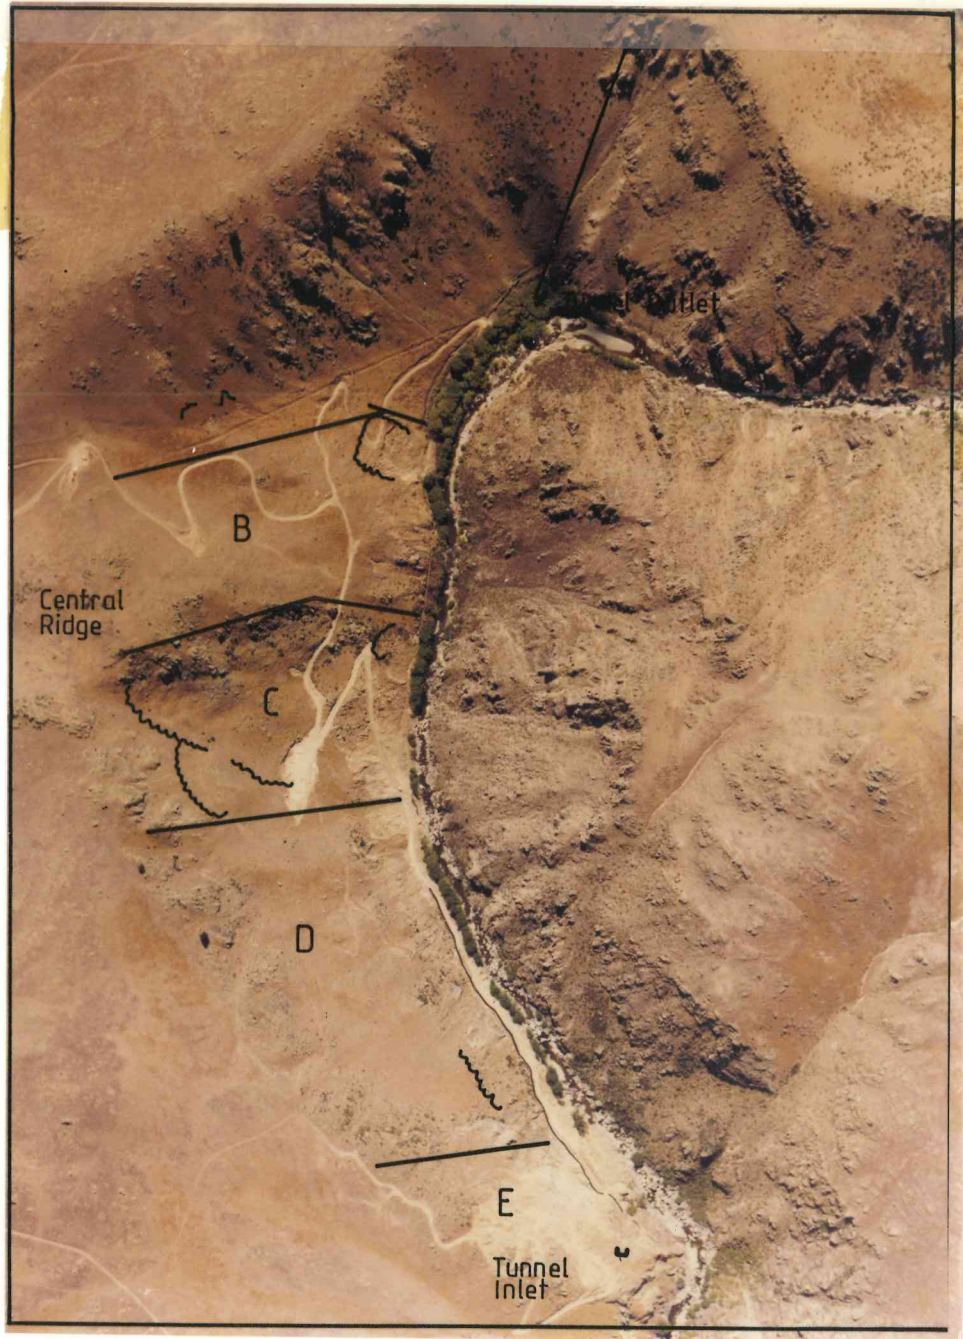
In order to describe and assess the geotechnical engineering implications of the geology in the Ophir Gorge, the existing aqueduct and the slopes above it are divided into five "design sectors". For the purposes of this report, "design sectors" are defined as areas of sufficiently similar geological and topographical characteristics to enable the typical section for the sectors to adequately represent the full range of conditions in the sectors. The design sector boundaries are illustrated on figure 2 and plate 3.

Plate 3
Aerial Photograph of the Ophir Gorge
Showing Design Sectors

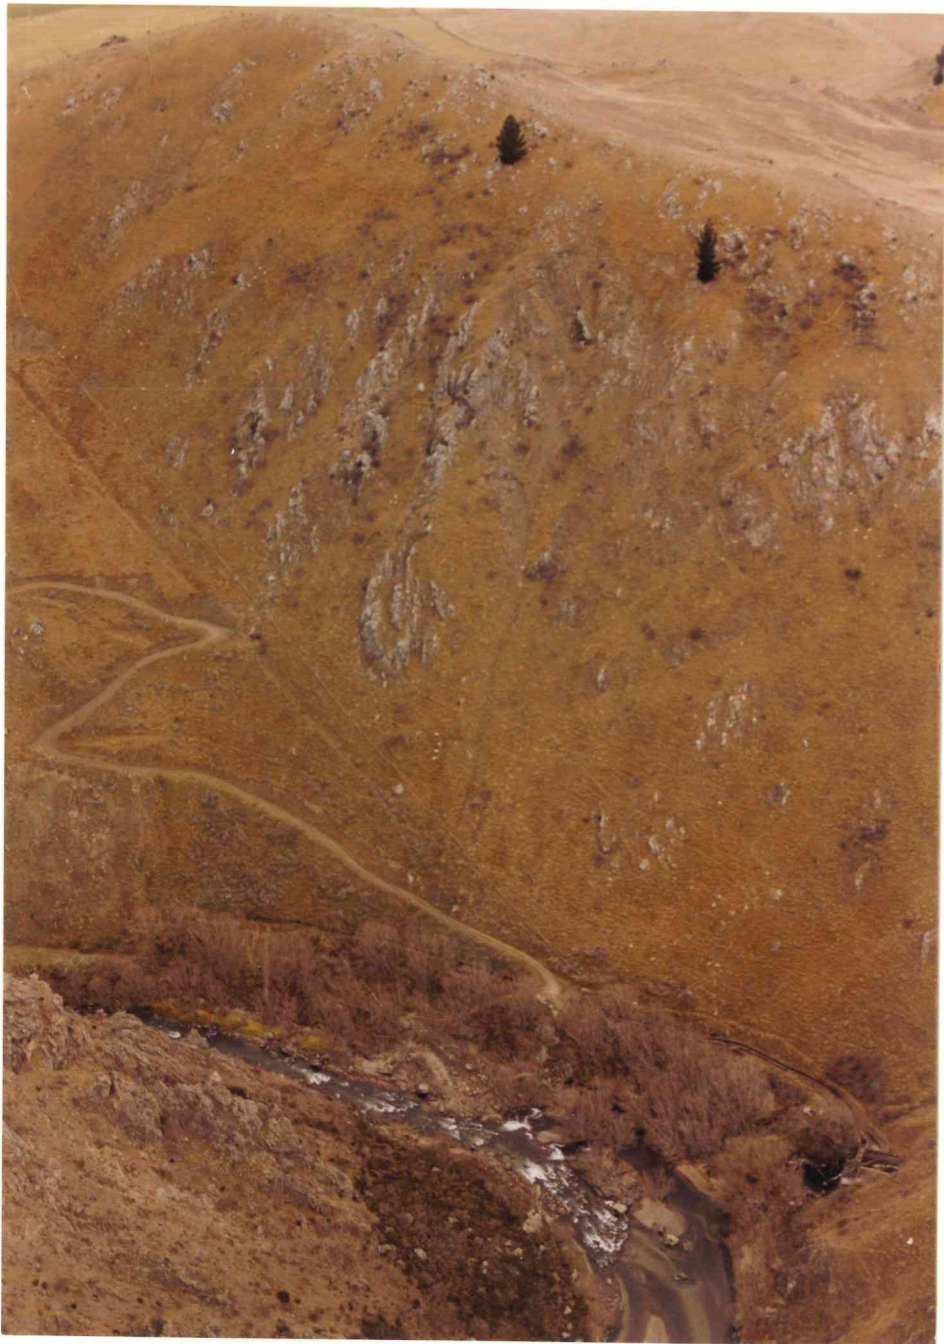
There are no serious geotechnical engineering problems in design sector A. However, the conditions currently exist for shallow slides in colluvium. These shallow slides could occur during periods of heavy rainfall.

Plate 4
Aerial Oblique of Colluvium Slope
Design Sector A

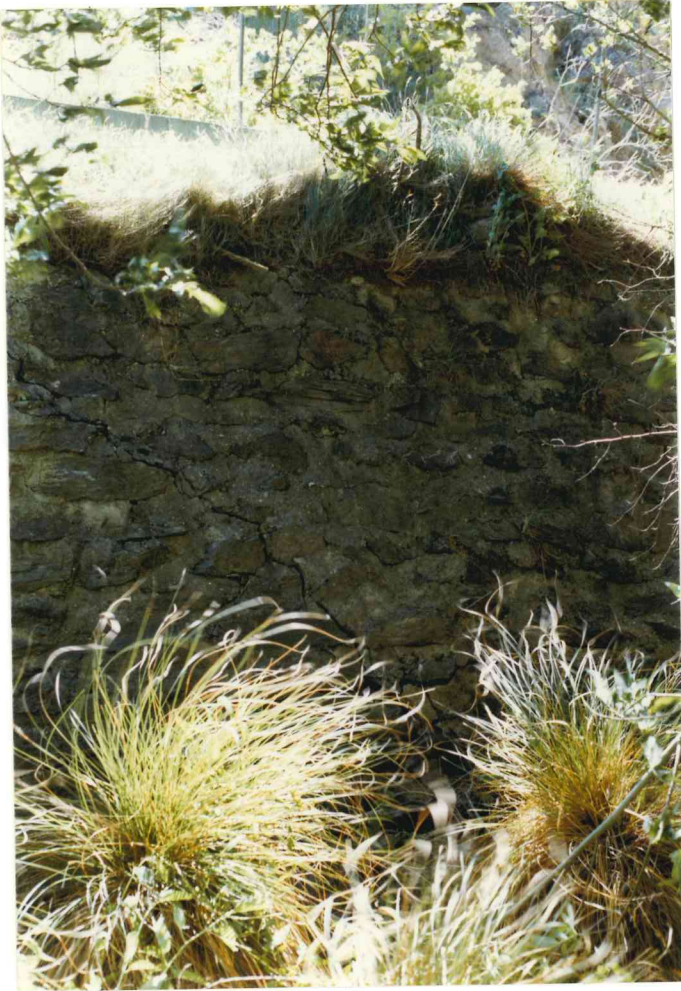
Plate 6
Cracks in Handplaced Rockfill
(Indicates Deep Seated Movement)

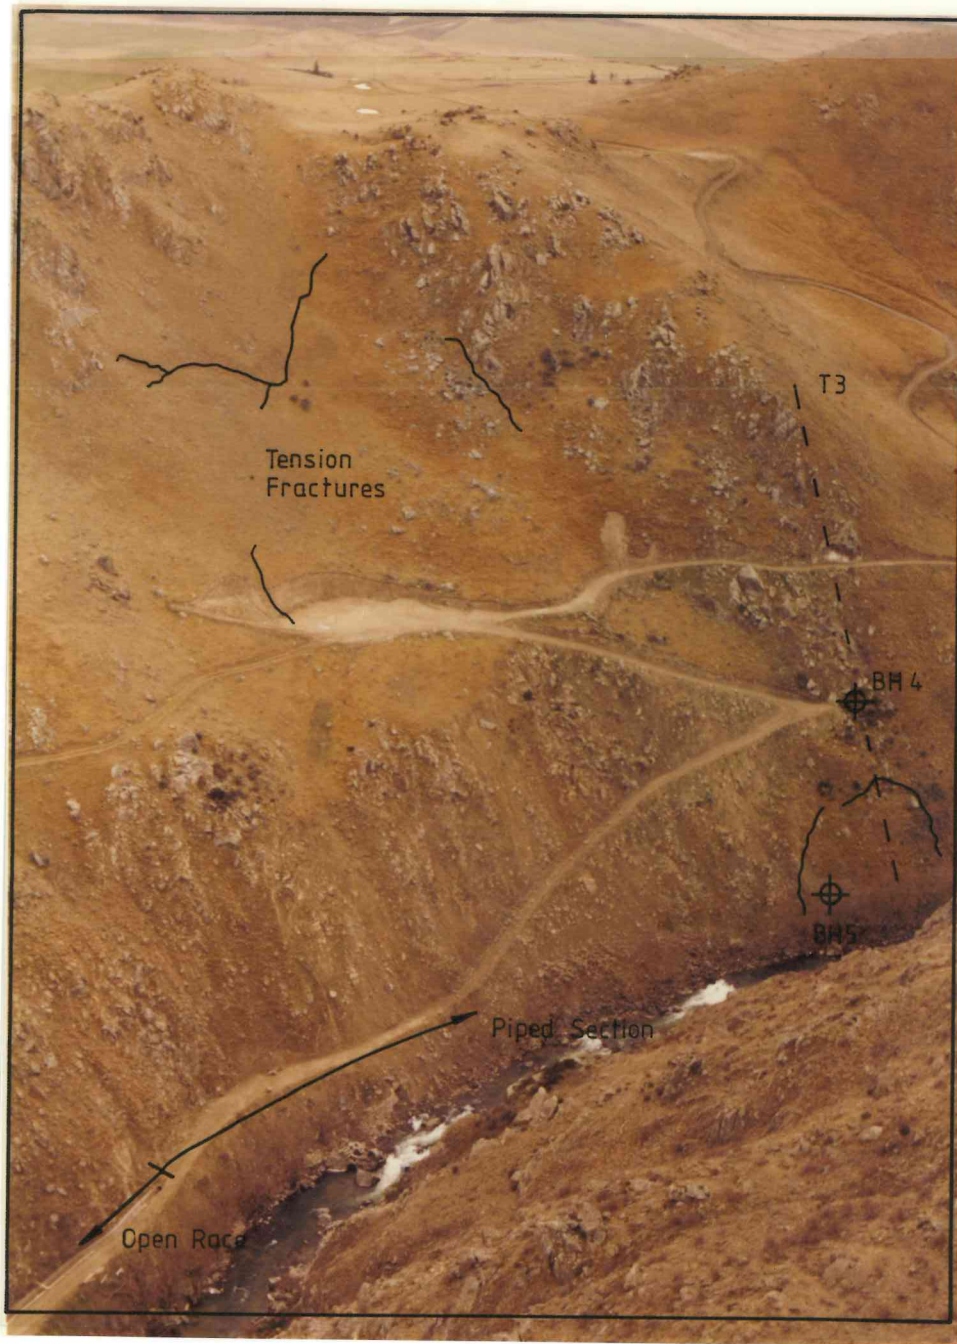
Design sector C extends from the central ridge in the north to where the access track intersects the aqueduct in the south, plate 8, figure 2.

Plate 8
Aerial oblique of Design Sector C

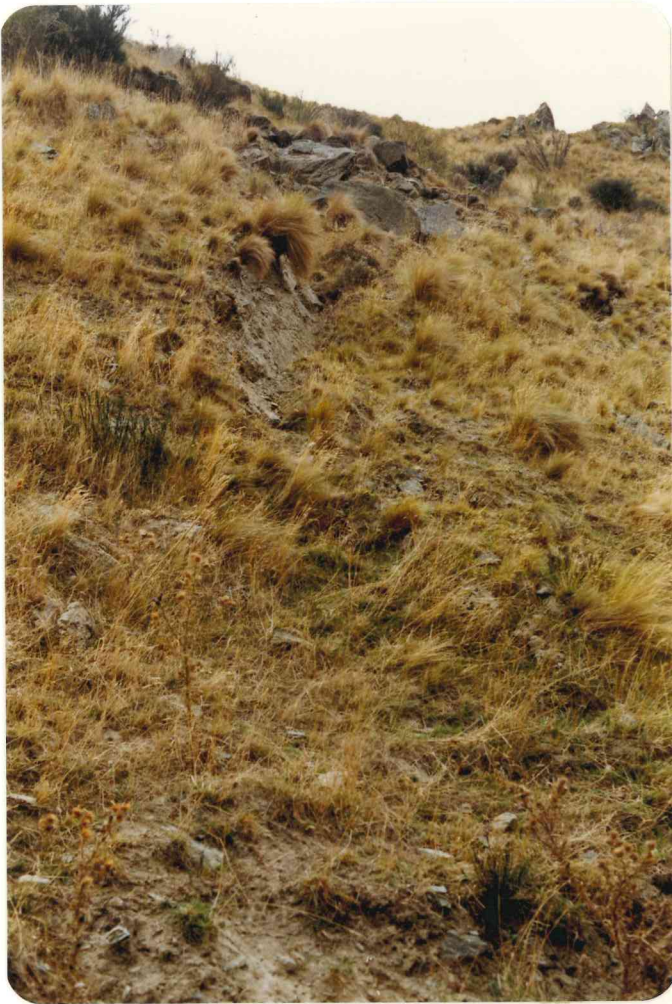
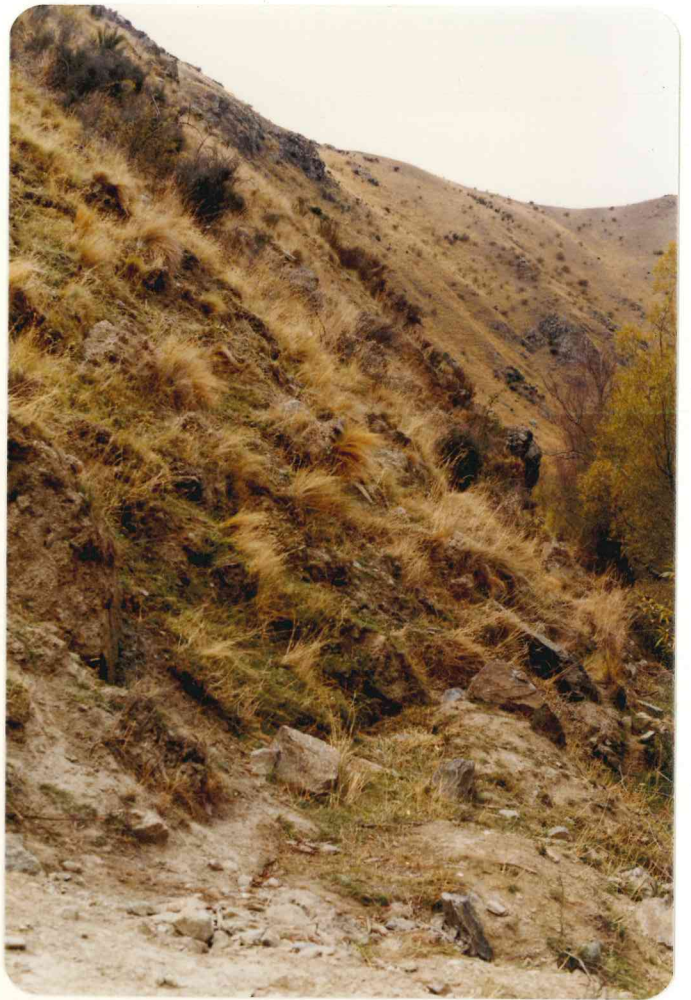
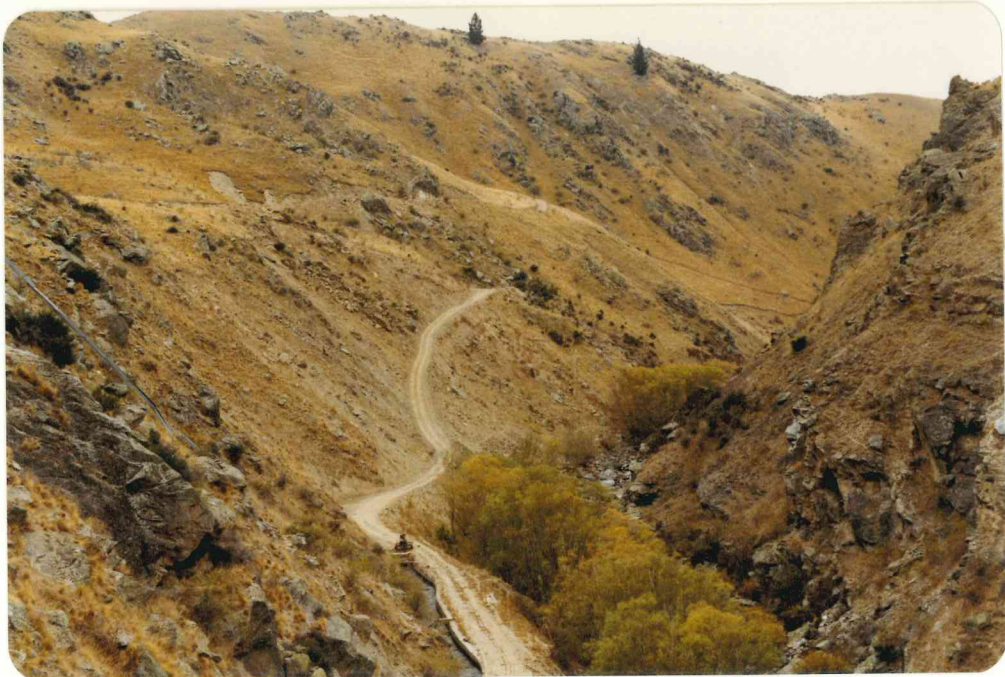
The landslide debris slide at RS 436 to 515 is typical of the second type of instability observed in design sector C. This landslide appears to be about 5 m deep plates 9, 10 and 11. A limiting equilibrium analysis of this landslide has been carried out (circle 5 of table 3). If a dry slope is assumed, circle 5 has a satisfactory factor of safety ($FS = 1.27$). A large volume of water is seeping from the slope beneath the race. It is assumed that this flow originates from open cracks in the side of the buried pipe (plate 12). In addition to these water seeps the surface of the landslide above the buried pipeline is also damp.

Plates 9, 10 & 11 Landslide at RS436-515

This water is probably surface run-off from the upper slopes concentrated by the access road and fed from the corner of the road to the head of the landslide, plate 11. The observed groundwater conditions are modelled by assuming the groundwater conditions as drawn in figure 4. For wet slope conditions, the factor of safety of circle 5 reduces to $FS = 0.69$. This result is consistent with the observations of recent landslide movements but also implies that the water table assumed in figure 4 is pessimistic. Analysis and observation suggest that this slide will migrate headwards and will be effected by rainfall.

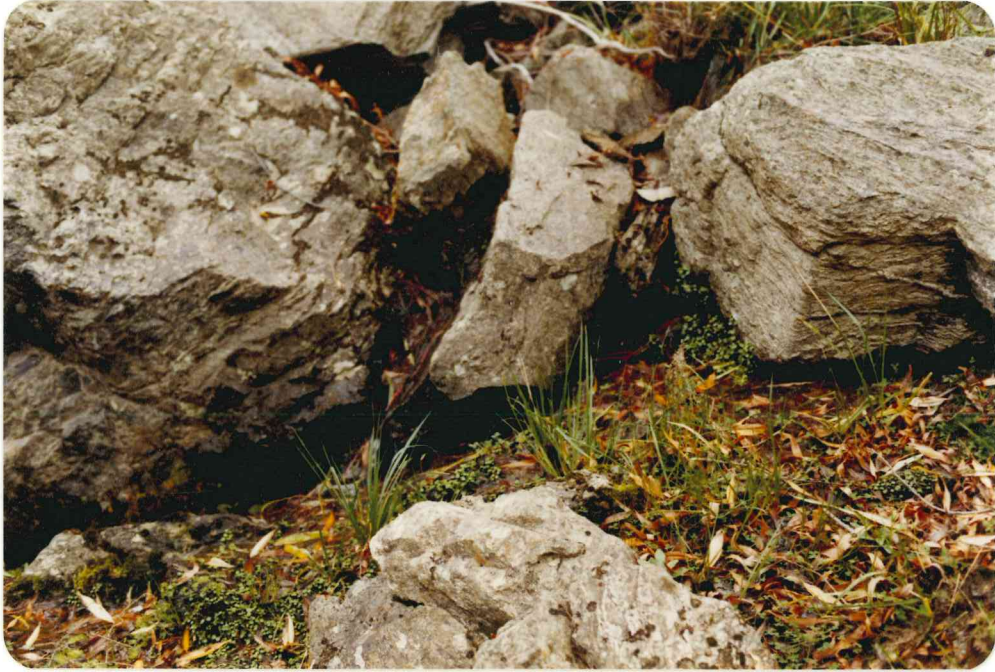
Plate 12 Water Seep from Buried Pipe
Landslide RS 436-515

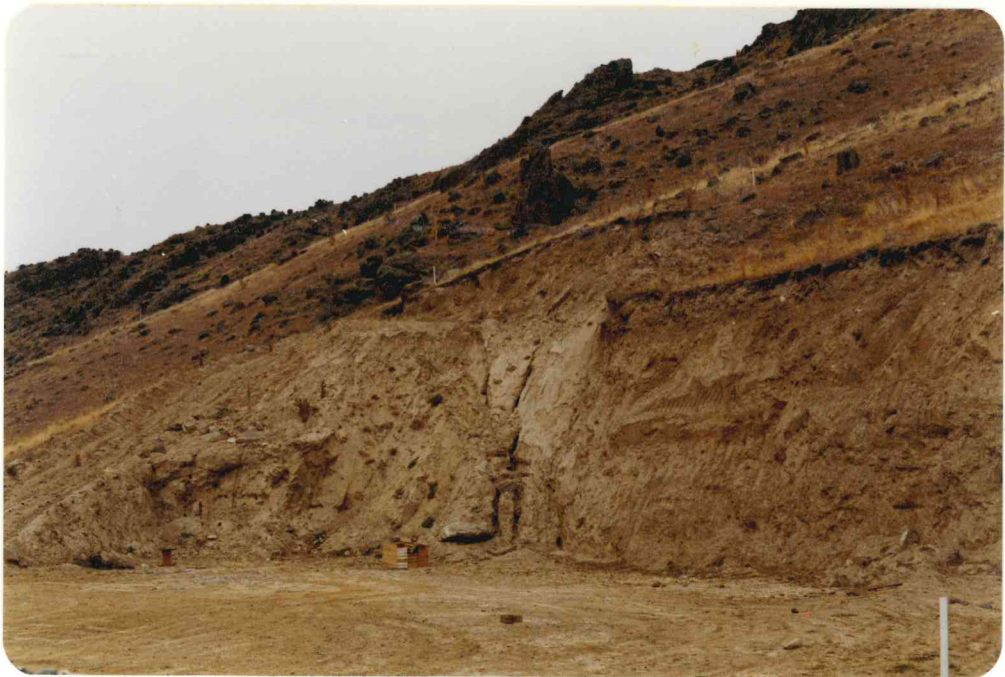
Plate 13 Tension Cracks in the borrow pit
(The core boxes give scale)

The third type of instability observed in design sector C is a basal landslide. The presence of this slide is inferred from the tension cracks in the upper basin, plates 3, 8 and 13, and from toe movements at the aqueduct level. Failure surface 2 has been used to model the basal landslide. A factor of safety ($FS = 1.03$) was calculated assuming a dry slope. A dry slope was analysed because not enough information was available to accurately infer a groundwater table for this landslide. If a groundwater table was present, then the calculated factor of safety would be lower. The dry slope factor of safety close to one is consistent with the engineering geologist's observations that the slide is currently moving.

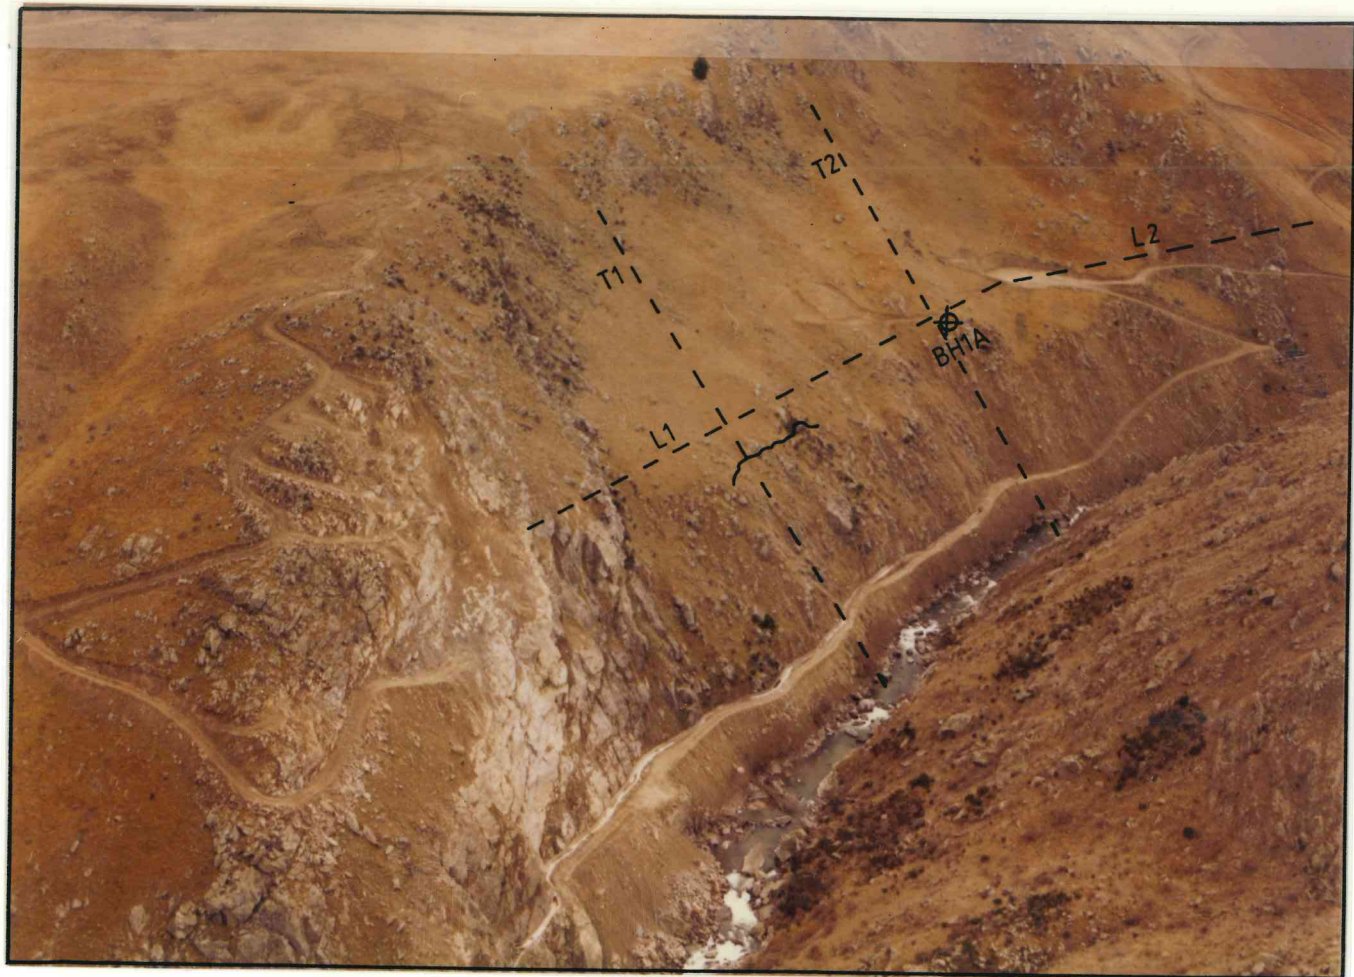
Design sector D extends from the point where the access road meets the aqueduct in the north to the in situ rock bluffs in the south, figure 2, plate 14. The slopes immediately above the aqueduct are composed of landslide debris. There is a break in

Plate 14
Aerial Oblique of Design Sector D

slope approximately 50 m above the aqueduct which separates an oversteepened face (at one to one) from a steep slope (two to one). A deep open tension crack approximately 30 m long traverses along the break in slope, plates 14 and 15.

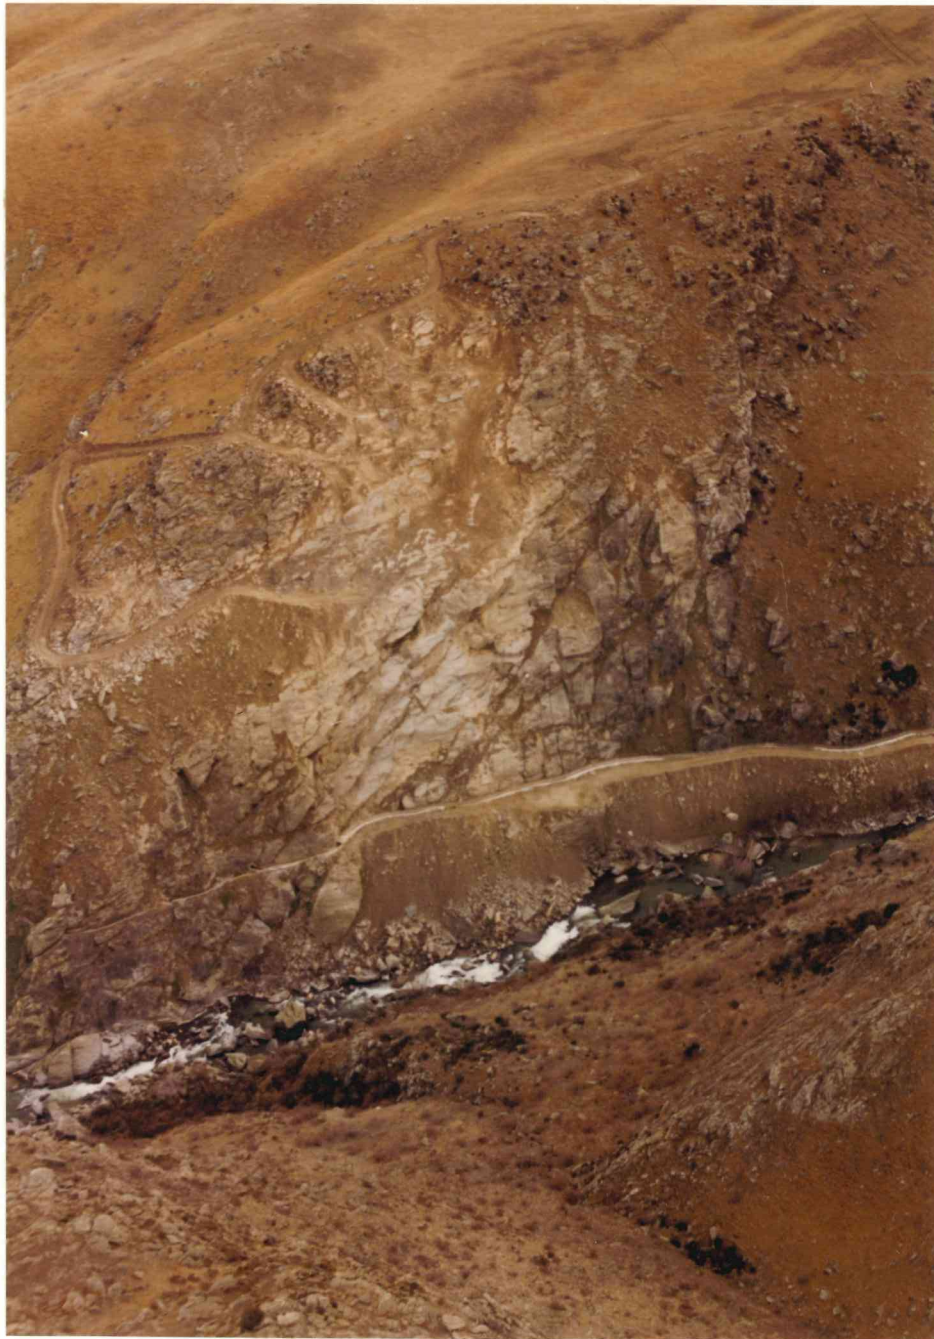
Plate 16. Aerial Oblique of Design Sector E
