Ministry of Works
and Development
ALEXANDRA RESIDENCY

CENTRAL OTAGO IRRIGATION SCHEMES

FLOOD DAMAGE REPORT

9-11 MARCH 1987

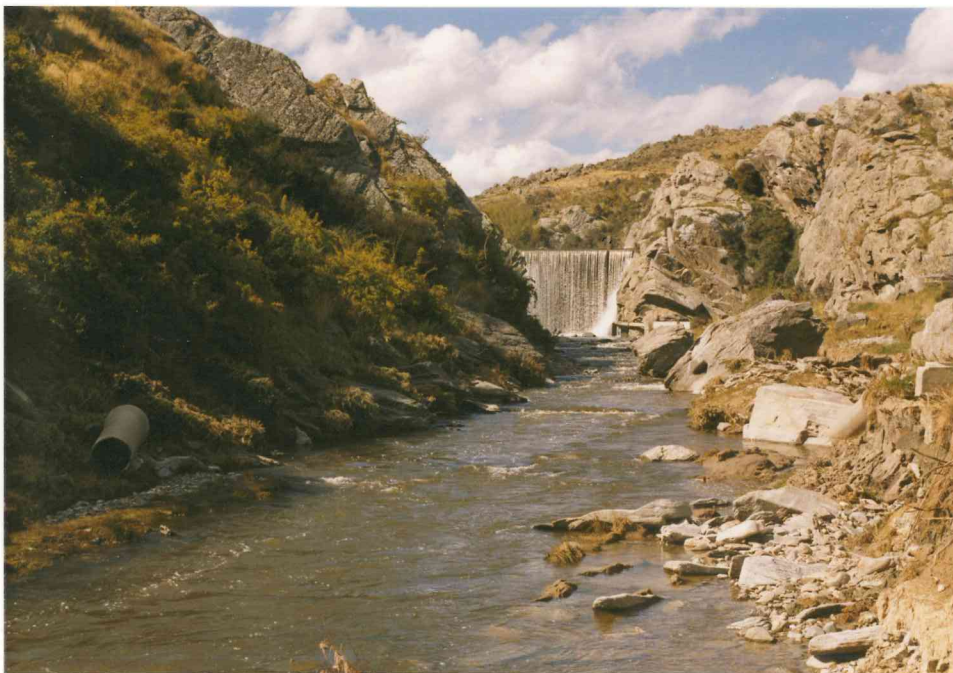
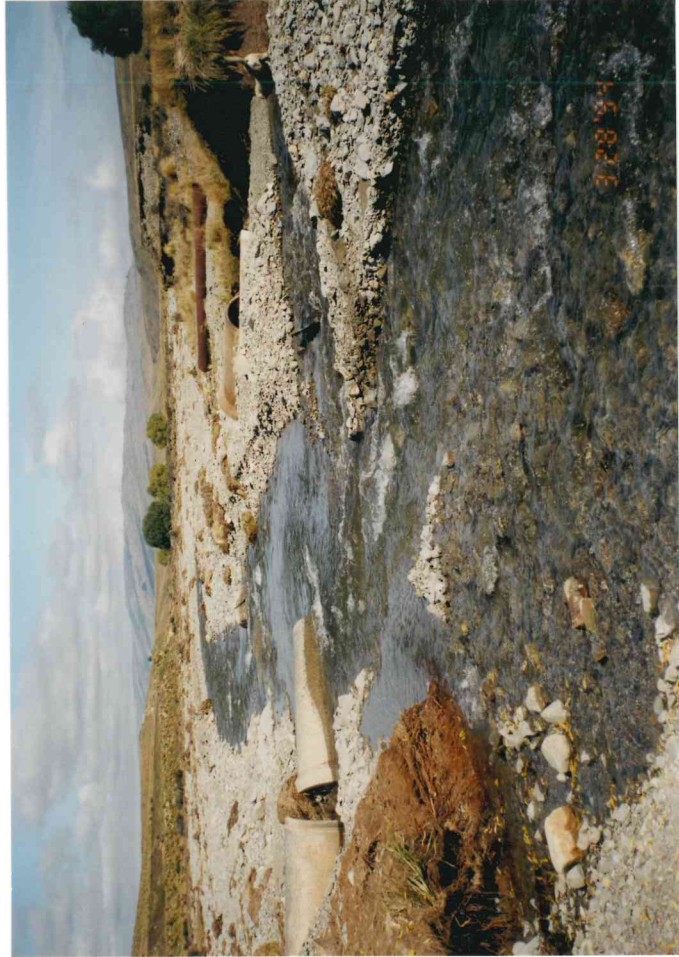
2.1 Idaburn Intake Structure

The existing intake structure over a distance of some 150 metres was washed away and a new pipeline structure is now required. The assessed very rough order costs to repair the intake has been estimated at \$11,000. However it is clear further engineering input is necessary in an effort to ensure the necessary remedial works for the Idaburn Intake are the most cost effective. The major component in any remedial proposal is the pipe conveying system.

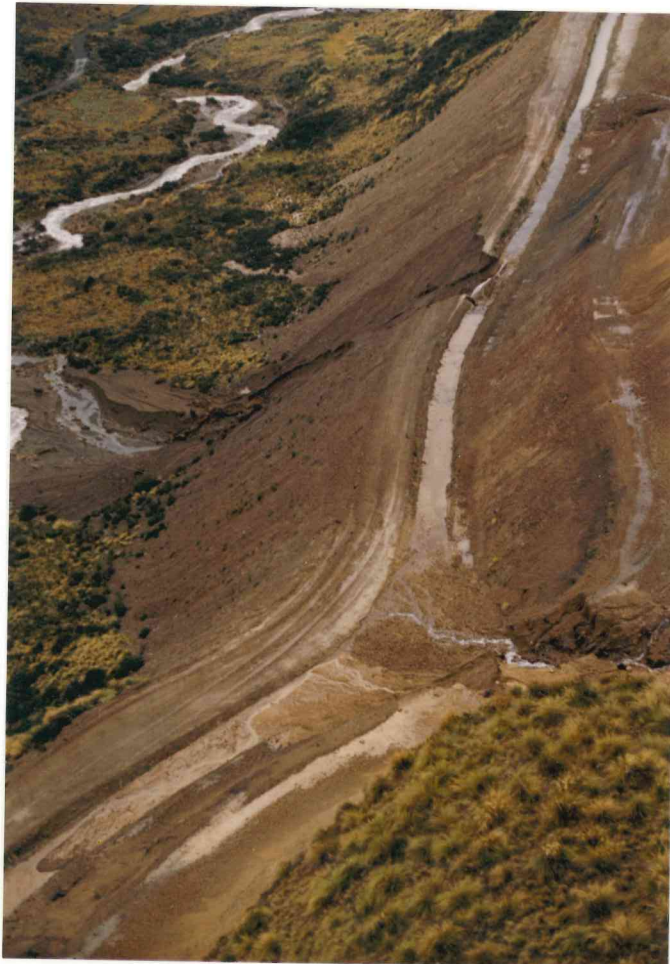
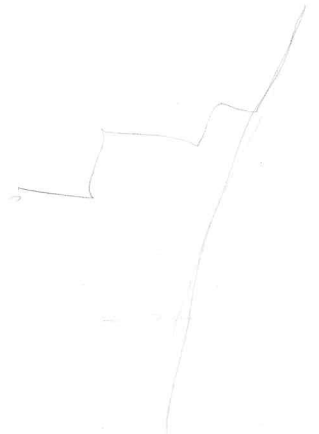
87060/8

A major race failure has occurred in the main race at Pierces Gorge which will involve significant remedial earthworks. The estimated cost of repairs is estimated at \$14,000.

Photograph highlighting the extent of the
Pierces Gorge Race failure

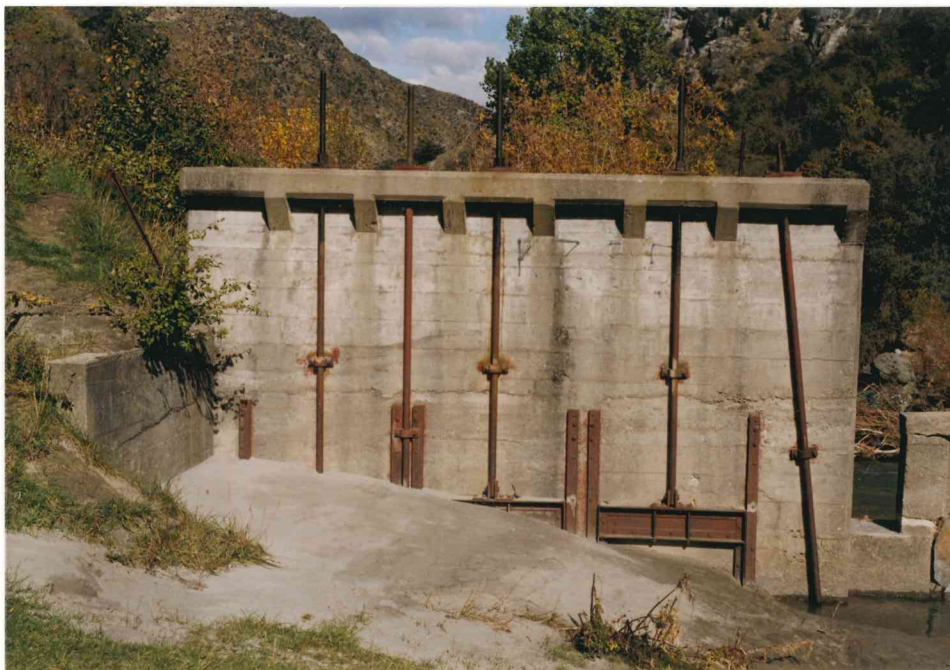
Repairs to the desilter which resulted as a consequence of the toe of the batter on which the structure is located being severely eroded and undermined by the high river flows, has been addressed separately in report 15/2, dated 30 March 1987. However for the basis of this report, photographs have been added for interest value.

The intake is blocked with a heavy buildup of silt which requires to be flushed away prior to commencement of supplying irrigation water.

View from the Arrow river looking directly towards the desilting structure. The bywash structure is reliant entirely on support gained from the 'flushing' pipes and the river has significantly undermined the toe of the batter.
