Ministry of Works and Development

FALLS DAM SITE VISIT REPORT

Inspection 24 April 1985

Author: D.W. Richards

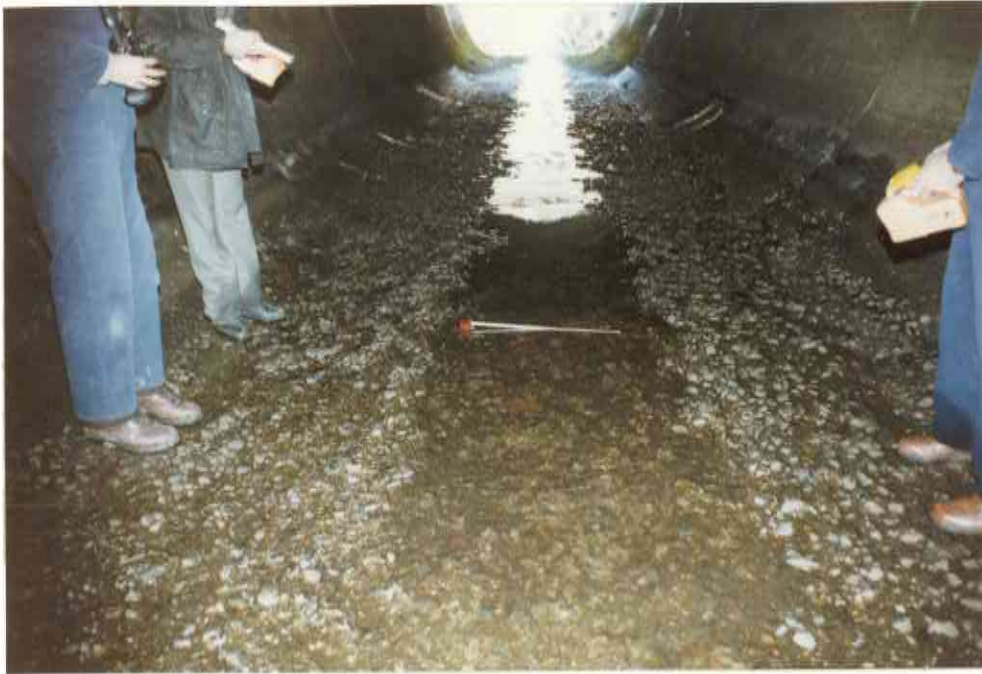
7. TYPICAL OF INVERT, 27" OF TAPE SHOWING

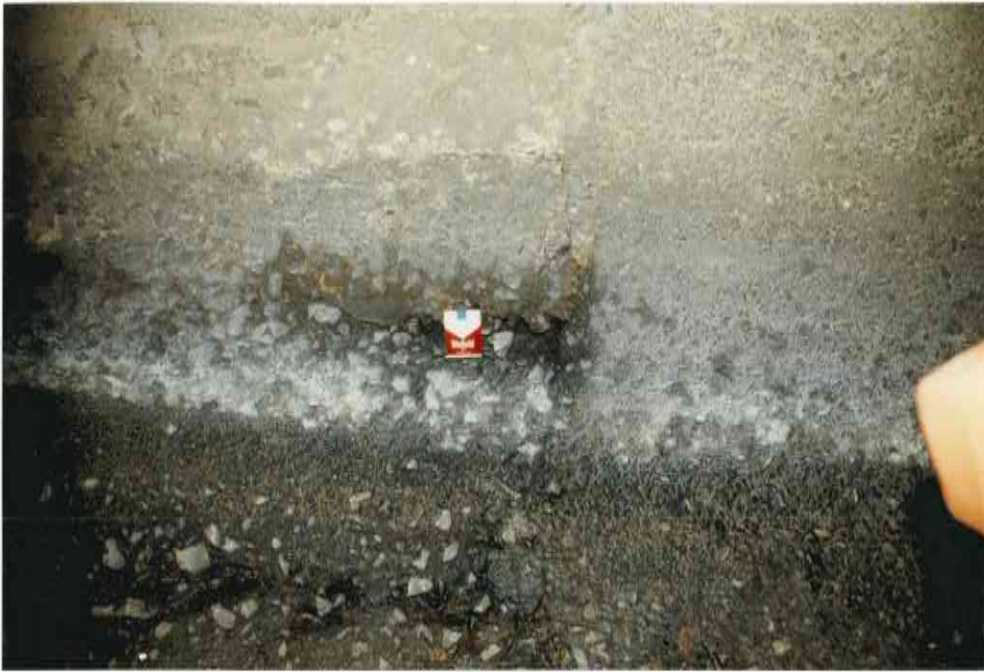
11. I/W jt TR NEXT TO JT 9/10. EROSION 150mm DEEP, 300m LONG

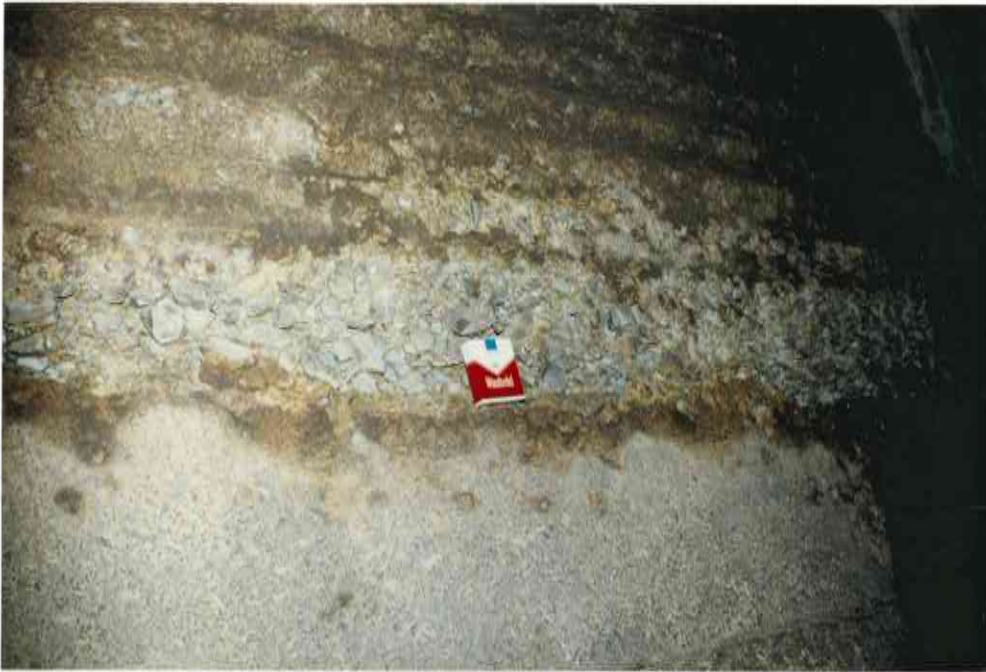
13. HOR jt 1.5m ABOVE INVERT TL FULL LENGTH POLYMER
200mm HIGH + 80mm DEEP

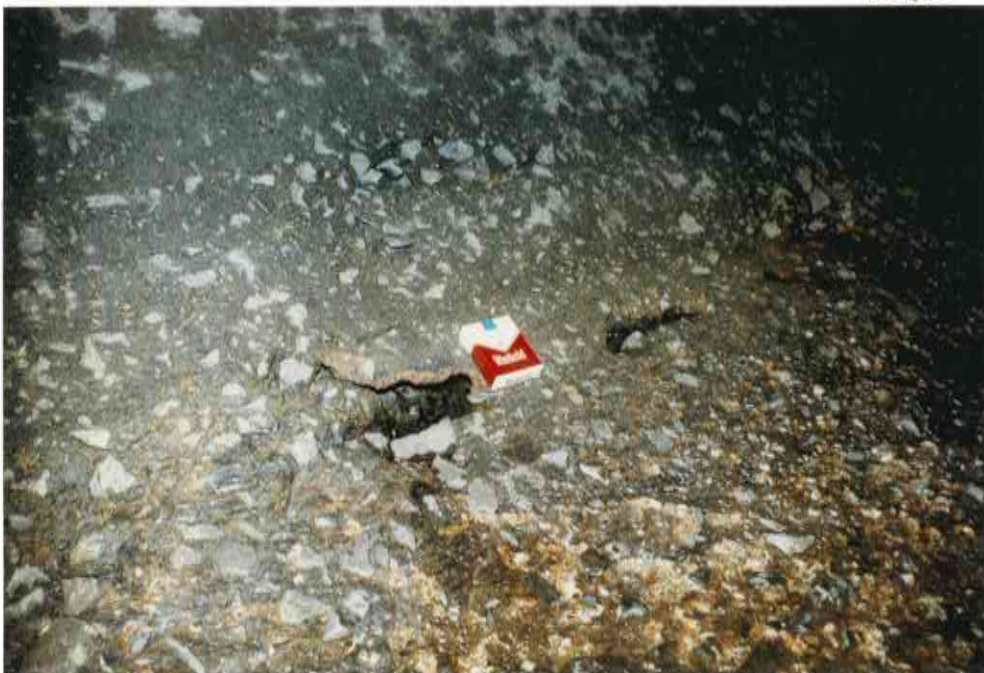
16. CAVITY UNDER WALL TL I/W jt

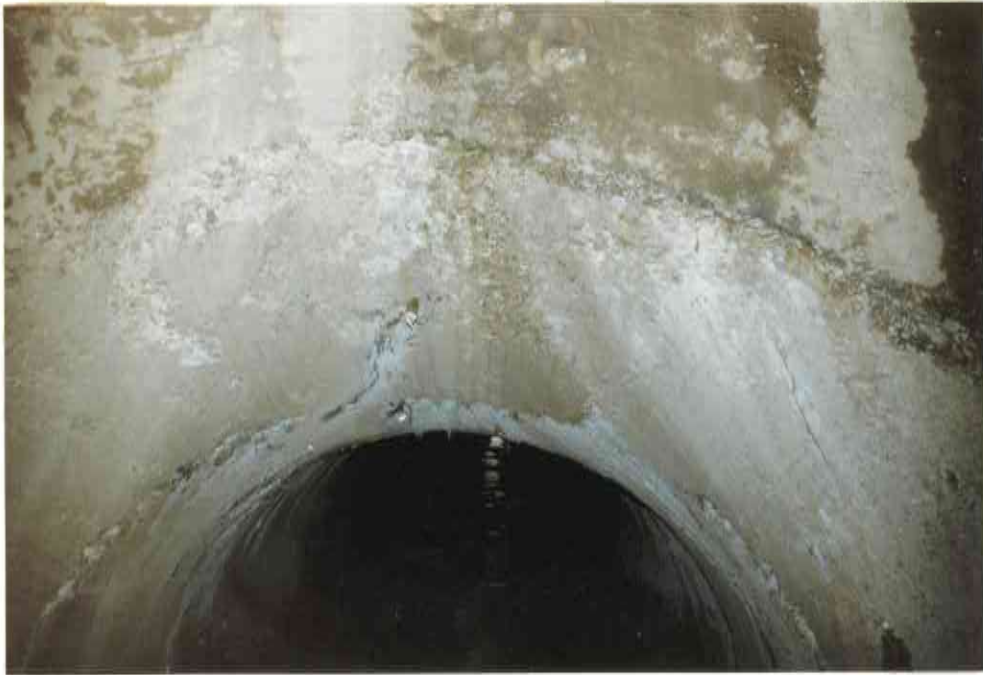
31. CROWN OF PANEL 33, OLD 19mm WEEP HOLE PIPE

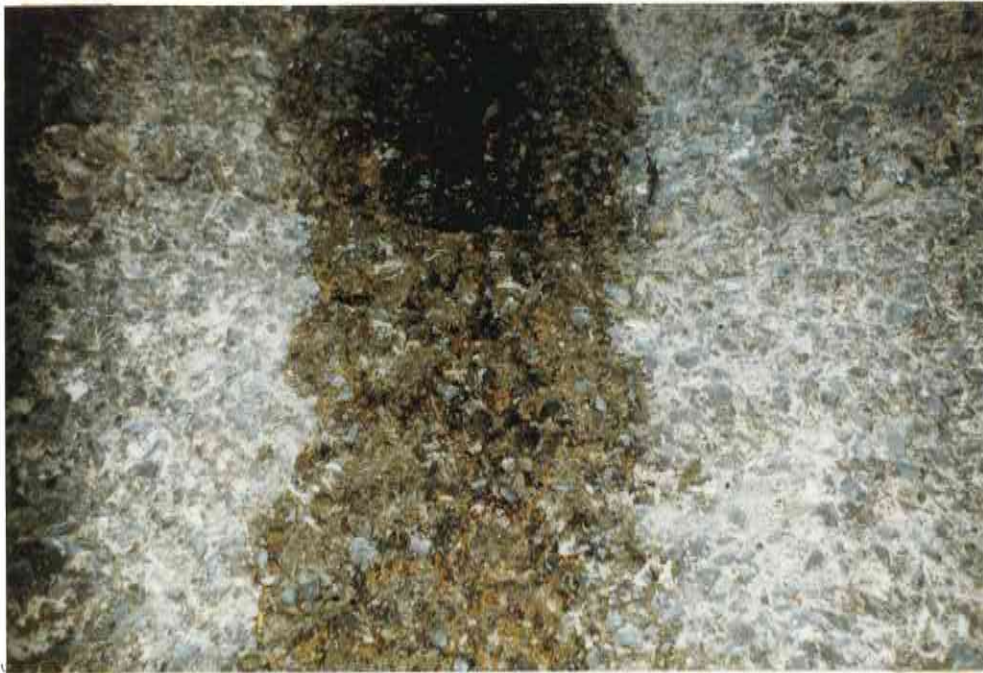
32. jt 33/34 AT INVERT SEVERELY ERODED

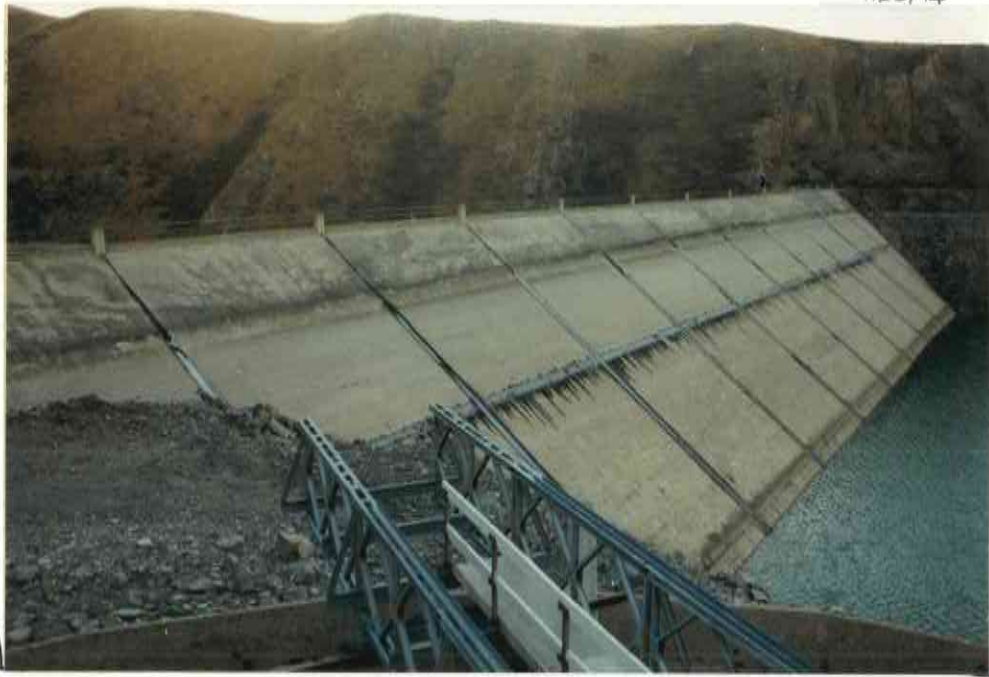
1126/14

The overall condition of the membrane concrete appears to be sound. The surface of the concrete below normal water level shows signs of general deterioration with only the occasional exposure of the 75 mm size coarse aggregates (see photo 92). The damage at the waterline is more significant. This should be excavated out to sound concrete and filled back with mortar such as Expocrete TG.

89. DAM MEMBRANE

The membrane appears to be in a relatively sound condition but should be separately inspected. This could be safely left until the spillway tunnel repairs are being undertaken. Meanwhile cracks and pitting visible on the surface of the concrete slab should be cleaned out and filled with Expocrete TG or similar.
