# Upper Manorburn Dam

Concrete Arch Dam	7500 cu yd concrete
Completed	1916
Height Above Stream bed	88 ft
Radius of dam	195 ft
Length of Crest	387 ft

## *Upper Manorburn Dam*

This account is prepared from the Engineering presentation to the NZ Society of Civil Engineers in the Proceedings 1920-21, Volume 7, and research of the Public Works Department files held at NZ Archives in Dunedin.

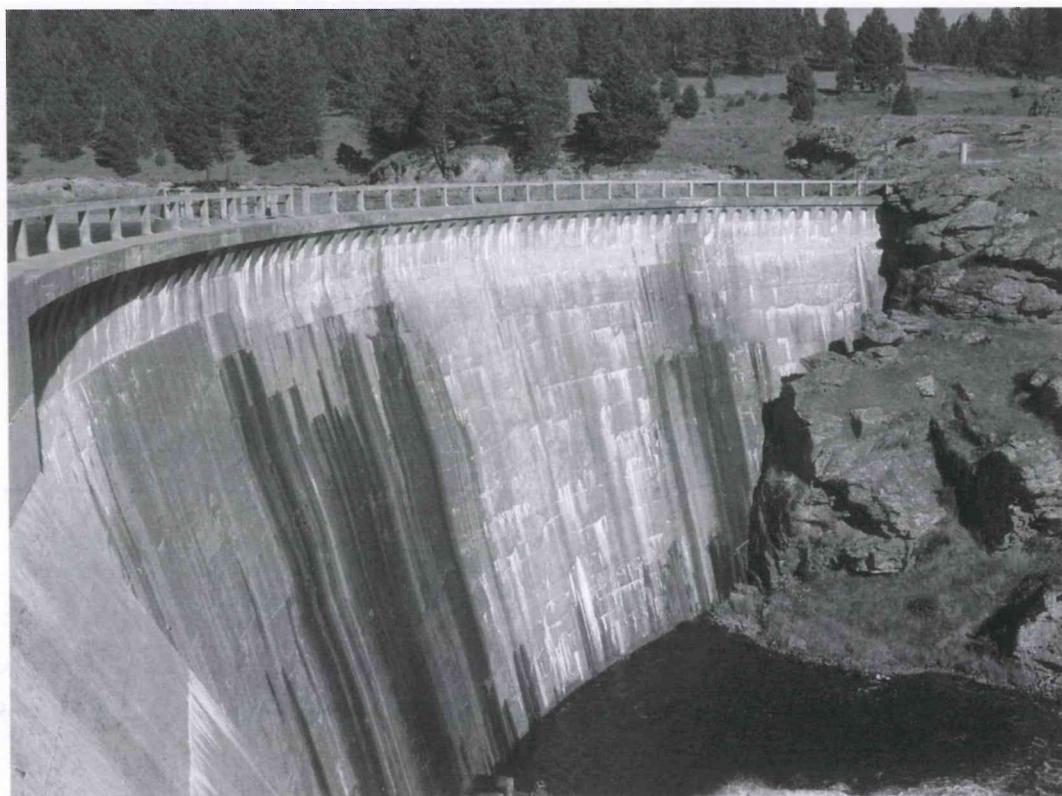
**A recent photograph showing the downstream face of the dam from the right abutment. The arch was replaced with a gravity section about 1955. The walkway on top of the dam provides access to the valve chamber on the upstream face of the dam. Water for irrigation is discharged at the base of the dam.**

Leakage at the dam, which had increased considerably over the period from 1942 to 1948, was controlled by the guniting of the upstream face in 1948-9. Later cracking in the right abutment of the arch was considered sufficiently serious to warrant the removal of about 100ft of arch concrete which was replaced by a mass concrete abutment block in 1955.

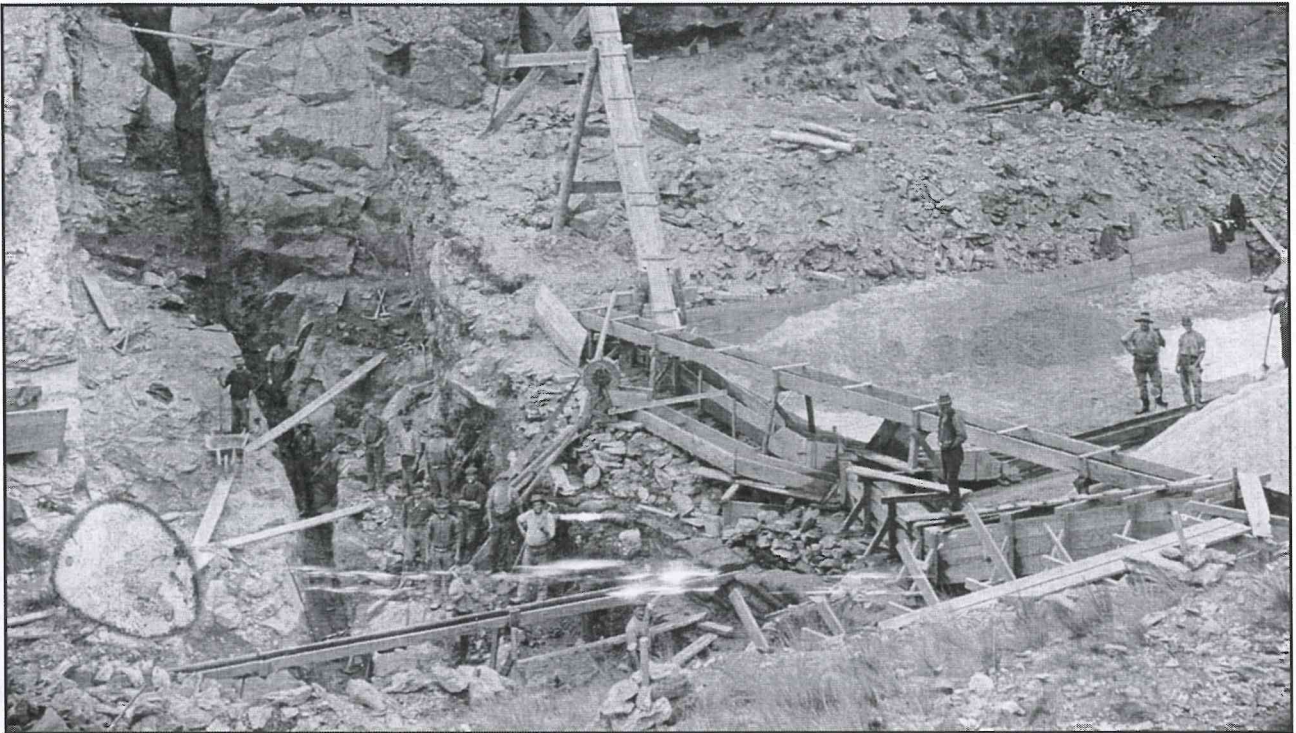
**A close up of work on the fault in the base of the dam. The excavation is being done by hand tools and it would have been laborious work lifting the material out of the deep slot in the rock. On the right of the photograph is the sand cleaning operation with the shute and raw sand behind, and washed sand at the front.**

At this stage Turnbull was trying to find work for the men at the site while the effect of the fault on the dam site was resolved by the engineers. On the 5 April a new plan of the dam was sent from Wellington through the District Office, to Poolburn where E.W. McEnnis an engineer from Head Office, was now located. He was told on 9 April by the Engineer in Chief that he was to fill the crack in the foundation with concrete.

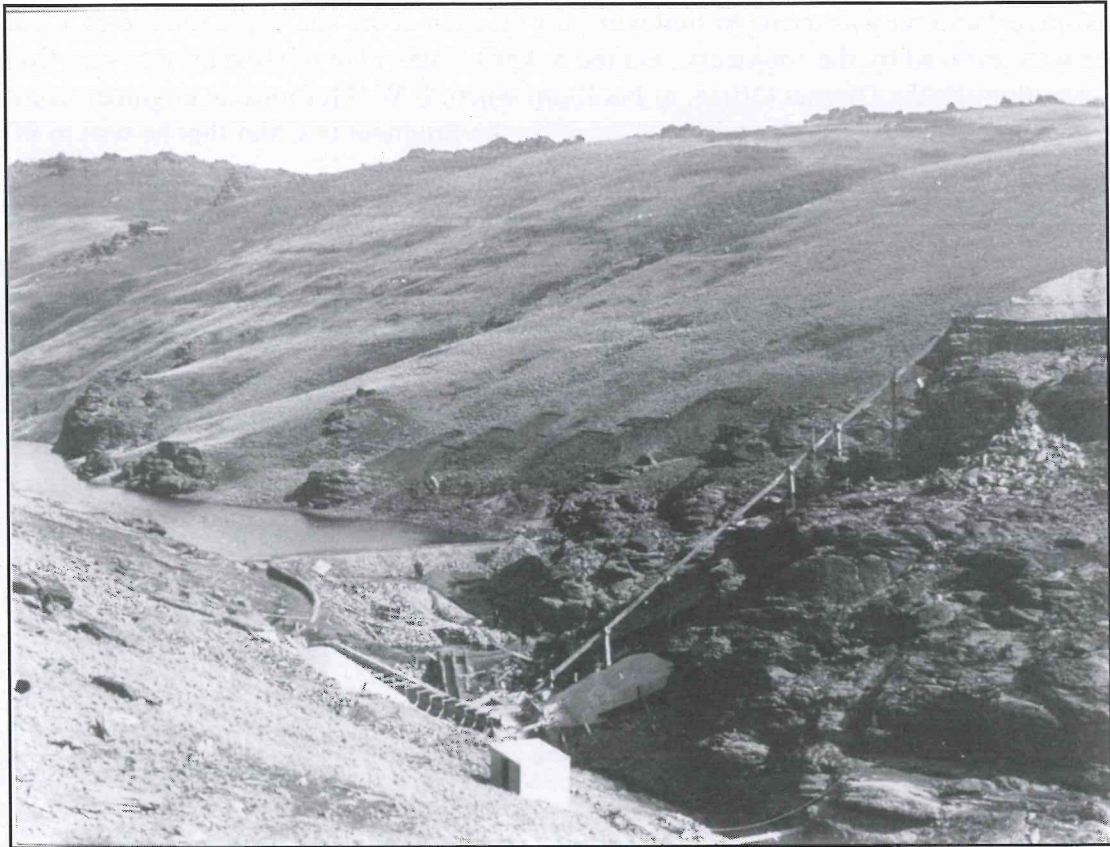
An early view of the dam construction. The upstream coffer dam is diverting the water around the right side of the valley in a race and flume. The long chute on the left bank is to allow the sand, which was being carted to the site, to be washed where there was access to water below the dam site. The dam site was still being investigated.

To allow the construction, an earthen dam was built a short distance above the permanent dam, to a height a little above the outlet valves, which are placed ten feet above the creek bed. From the by-wash of this dam, a wooden flume carried water over the new dam in the earlier stages of the work, and later, into the outlet pipes after these had been placed. The Greenland dam also acted as a regulator to prevent floods at the new dam. Irrigators had to be supplied from the Greenland dam during construction. Owing to the climate, it was impossible to carry on work during the winter, after which the water rose and swept over the unfinished work. However no damage was done.

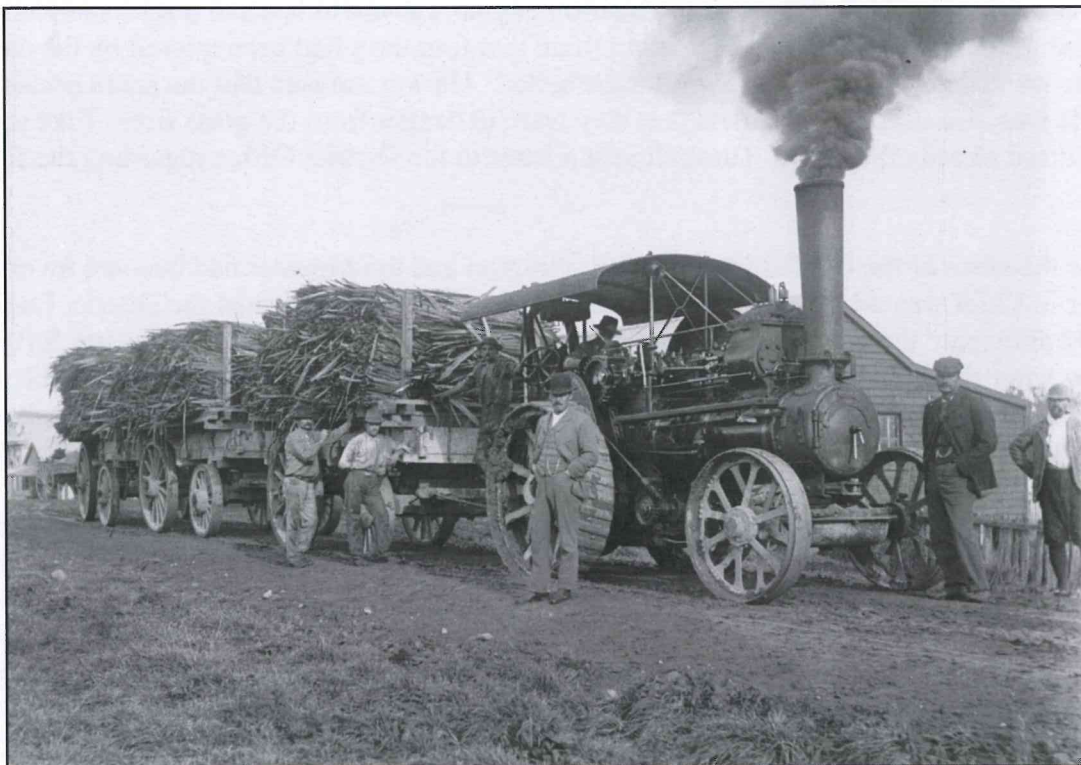
Alexander Turnbull Library Wellington NZ G-49531-1/2

**A traction engine of the period steam driven with a coal fired boiler. The engines were rated at six horsepower and could pull wagons along flat roads. This engine is pulling a load of flax but similar wagons would have been used for hauling the cement in the Ida Valley.**

On 21 November the District Engineer advised J. Turnbull that a traction engine, together with two twelve ton trucks, were being dispatched from Canterbury to take over haulage of the cement from the Ida Valley rail head to Aston Rd. The engine could travel 40 miles a day and a coal stage would be required to feed the steam engine.

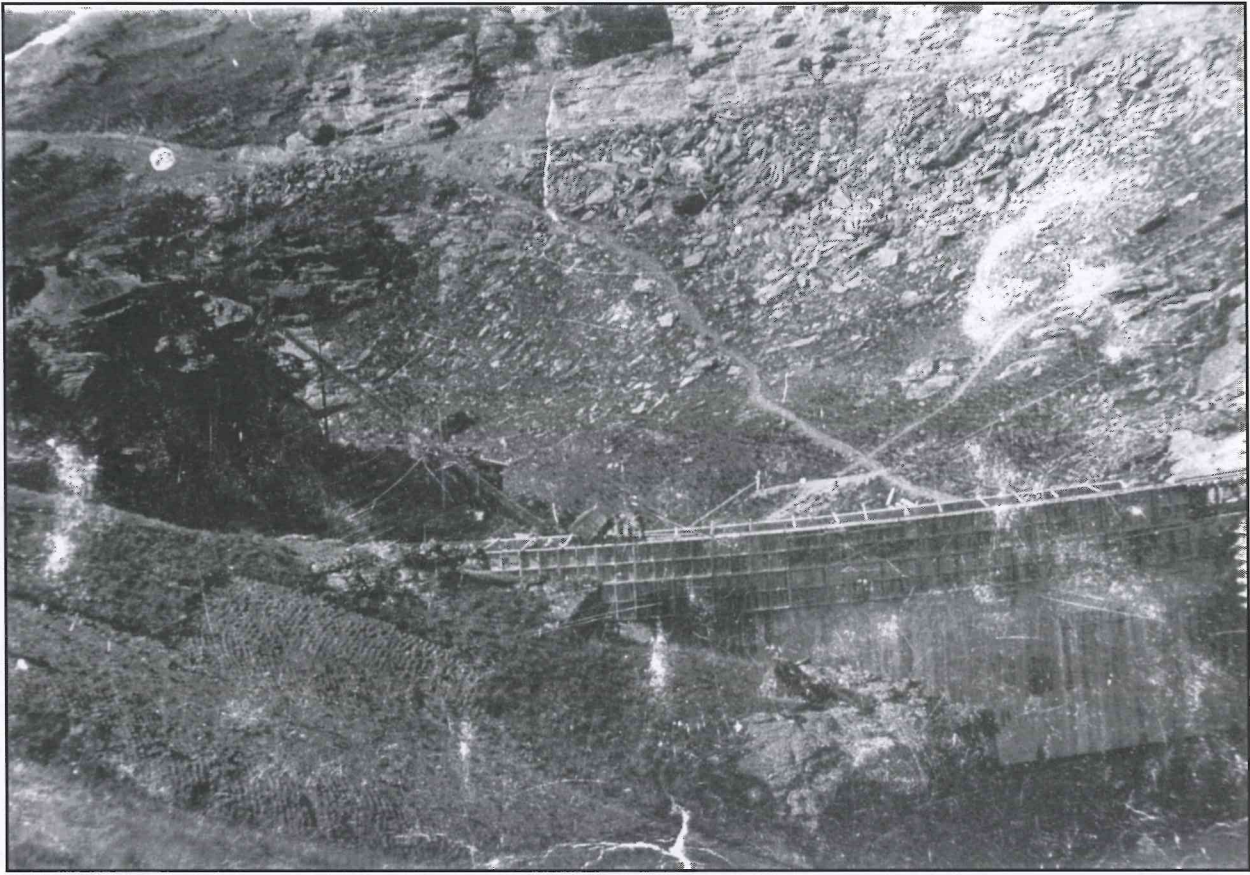
The dam is over halfway in height as concrete is being lowered from the overhead cableway and poured into the prepared boxing. Behind the dam on the left hand side can be seen the chute for the sand with the unloading point above. There is an access track on the right below the cliffs to allow cement to be taken to the concrete plant. The overhead wire can be seen just above the track level.

A cableway, which was also called the transporter, was designed to cover the greater part of the dam without any dismantling. The loading end was fixed above the batching plant while the other end was attached to a pier mounted on a truck. This pier was inclined backwards at about 45° and the upper end weighted with concrete. The truck moved on a railway track set at the radius of the cableway, and was hauled along with a winch, but due to the engine power being too small, the transporter was too slow to handle both the sand from the washer and the concrete delivery to the dam. A jig was installed to deliver the concrete and this proved satisfactory until the thickness of the dam became less than necessary to support the trestle for the truck. The rest of the dam was then filled from the cableway.

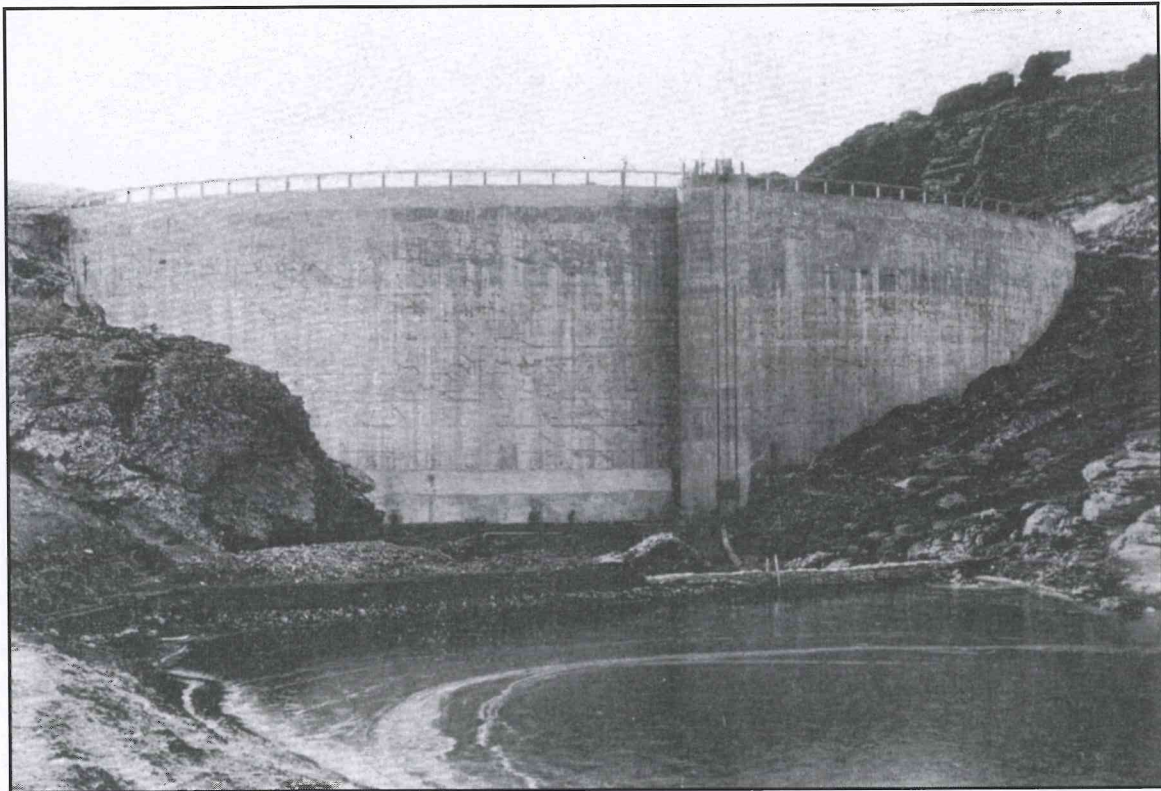
University of Otago S08-227a

**A view of the upstream coffer dam and the face of the dam before the gate was shut and the area flooded. The circular valve tower shows clearly and at the bottom can be seen the shut off gate valve. At the stage the photograph was taken the water was being released through the valve chamber and into the pipes through the dam wall.**

An unusual feature of the dam was the use of a separate valve chamber 16ft in diameter, located on the upstream side of the dam. This contained two 24 inch diameter gate valves which are connected to 24 inch cast iron pipes carried through the wall of the dam. The purpose of the tower was to enable inspection of the valves. The valves are operated by hand wheels at the top of the tower. A sluice valve was located on the upstream face of the tower to shut off the water entry, and allow the tower to be drained for inspection of the gate valves.

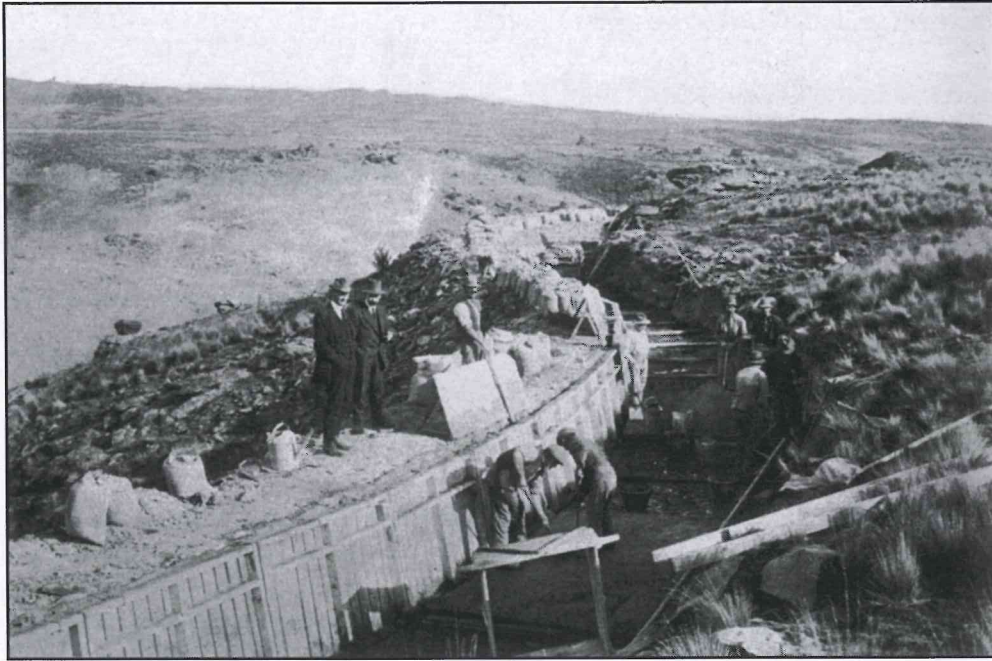
University of Otago S08-227b

**The Upper Bonanza race is being lined with concrete to reduce the leakage of water. The cement was judged to be too old to be used in the dam. Concrete is mixed in the race and the bags of aggregate along the race, will have been carried in by workmen. Looking on is J. R. Marks, on the left, the site Engineer, and alongside C. J. McKenzie the Engineer in Chief from Wellington.**

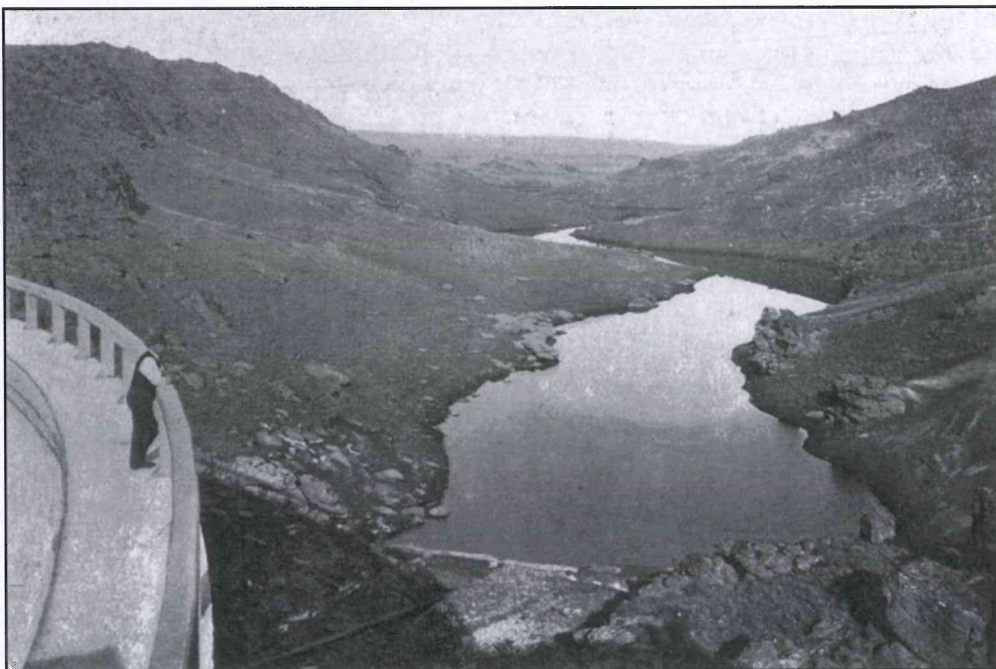
University of Otago S08-227c

**Looking back up the Manorburn Creek from the left of the dam before it is filled. The upstream coffer dam is still in operation. The quarry and concrete batching plant is on the right hand abutment and out of sight.**

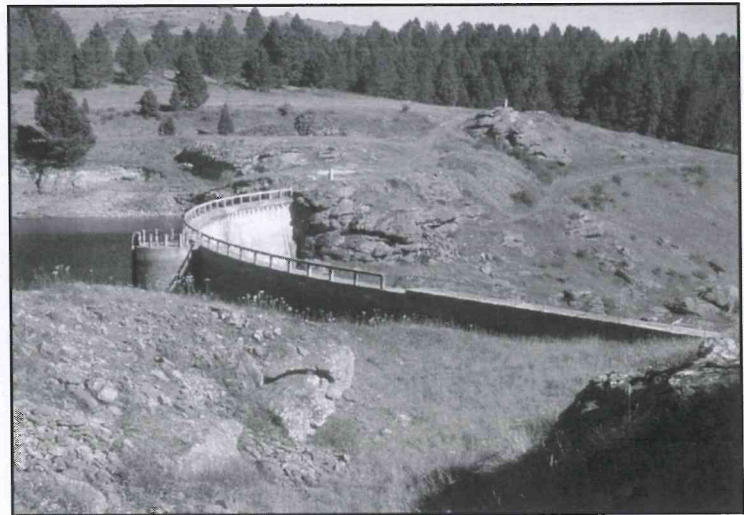
A recent view from the location where the cableway operated. Above the left abutment can be seen the platform for the rail track, which allowed the cable to span the main part of the dam.

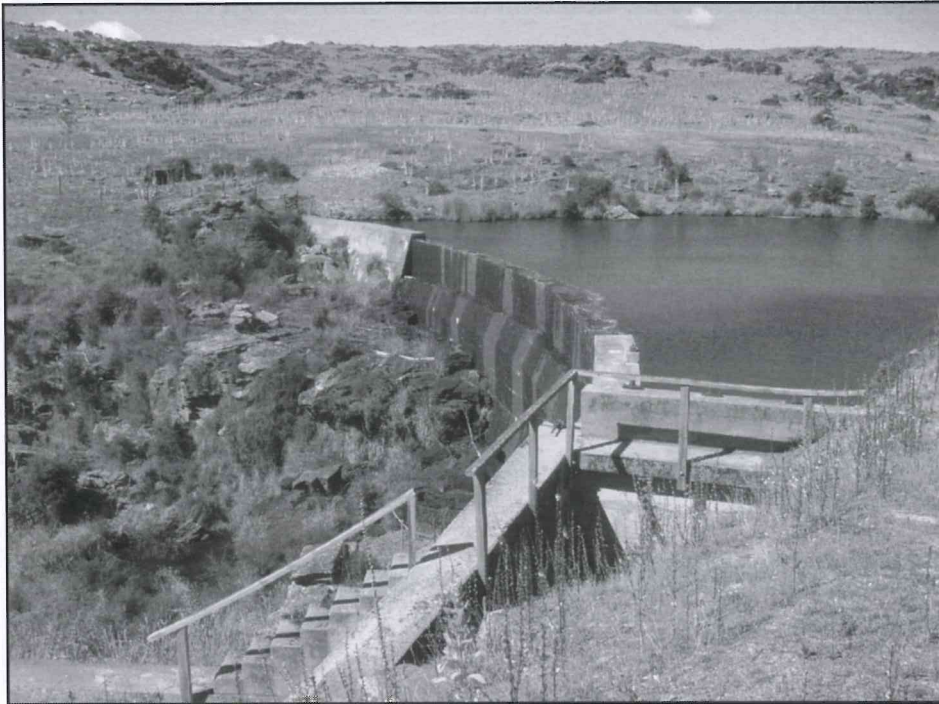
**There is an unusual front face on this dam. The structure on the left abutment is a settling chamber and an outlet measuring weir to deliver water to the race system. A valve sets the water discharge from the dam.**

This is a concrete arch structure 41ft high and 200ft across the crest. It has a stilling basin to allow water to be diverted into a race. The dam has a storage of 31 acre ft and is used for day to day regulation of irrigation flows.

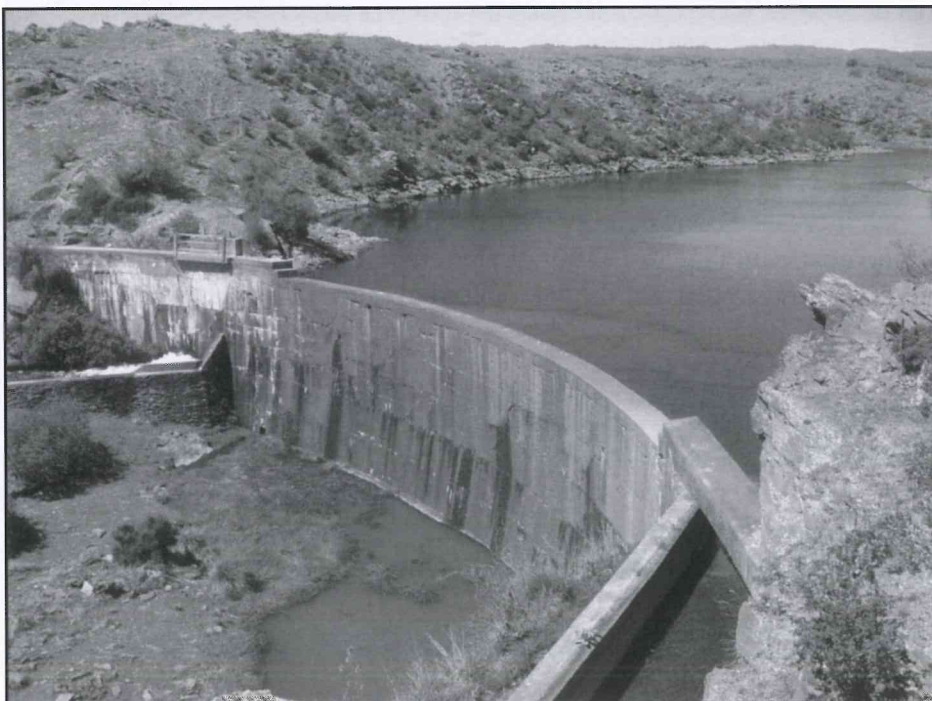
**There is a more conventional concrete arch structure at this dam. Water flows in from the Moa Creek weir at the left abutment and discharges to the race system on the east side of the valley at the right abutment.**

This dam was in service long before the main Poolburn dam was constructed. It is a concrete arch dam 37ft high and 248ft across the crest. A race interconnects the Moa Creek weir and the Poolburn weir providing water for irrigation of the east side of the Ida Valley. The Poolburn weir stores 48 acre ft of water, and is also used for daily regulation of irrigation flows.

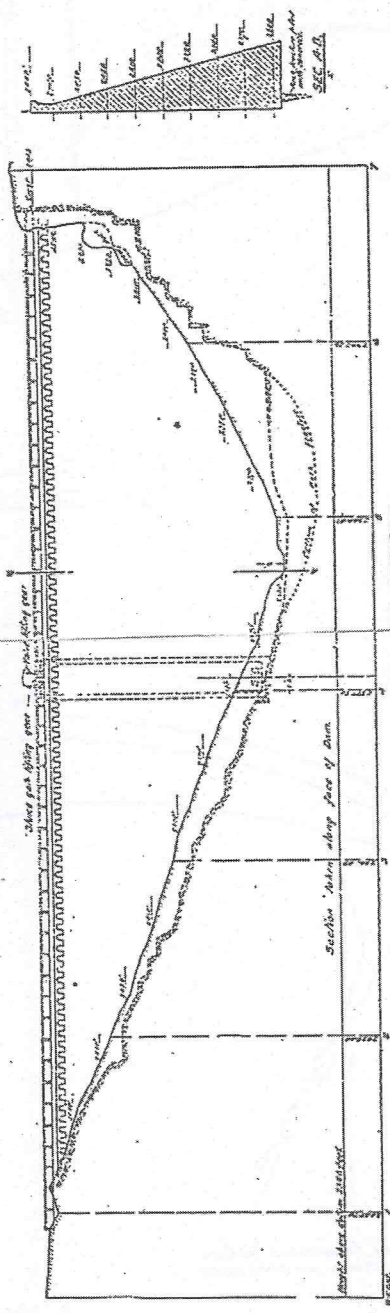
FIGURE No. 4.

**DEVELOPED ELEVATION**  
 Scale - 20 feet to an inch.

Contours are for ground surface  
 in 1913, as shown on P.M.D. 33062.
