Ministry of Works and Development

FALLS DAM SITE VISIT REPORT

Inspection 24 April 1985

Author: D.W. Richards

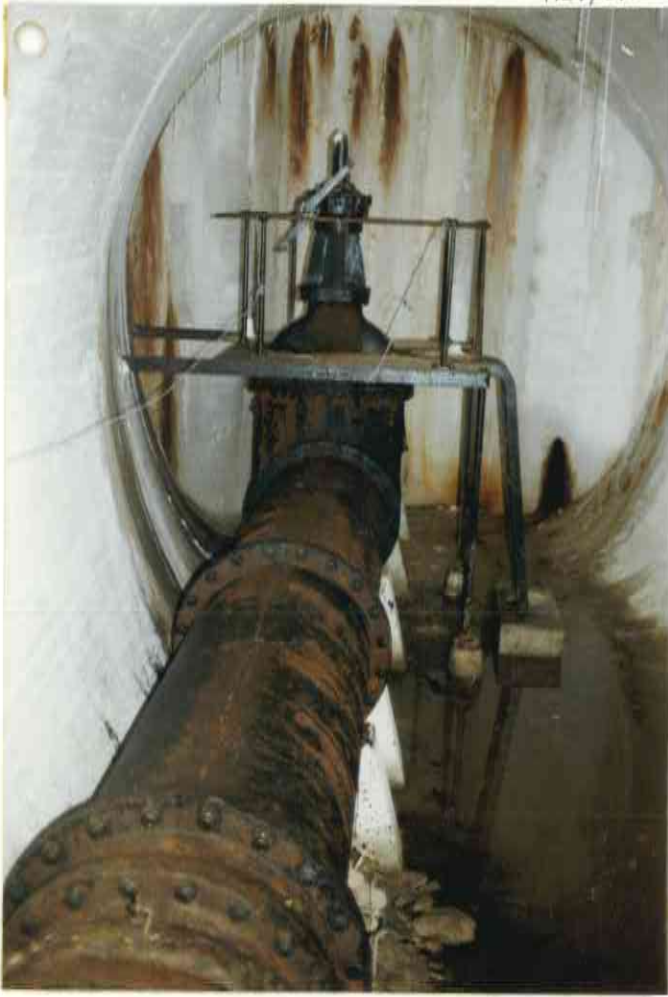
1. GATE VALVE

Externally the paint system used has large areas which have been lost because of corrosion. This is superficial and no cause for concern. The valve's travel indicator is missing.

The seat into which it sits is still in place on the screw thread and it would be a simple matter to replace the indicator. Closing the valve is quite a lengthy job because of the internal gearing (it took a little over 3000 revolutions to close) and this may be the reason why it is seldom used.

It is recommended that the travel indicator be reinstated and that the gate valve be serviced and its operation checked regularly, at least bi-annually.

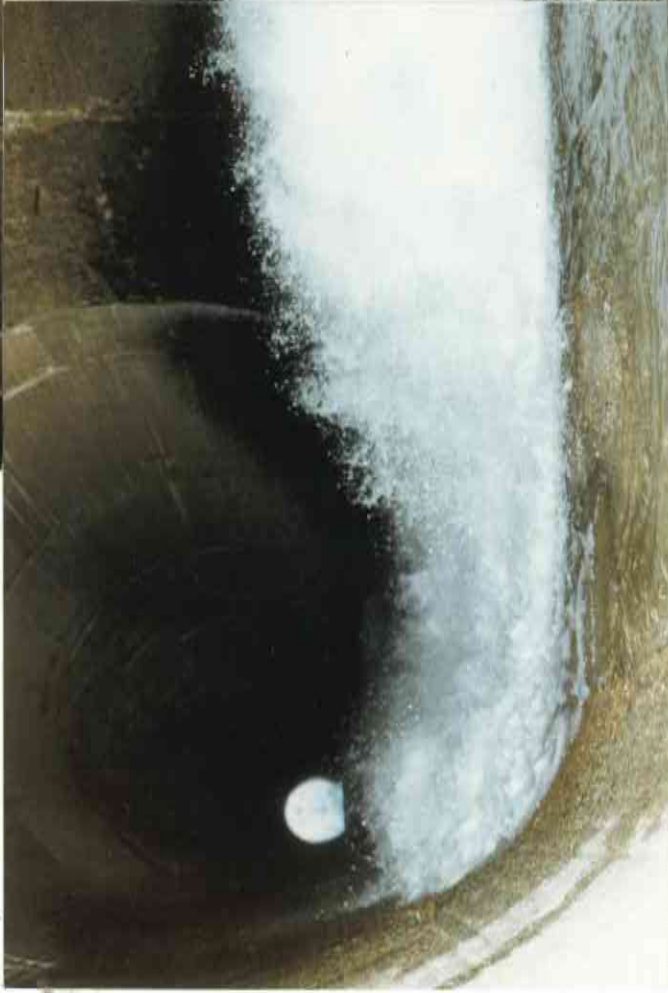
21. NEEDLE VALVE JET (AT LOW HEAD) AND VALVE CHAMBER BAY TR SHOWING VERTICAL CONSTRUCTION JOINTS

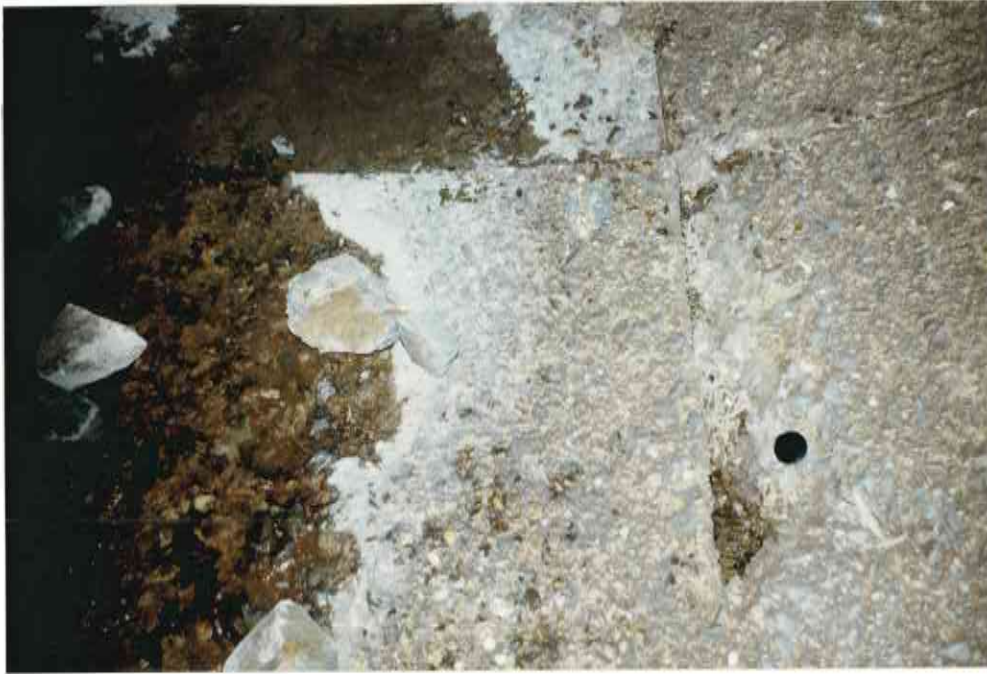
22. I/W jt HOLE TR JUST U/S OF JT 29/30

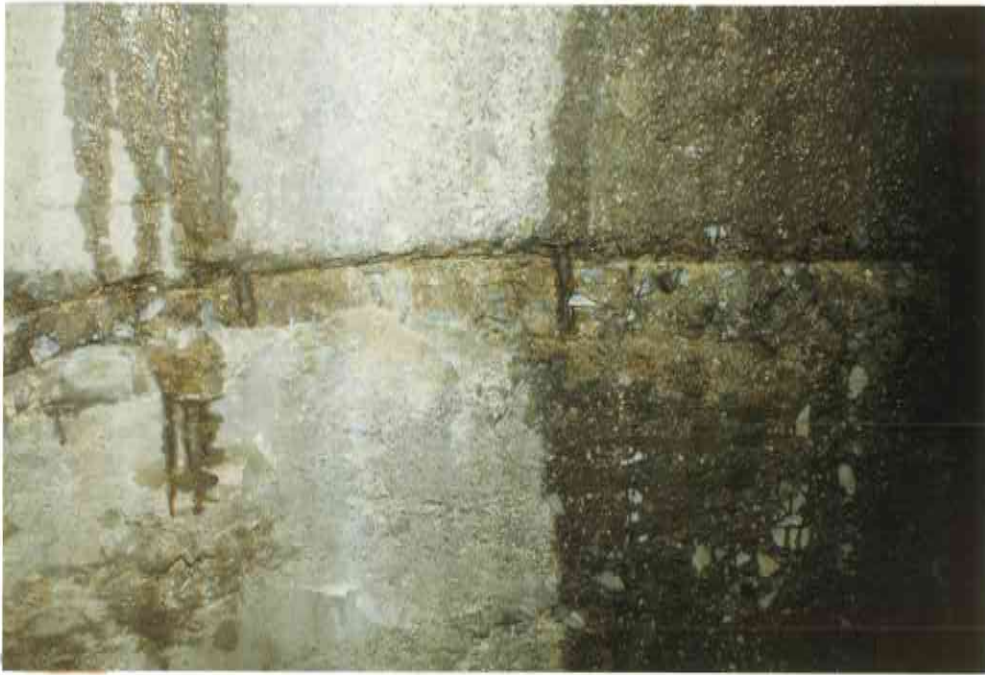
40. Jt 35/36 CROWN (D/S), EXPOSED STEEL, GAP 75mm DEEP, 150mm WIDE + 3m LONG, OLD PLASTER NOT ADHERING WELL ON THIS SIDE WHERE IT HAS BEEN APPLIED

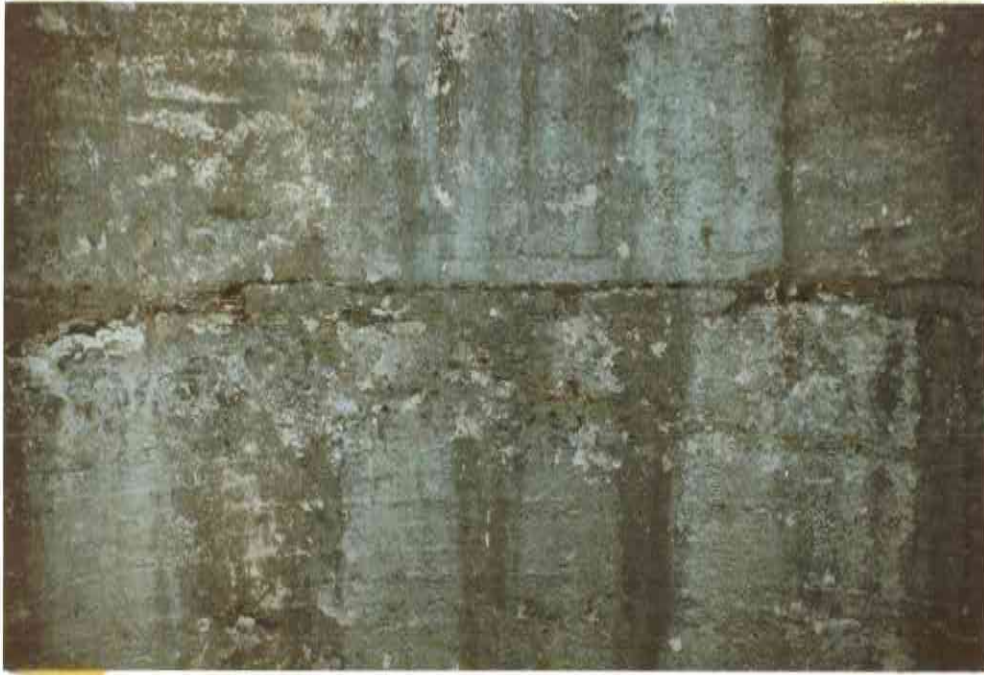
1122/4

49. Jt 37/38 TL, NOTE STEEL

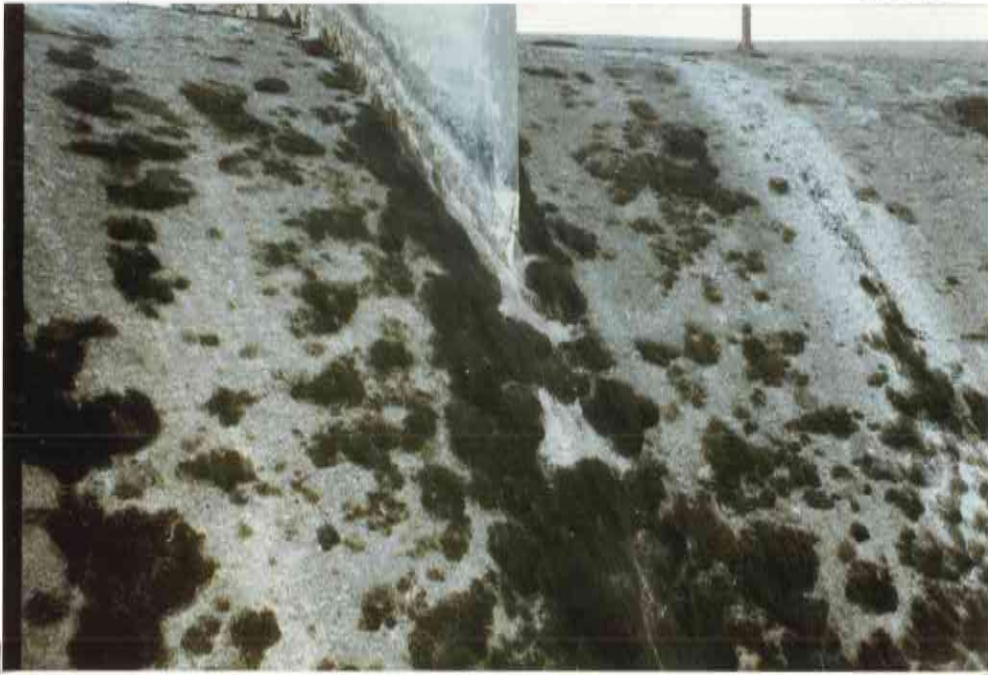
1122/24

69. JT 42/43 TL, ERODED 50mm WIDE, 100-150mm
DEEP

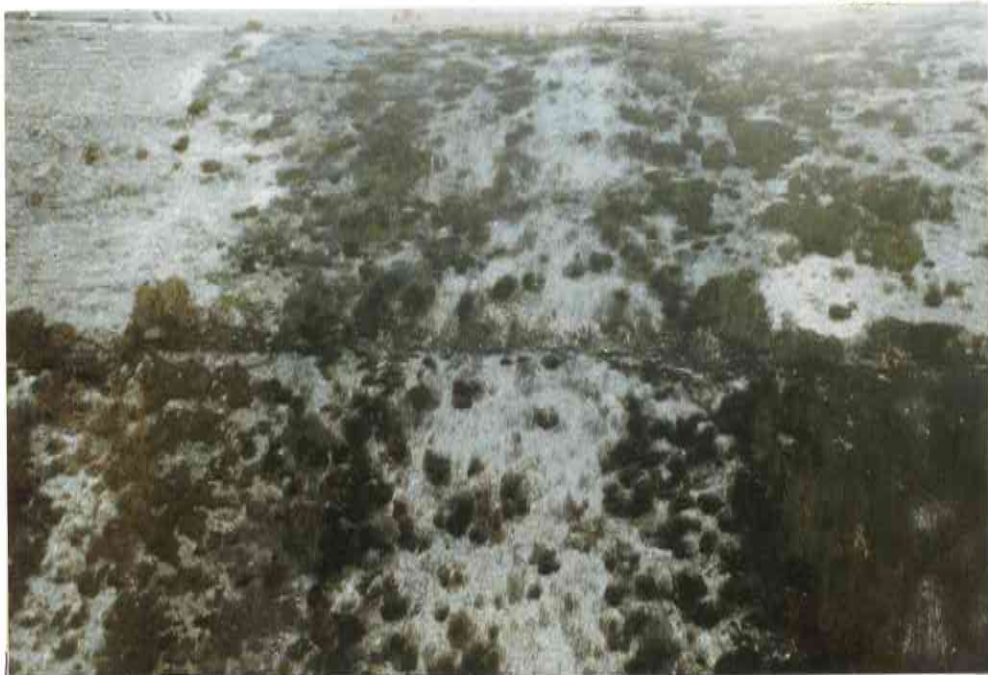
1122/23

70. Jf 42/43 D/S, ERRODED 200mm WIDE, 100-150mm DEEP, POSSIBLE STEEL EXPOSED

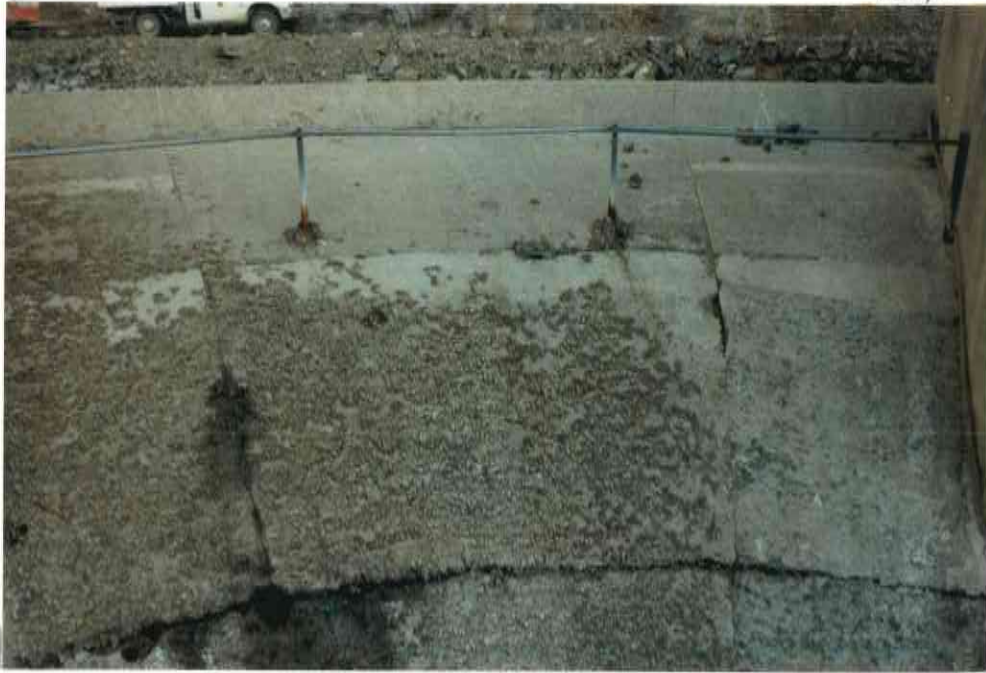
1126/3

73. BAY 1, AGGREGATE EXPOSED 70% AREA
NO STEEL EXPOSED IN PANEL

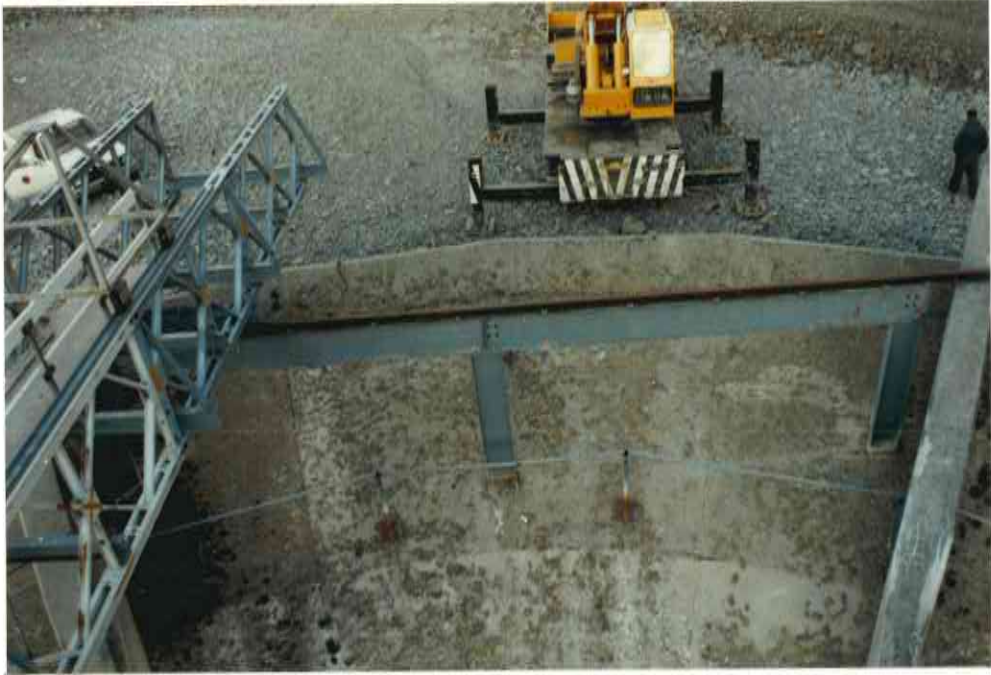
1126/8

79. BAY 6, MINOR SPALLING, WORSE THAN BAY 5, NOT SEVERE, MINOR PATCHING ONLY

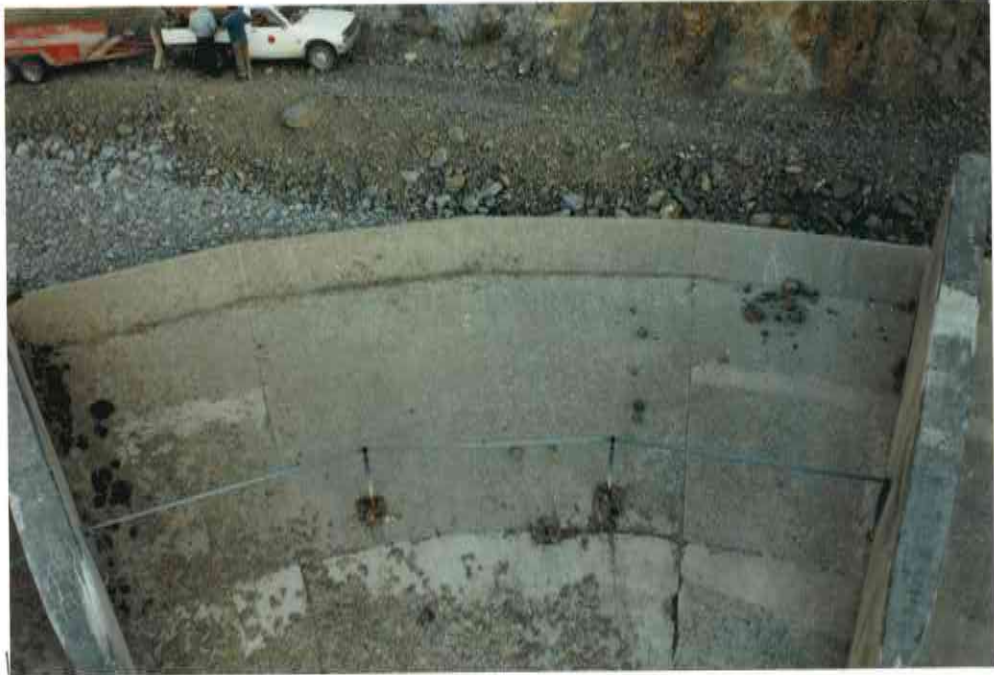
1126/9

80. BAY 1

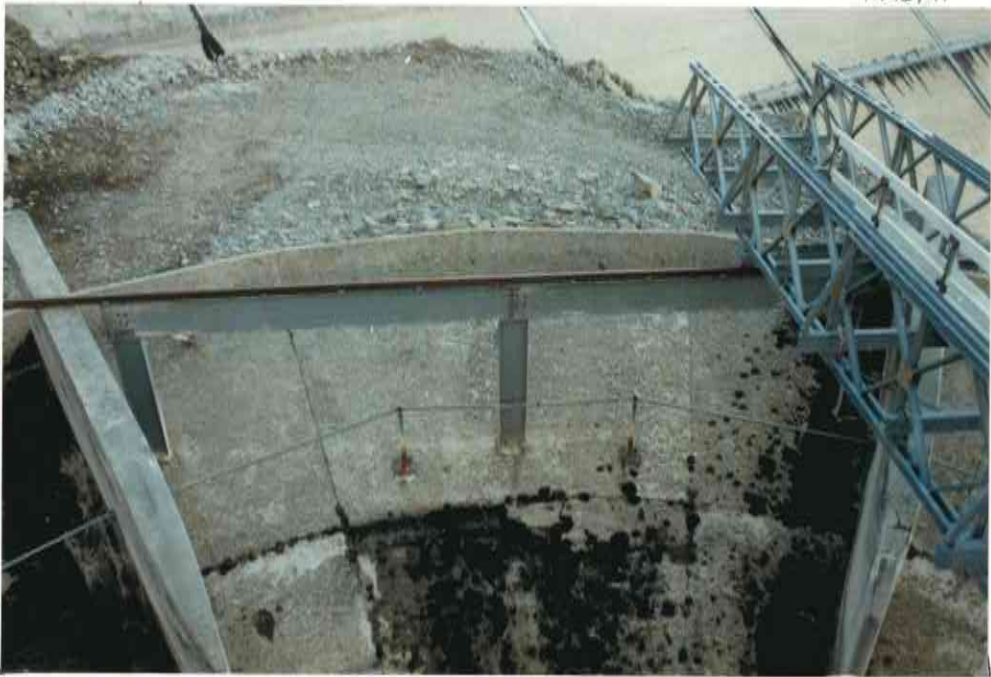
1126/11

82. BAY 3, REPAIR POOR CONSTRUCTION OF MID PANEL

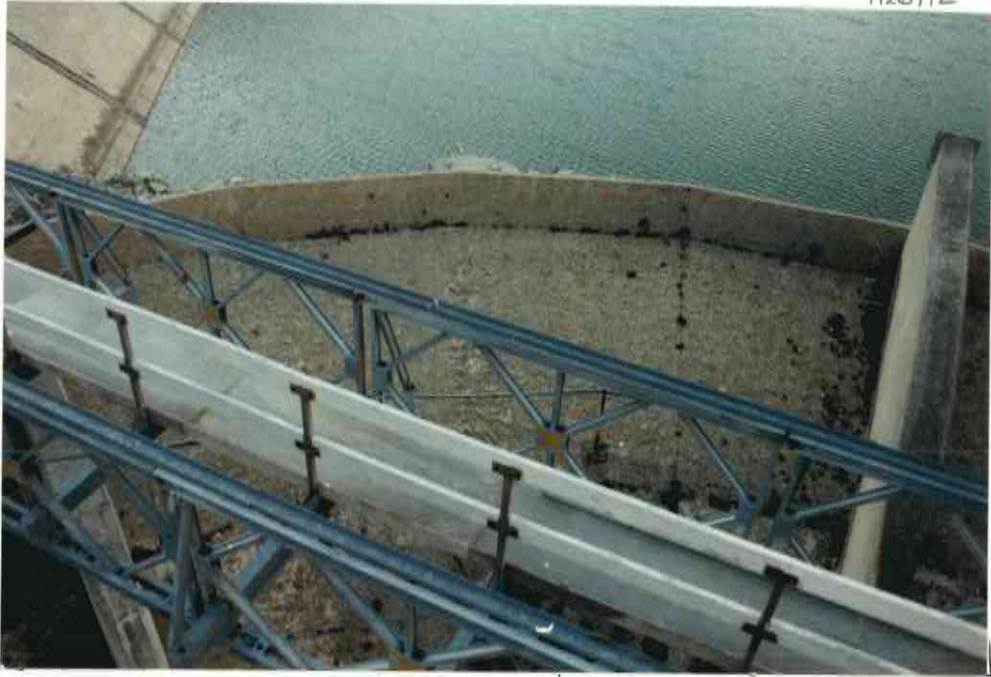
1126/12

83. BAY 4

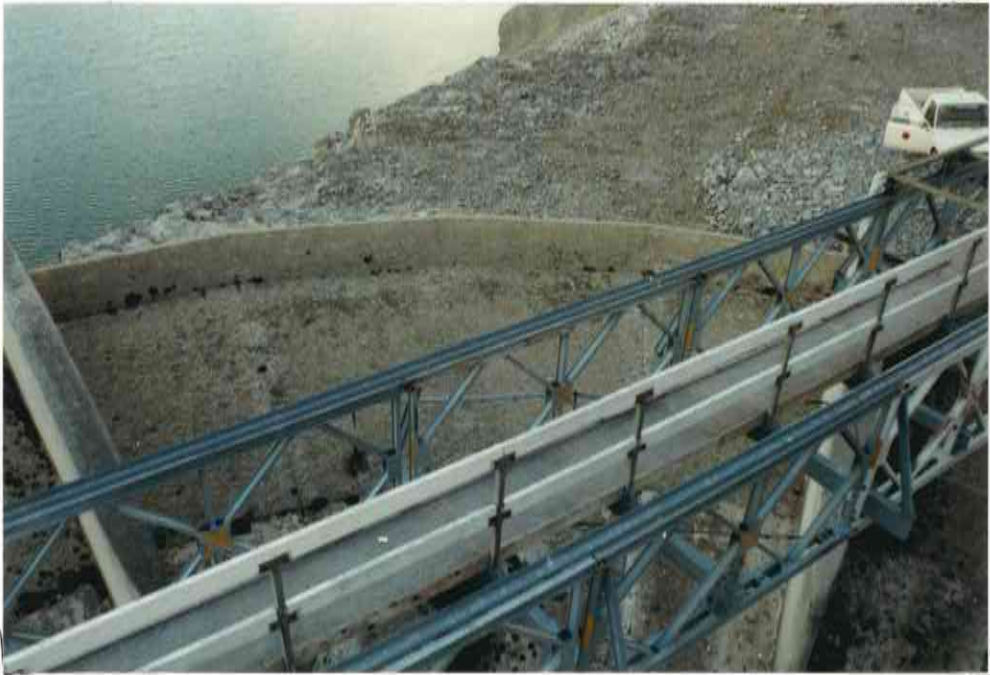
1126/13

84. BAY D

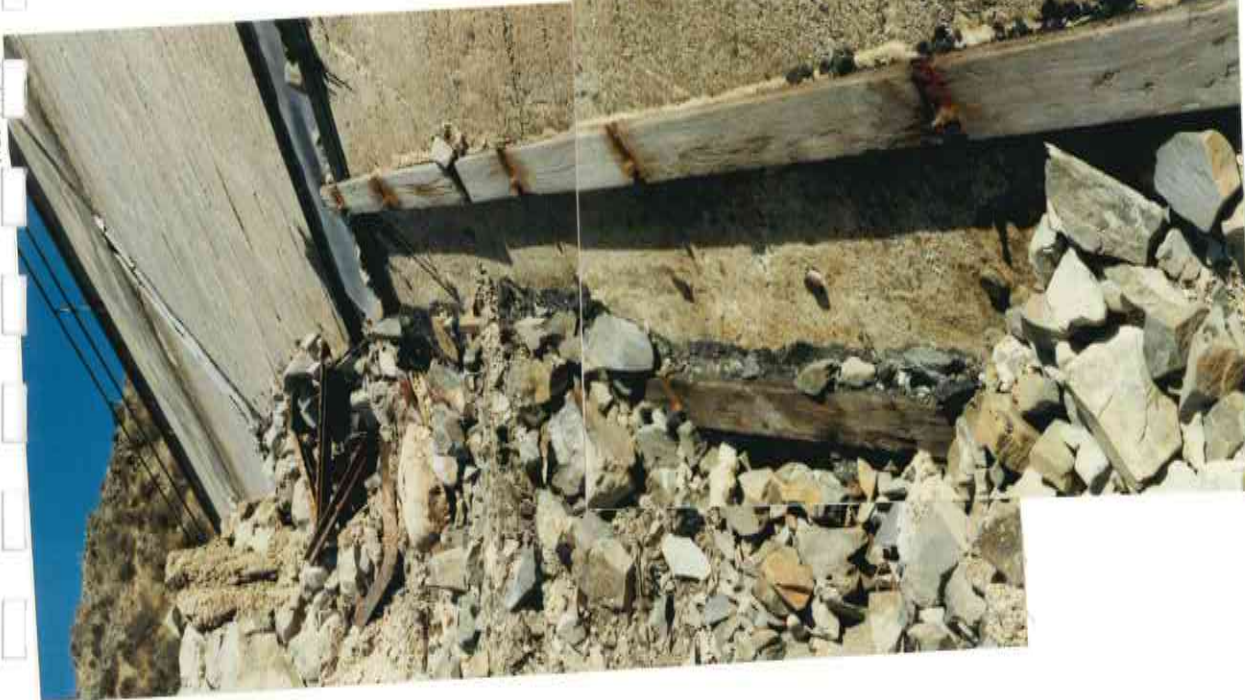
1127/19A

Photo 91: Close up of surface damage at normal water level between first and second panels

91. CLOSE UP OF SURFACE DAMAGE AT NORMAL WATER LEVEL BETWEEN FIRST + SECOND PANELS

The membrane appears to be in a relatively sound condition but should be separately inspected. This could be safely left until the spillway tunnel repairs are being undertaken. Meanwhile cracks and pitting visible on the surface of the concrete slab should be cleaned out and filled with Expocrete TG or similar.

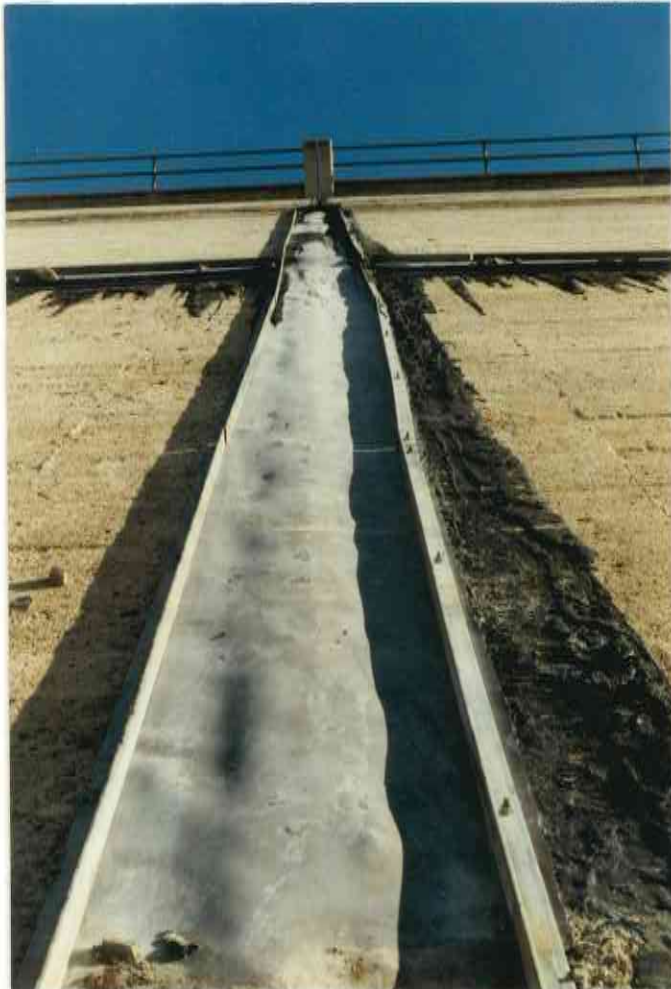
1127/16A

95. END OF SECOND HORIZONTAL JOINT WHERE IT COMES INTO THE TL ABUTMENT SHOWING HOW THE RUBBER STRIPS ARE HELD DOWN
